# Limited Wind Hardening Study Lealman Gymnasium

**5175 45th St. N.  
St. Petersburg, FL 33714**

Project No. MBAAC23005

Issue Date: September 28, 2023

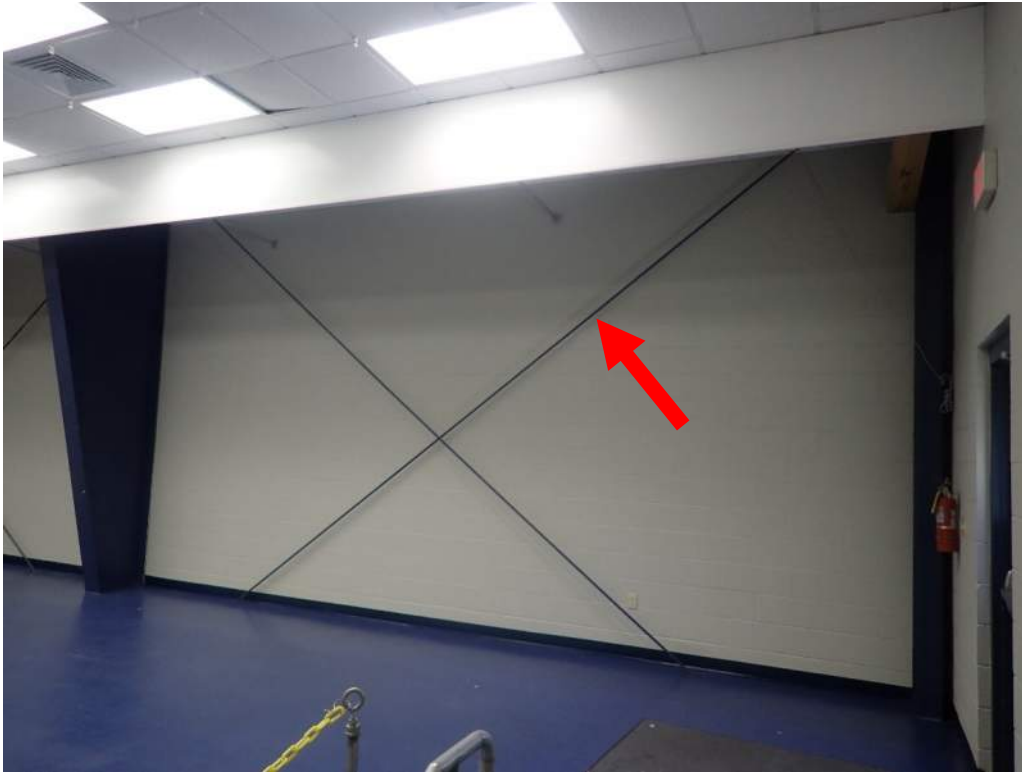
- Loose X bracing (wall) in the steel rigid frames, see **Photo 7-8**.
- Vegetation growth on roofing, see **Photo 9**. The roofing needs to be inspected by a registered roofing professional for leaks.

**Photograph 7 – Loose X bracing in Rigid Frames**

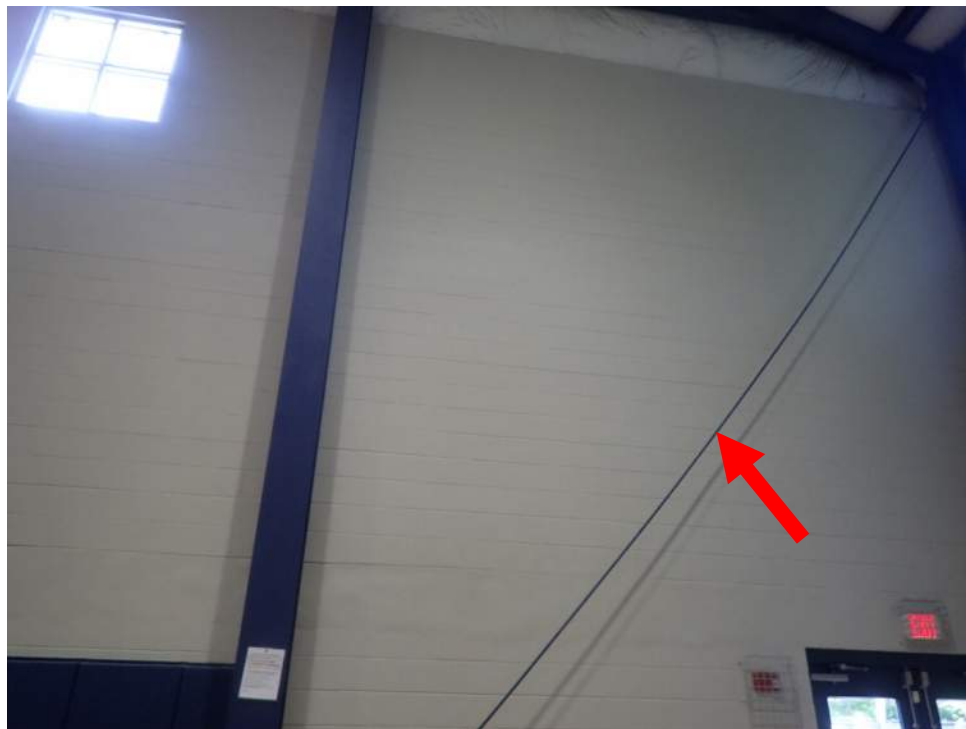
**Photograph 8 – Loose X Bracing between Rigid Frames**

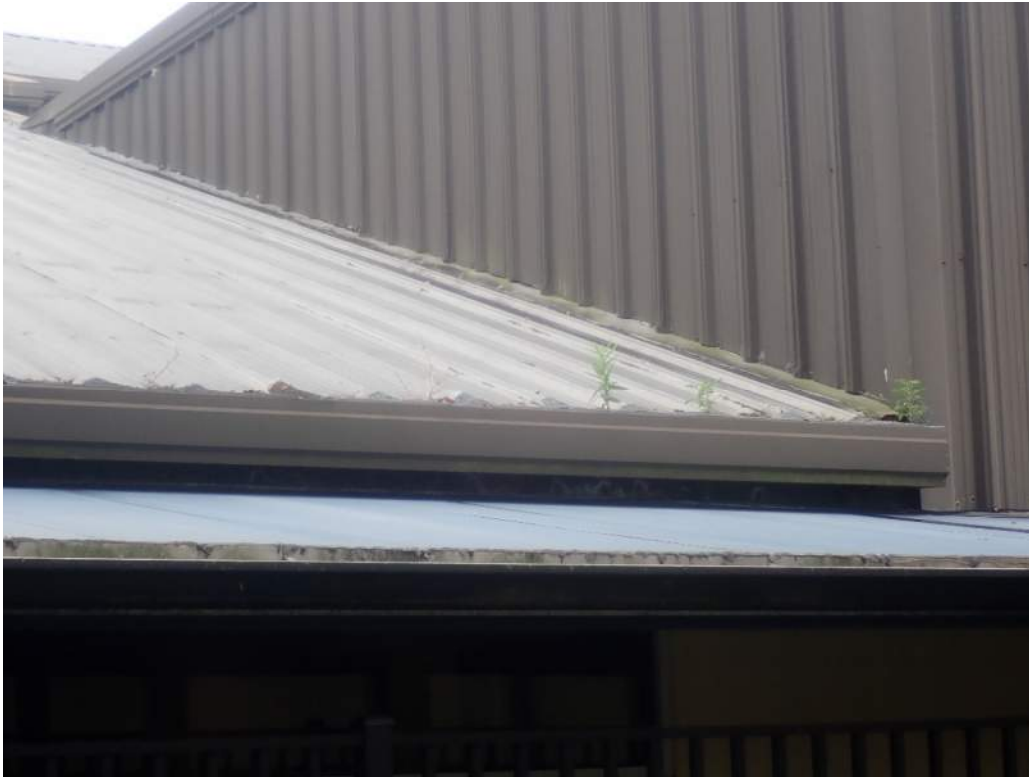
**Photograph 9 – Vegetation Growth at Roof Edges**

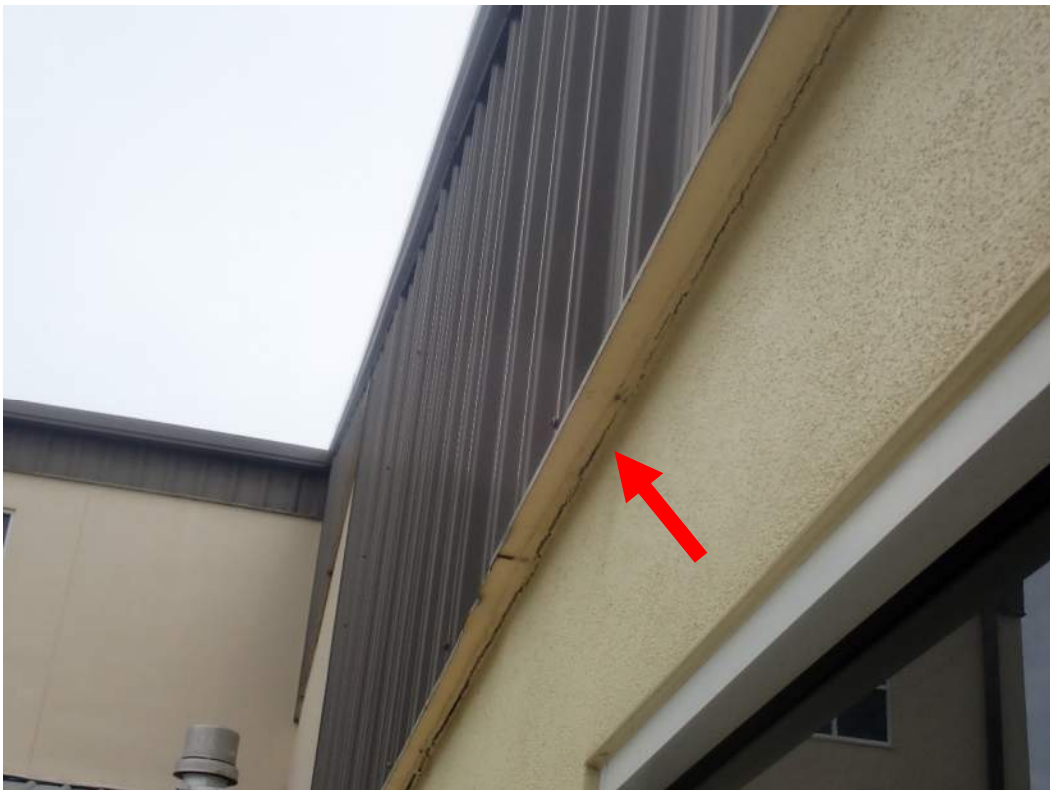
- Flashing damage at the ends of metal wall panels, see **Photo 10**.
- Water intrusion is reported from the louvers in end walls. Source of water intrusion is not known.

**Photograph 10 – Damage and Separation at Metal Wall Flashing**

| <b>Required Harding / Improvements</b> |
|---|
| 9) Repair damaged flashing in exterior metal wall panels to prevent water intrusion. |

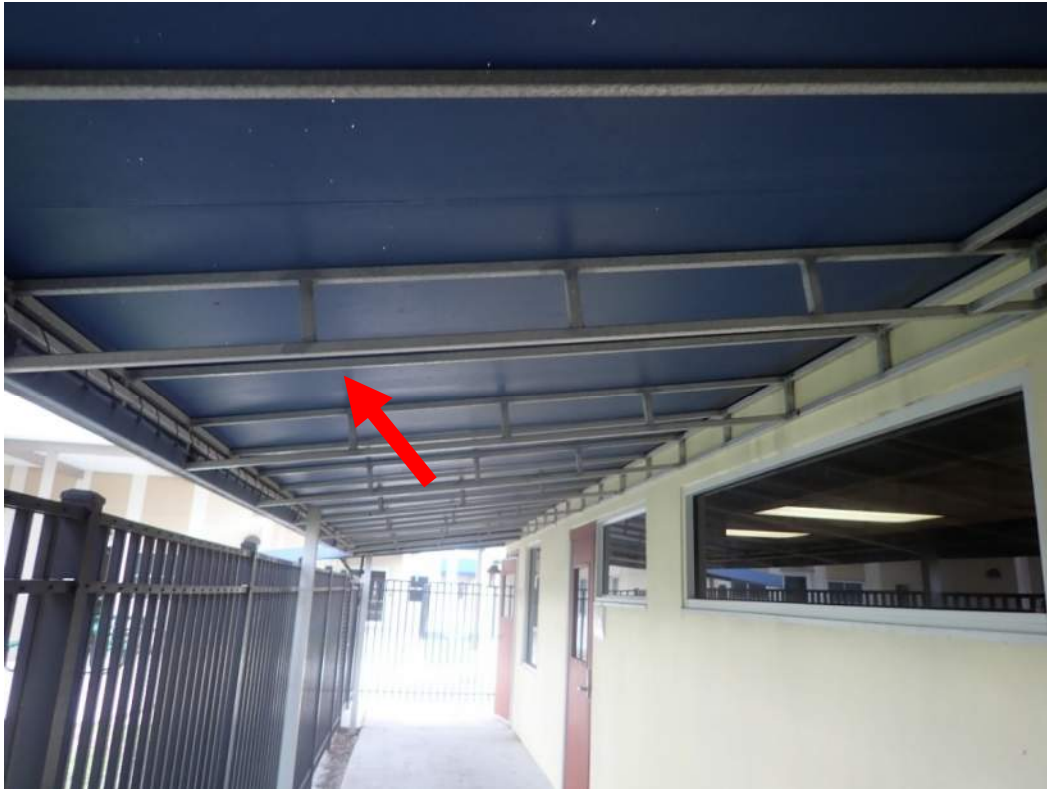
**Photograph 11 – Canopy Attached To Exterior Walls**

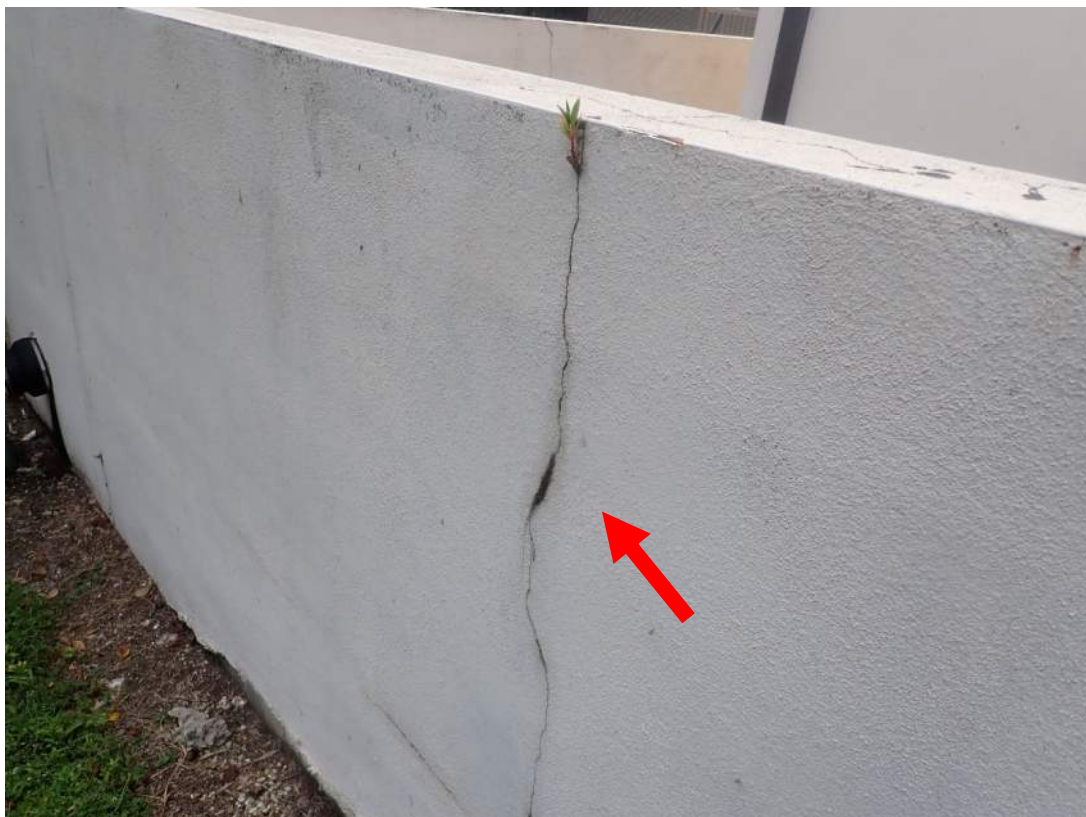
- The site retaining/screen wall located along the rear of the building had cracking. The cracking appears to be due to expansion and contraction of the wall. The wall does not appear to have vertical masonry control joints as specified in the original construction documents. See **Photos 12 and 13**.

**Photograph 12 – Cracks In Site Wall At South East Corner**

REPAIR CRACKS IN  
SITE RETAINING  
WALL. SEE  
PHOTOS 12 and 13  
IN EXHIBIT A

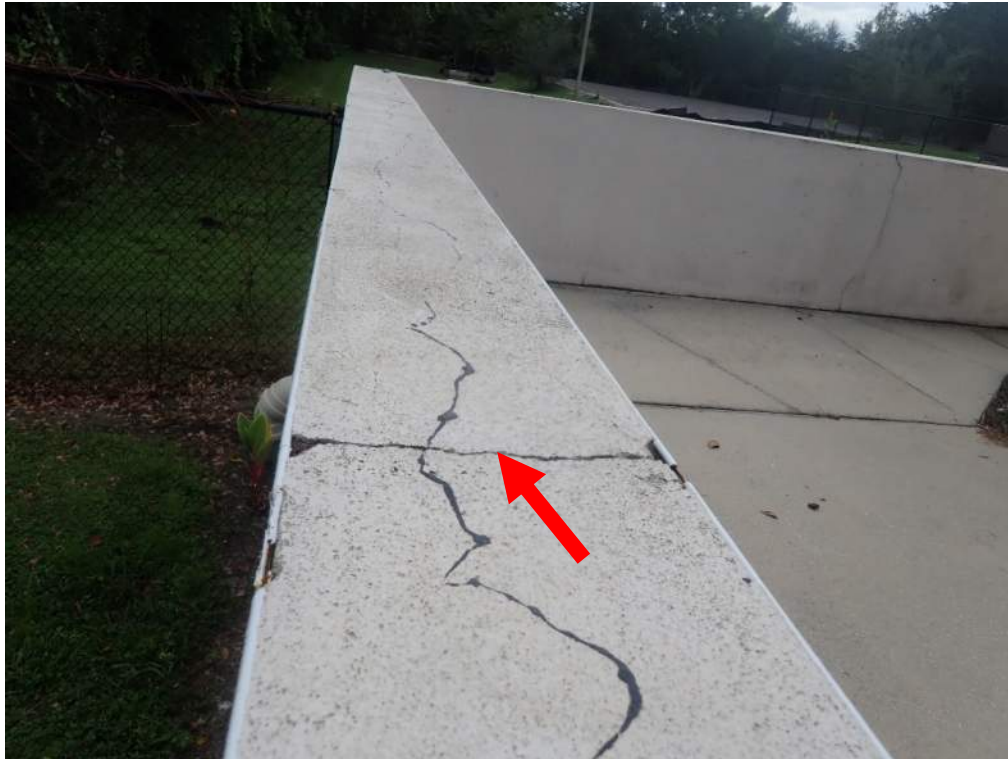
**Photograph 13 –Cracks In Site Wall At South East Corner**

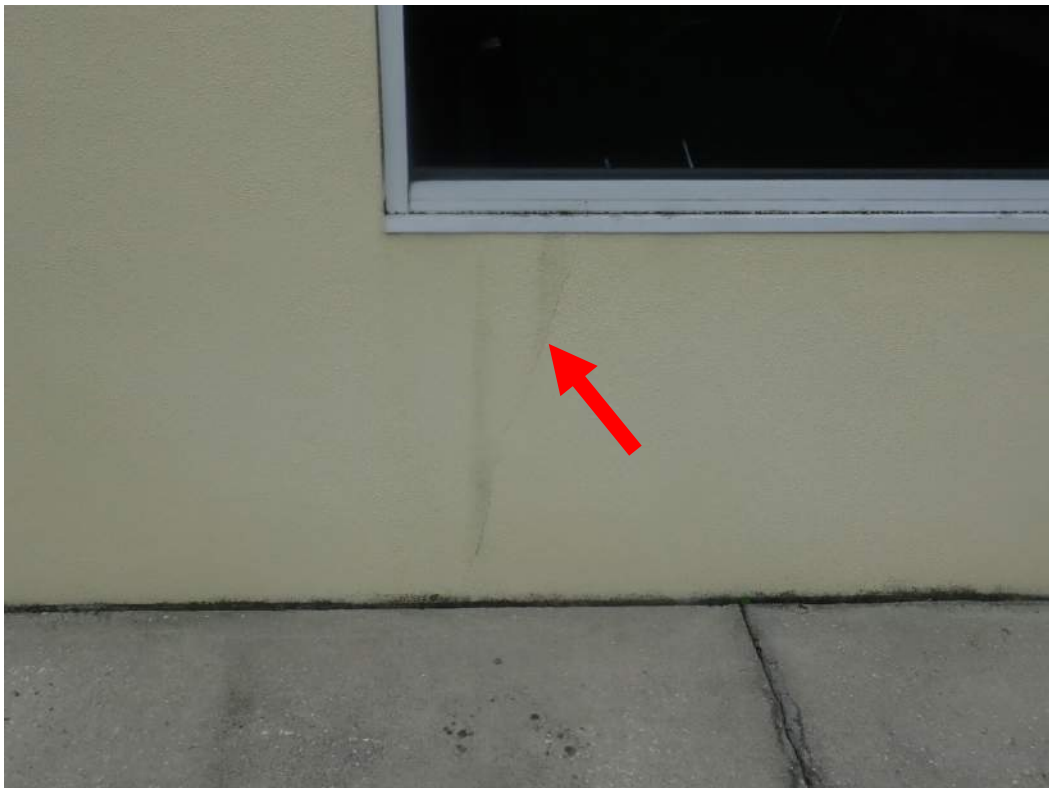
- Stucco cracking was noted between the windows. The wall was noted to be absent of control or expansion joints to mitigate the effects of thermal expansion and contraction of the building. The cracking is cosmetic in nature. See **Photos 14 and 15**.

**Photograph 14 – Example of Stucco Cracks Near Windows In Exterior Walls of Gym**

| <b>Required Harding / Improvements</b> |
|---|
| 11) Repair of minor masonry and stucco cracking by repointing to mitigate water intrusion. |

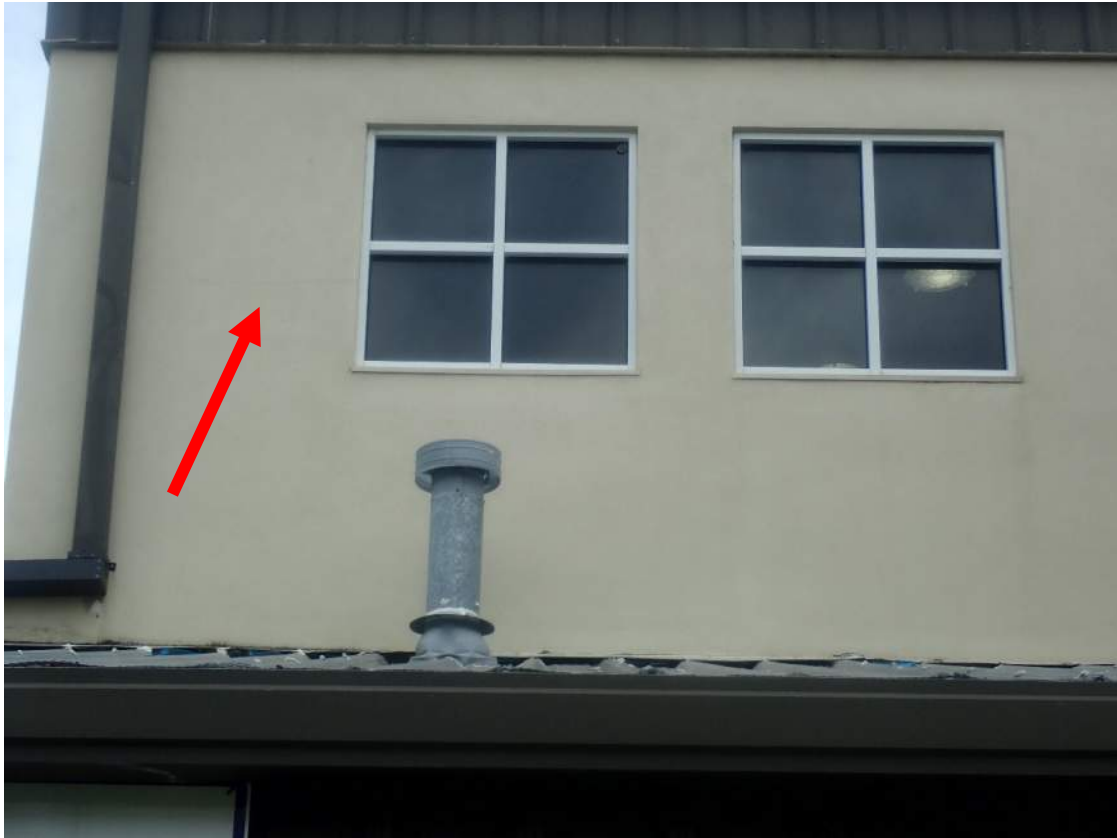
**Photograph 15 – Example of Stucco Cracks Near Windows In Exterior Walls of Gym**

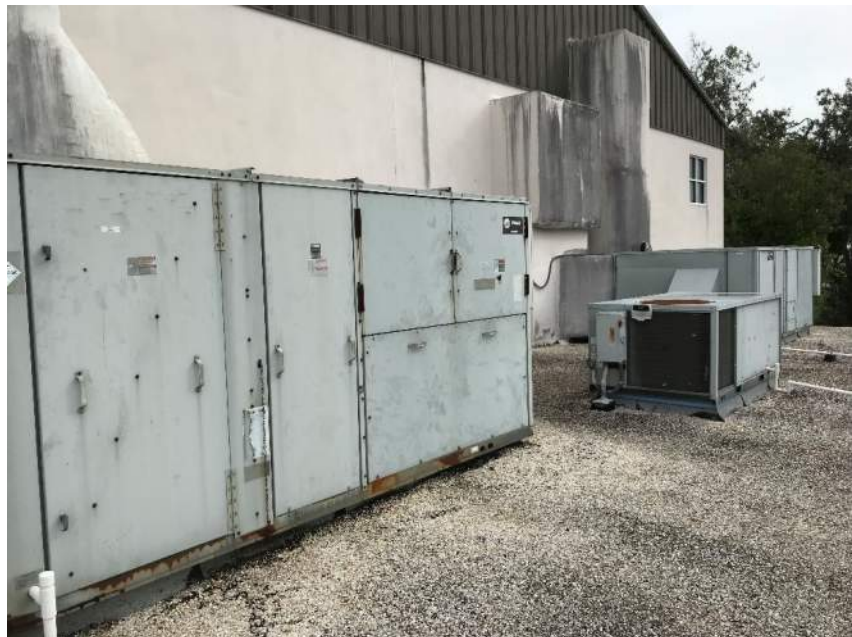
##### GYM ROOFTOP UNITS

The Gymnasium's play-court side of the building is serviced by three, packaged, DX, rooftop units (i.e., 1, 25-ton, 1, 30 ton, and 1, 5-ton unit). The rooftop units are nearing the end of their useful life. The office and meeting room side of the building is serviced by four, split system, DX air conditioning units. These units range in size from 3.5-tons to 15-tons. The condensing units are located on-grade adjacent to the building and the air handler units are in mechanical equipment rooms or above ceiling. The split system DX units are nearing the end of their useful life.
