SITE INSPECTION REPORT - 4828 Helene

CATEGORY G - PARKS, RECREATION, CEMETERY, OTHER

| Physical Location (Address of Damage Site) 9600 Bay Pines Boulevard St. Petersburg, Florida 33708 | Date Damaged <i>Sept 24, 2024</i> | Age of Facility <input type="checkbox"/> Exact <input checked="" type="checkbox"/> Approximate Year Built: <i>1974</i> | Legal Responsibility <input checked="" type="checkbox"/> Yes <input type="checkbox"/> No |

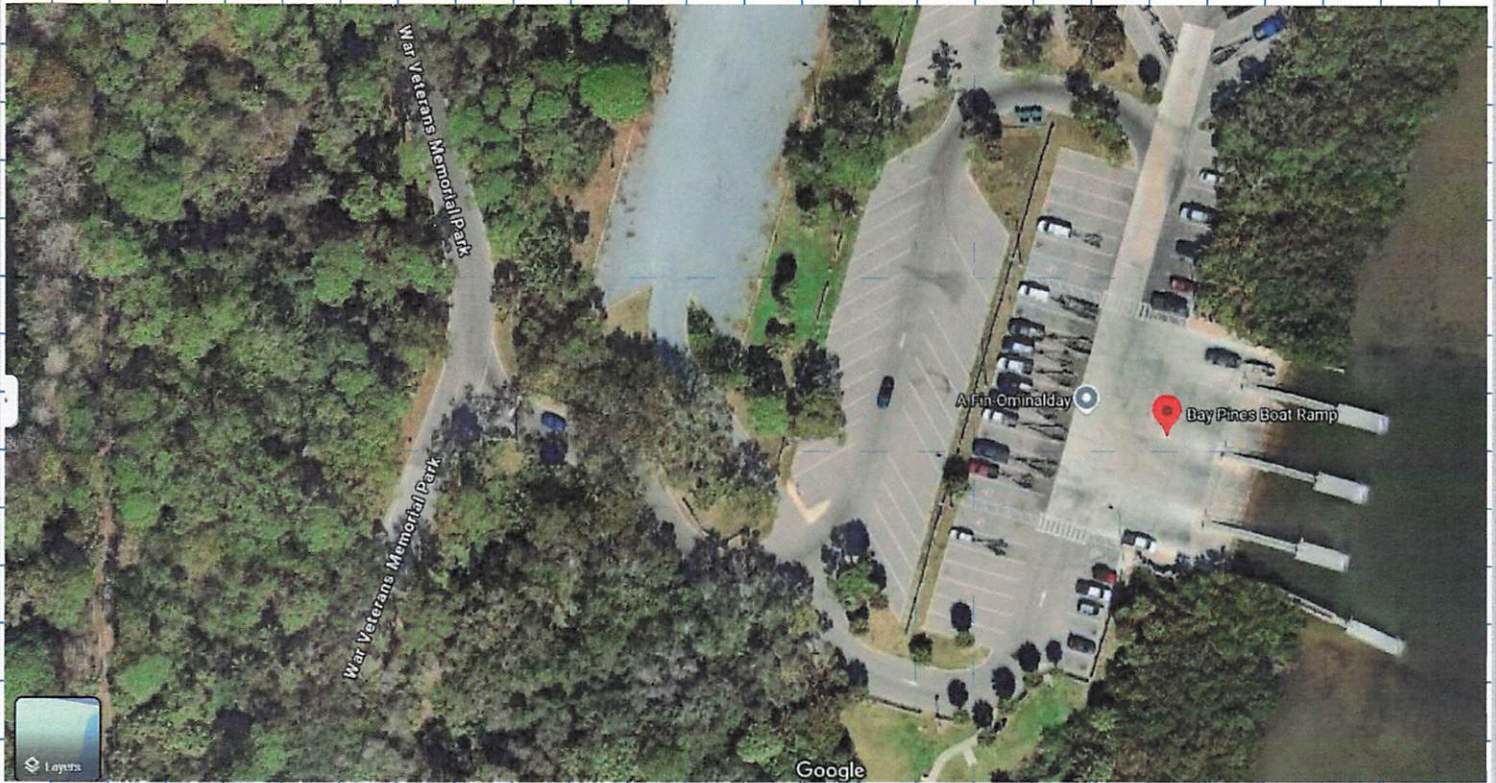
SKETCH: (Click grid to upload an image):

Storm surge - flooding 3 of 4 detached
4 gangways became detached
and have been disposed
3ft of surge water pressure pushed the doors
inward on building

Comments: The materials will change from wood to concrete and high-grade aluminum. The docks will also be extended & the piles raised higher.
