# Limited Wind Hardening Study Lealman Gymnasium

**5175 45th St. N.  
St. Petersburg, FL 33714**

Project No. STHAX26009

Re- Issue Date: July 16, 2026

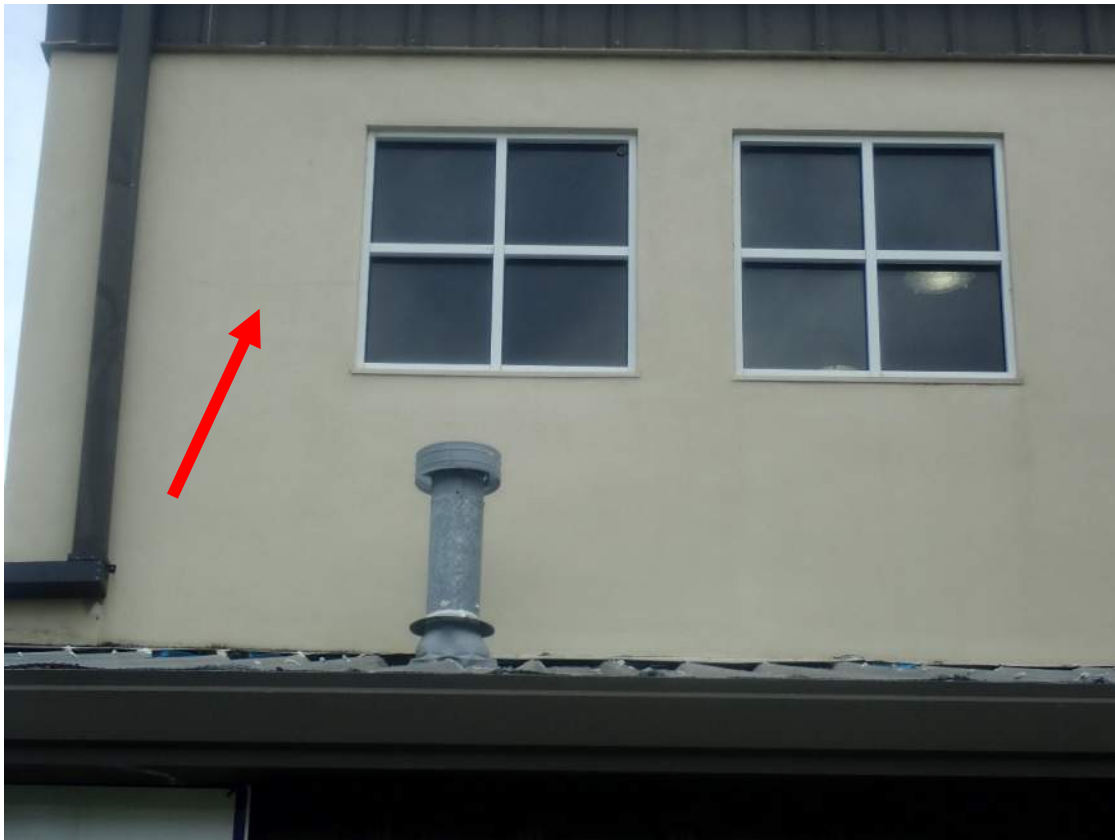
- Stucco cracking was noted between the windows. The wall was noted to be absent of control or expansion joints to mitigate the effects of thermal expansion and contraction of the building. The cracking is cosmetic in nature. See **Photos 14 and 15**.

**Photograph 15 – Example of Stucco Cracks Near Windows In Exterior Walls of Gym**

| <b>Required Hardening / Improvements</b> |
|---|
| 11) Repair of minor masonry and stucco cracking by repointing to mitigate water intrusion. |

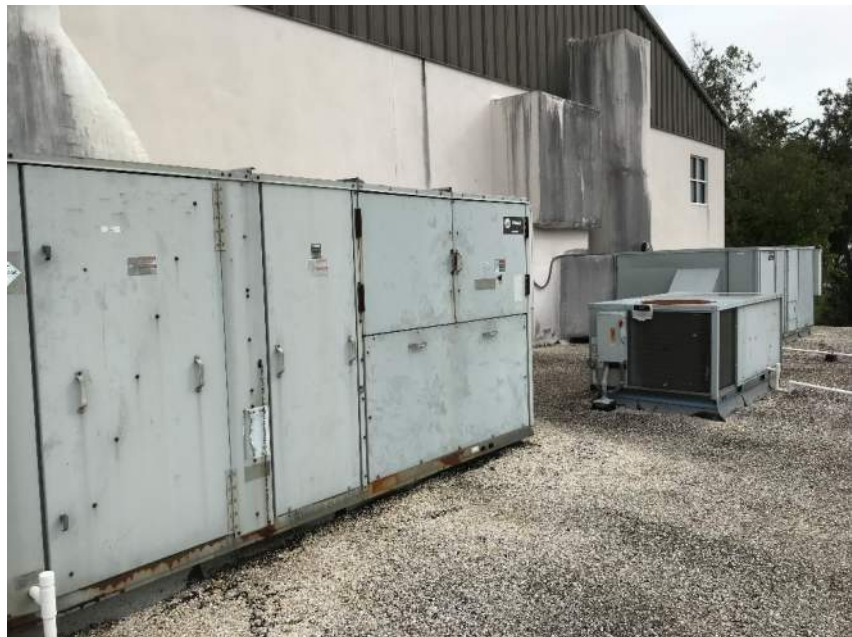
##### **GYM ROOFTOP UNITS**

The Gymnasium's play-court side of the building is serviced by three, packaged, DX, rooftop units (i.e., 1, 25-ton, 1, 30 ton, and 1, 5-ton unit). The rooftop units are nearing the end of their useful life. The office and meeting room side of the building is serviced by four, split system, DX air conditioning units. These units range in size from 3.5-tons to 15-tons. The condensing units are located on-grade adjacent to the building and the air handler units are in mechanical equipment rooms or above ceiling. The split system DX units are nearing the end of their useful life.
