RE: Demand for Immediate Investigation and Remediation of Private Property Damage Due to
Extensive and Continuing Soil Subsidence Within Pinellas County Drainage Easement.
Subject Property: 35 Velma Drive West, Largo FL
Property Owners: Cathy L Doxsey & Laura A Havlin.

Revised: July 14, 2021
AEI Project No.: APGT-21-013

SUBJECT: Geotechnical Investigation, Doxsey Residence, 35 Velma Drive West, Largo, Florida

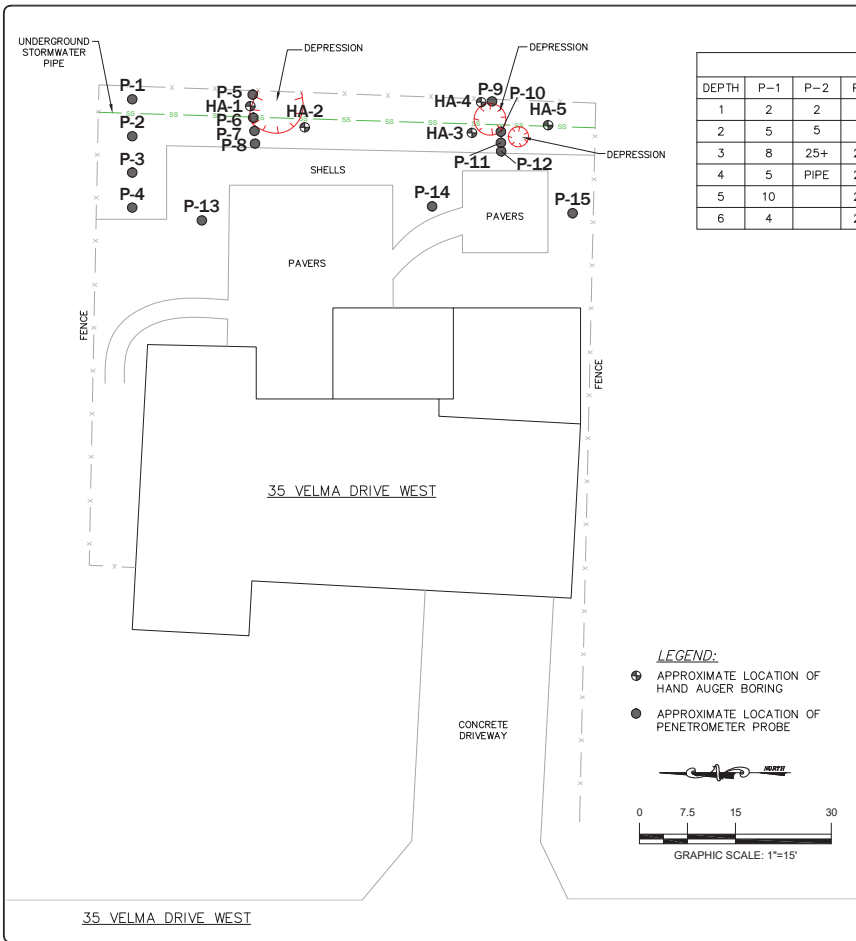
Andreyev Engineering, Inc.	GEOTECHNICAL INVESTIGATION DOXSEY RESIDENCE 35 VELMA DRIVE WEST LARGO, PINELLAS COUNTY, FL	
	BORING LOCATION PLAN FIGURE 2	
APPROXIMATE SCALE: 1"=15'	DATE: 03/04/21 PN: APGT-21-013	ENGINEER: JE DRAWN BY: DLS

Based on the results of the penetrometer readings, the sandy soils at the locations tested ranged from very loose to very dense. The very loose conditions were generally encountered adjacent to the buried pipe and depressional areas, with the denser readings coming from locations further away from the pipe.

The relative density measurements collected indicate that the soil density generally decreases at locations closer to the storm pipe, which could indicate the migration of sandy soils into a leaky storm pipe. In our professional opinion we feel that it is likely that the observed surface depressions were caused by the migration of sandy soils into the cracks and/or joints of the storm sewer system.

During the advancement of the hand auger borings, and in a grid around the buried stormwater pipe, a cone penetrometer was used to collect relative density measurements of the undisturbed soils. The grid layout is displayed on **Figure 2**. The results of the penetrometer readings are presented adjacent to the penetrometer locations on **Figure 2** and soil profiles on **Figure 3**. Based on the results of the penetrometer readings, the sandy soils at the locations tested ranged from very loose to very dense. The very loose conditions were generally encountered adjacent to the buried pipe and depressional areas, with the denser readings coming from locations further away from the pipe. Correlation of the penetrometer values with relative density are provided in the following table:

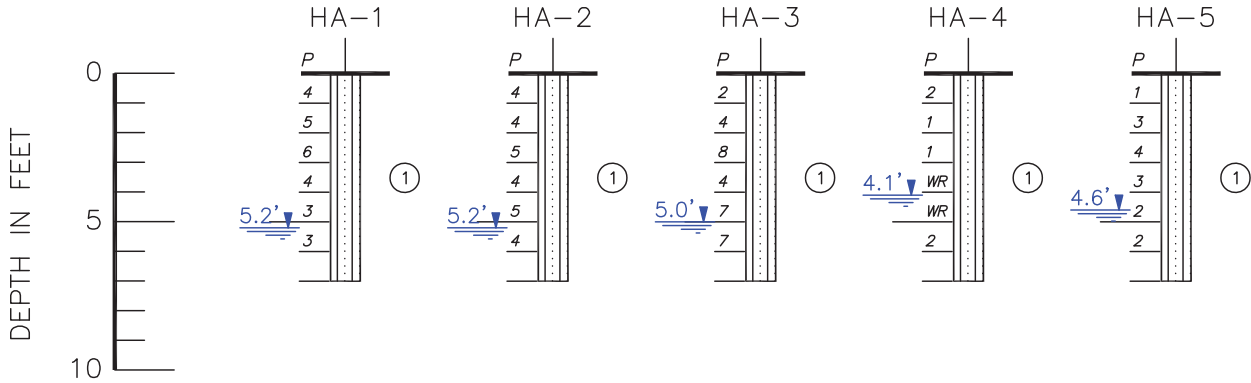
Andreyev Engineering, Inc.	GEOTECHNICAL INVESTIGATION DOXSEY RESIDENCE 35 VELMA DRIVE WEST LARGO, PINELLAS COUNTY, FL	
	APPROXIMATE SCALE: 1" = 5'	DATE: 03/04/21 PN: APGT-21-013
SOIL PROFILES		FIGURE 3

In general, the borings encountered slightly silty fine sand (Stratum 1) from the ground surface to the termination depth of 7 feet below land surface (bls).

The shallow groundwater table was encountered at depths of 4.1 to 5.2 feet bls in the hand auger borings conducted for this study. The shallow groundwater level should be expected to vary during wet seasons and heavy rainfall events.
