Applicant: Pinellas County		Damage Inventory # 1525703	Category D
Work Order # 108615	FIPS # 103-99103-00	Date: 05/05/25	GPS
Site Inspector: Miguel Lazu		Damage Facility: Fort Desoto Park - Southwest Point Seawall

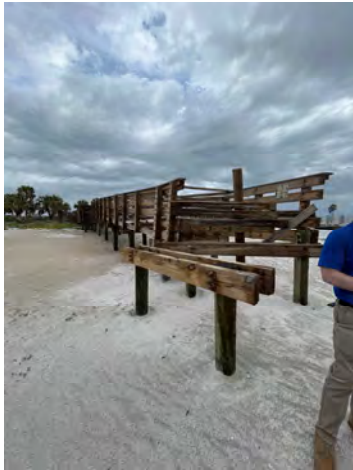
Damage Description: Photo# 1
Pier #1 and Pier #2, 1 each of wood, BLUEPRINT WILL BE PROVIDED BY APPLICANT, storm surge and rising waters, 0% work completed.

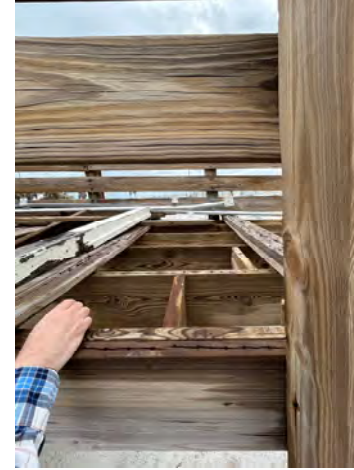
Damage Description: Photo# 2
Pier #1 and Pier #2, 1 each of wood, BLUEPRINT WILL BE PROVIDED BY APPLICANT, storm surge and rising waters, 0% work completed.

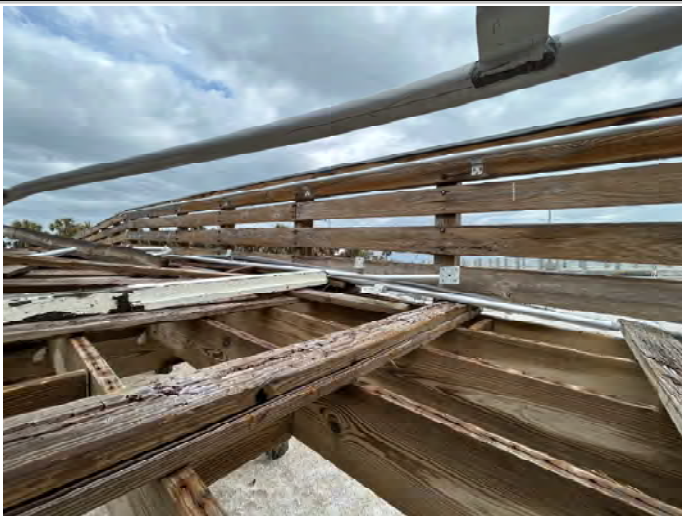
Damage Description: Photo# 3
Pier #1 and Pier #2, 1 each of wood, BLUEPRINT WILL BE PROVIDED BY APPLICANT, storm surge and rising waters, 0% work completed.

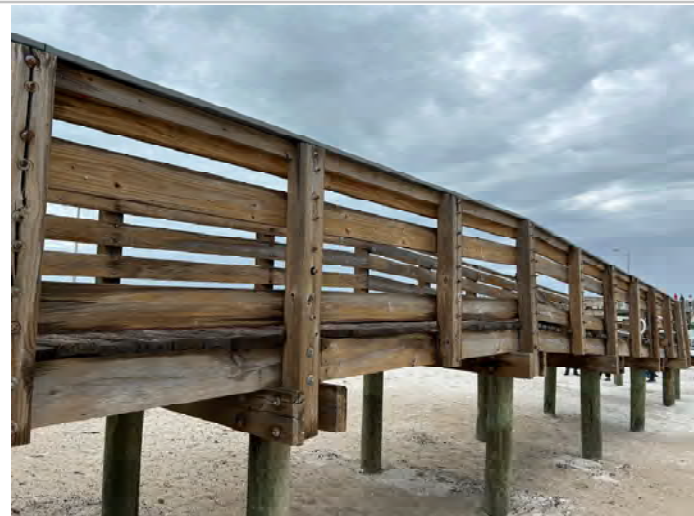
Damage Description: Photo# 4
Pier #1 and Pier #2, 1 each of wood, BLUEPRINT WILL BE PROVIDED BY APPLICANT, storm surge and rising waters, 0% work completed.

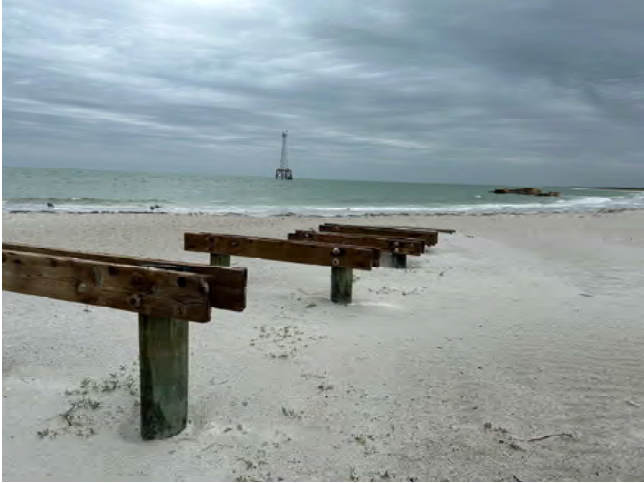
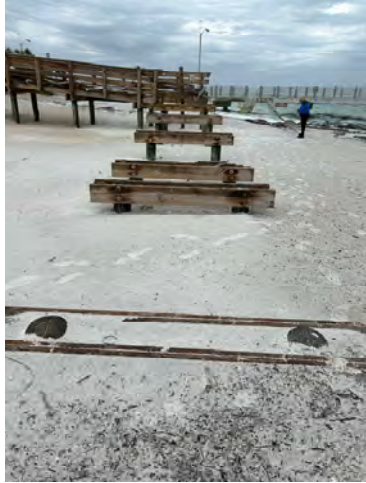
Applicant: Pinellas County		Damage Inventory # 1525703		Category D	
Work Order# 108615		FIPS # 103-99103-00		Date: 05/05/25 GPS	
Site Inspector: Miguel Lazú		Damage Facility: Fort Desoto Park - Southwest Point Seawall			
Damage Description:		Photo# 5		Damage Description:	
Pier #1 and Pier #2, 1 each of wood, BLUEPRINT WILL BE PROVIDED BY APPLICANT, storm surge and rising waters, 0% work completed.				Pier #1 and Pier #2, 1 each of wood, BLUEPRINT WILL BE PROVIDED BY APPLICANT, storm surge and rising waters, 0% work completed.

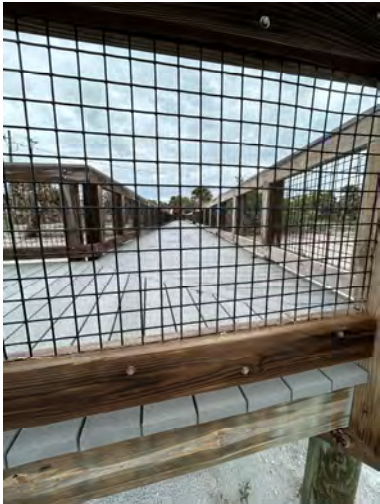
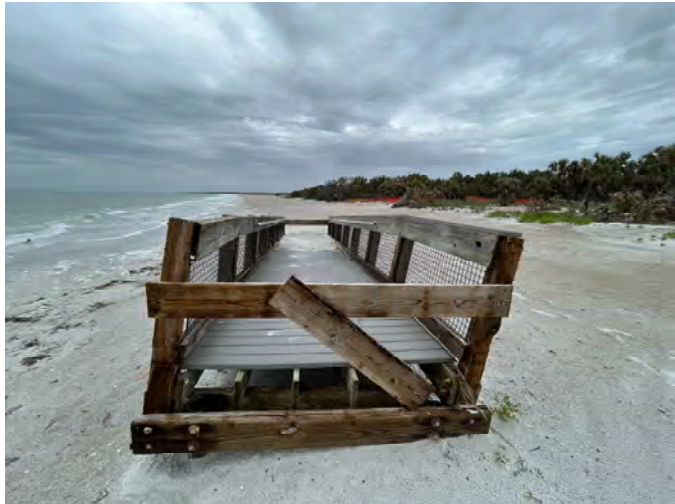
Damage Description:		Photo# 7		Damage Description:	
Pier #1 and Pier #2, 1 each of wood, BLUEPRINT WILL BE PROVIDED BY APPLICANT, storm surge and rising waters, 0% work completed.				Pier #1 and Pier #2, 1 each of wood, BLUEPRINT WILL BE PROVIDED BY APPLICANT, storm surge and rising waters, 0% work completed.

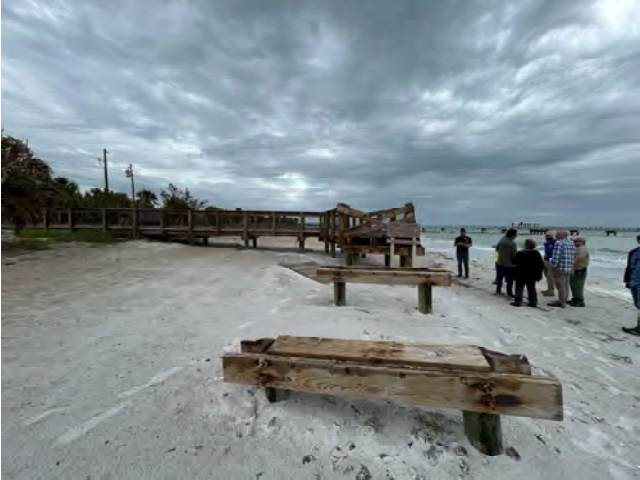
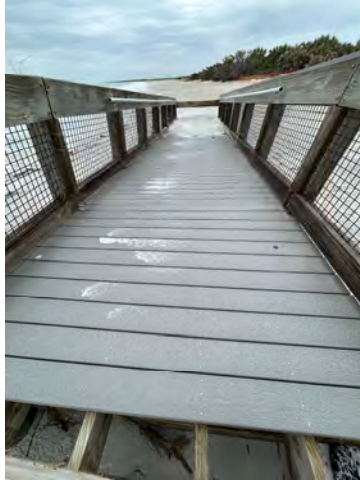
Applicant: Pinellas County		Damage Inventory # 1525703		Category D	
Work Order # 108615		FIPS # 103-99103-00		Date: 05/05/25	
Site Inspector: Miguel Lazu				GPS	
				Damage Facility: Fort Desoto Park - Southwest Point Seawall	
Damage Description:		Photo# 9		Damage Description:	
Pier #1 and Pier #2, 1 each of wood, BLUEPRINT WILL BE PROVIDED BY APPLICANT, storm surge and rising waters, 0% work completed.				Pier #1 and Pier #2, 1 each of wood, BLUEPRINT WILL BE PROVIDED BY APPLICANT, storm surge and rising waters, 0% work completed.

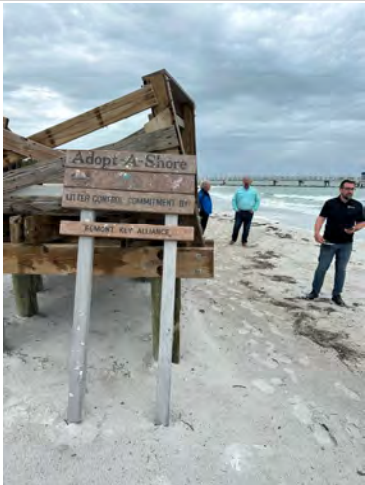
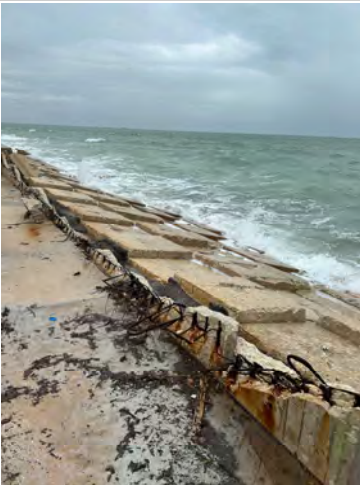
Damage Description:		Photo# 11		Damage Description:	
Pier #1 and Pier #2, 1 each of wood, BLUEPRINT WILL BE PROVIDED BY APPLICANT, storm surge and rising waters, 0% work completed.				Start 27.61313, -82.73699 End 27.61248, -82.73697: Sea Wall, sea wall, 238 FT long, storm surge and rising waters, 0% work completed.

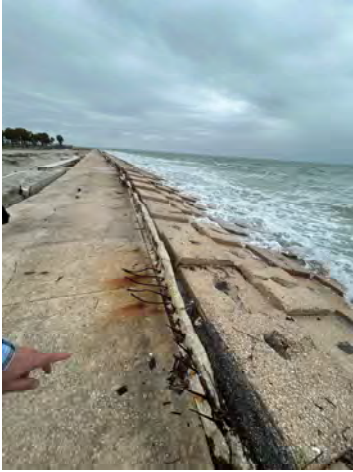
Applicant: Pinellas County		Damage Inventory # 1525703		Category D	
Work Order # 108615		FIPS # 103-99103-00		Date: 05/05/25 GPS	
Site Inspector: Miguel Lazu		Damage Facility: Fort Desoto Park - Southwest Point Seawall			
Damage Description:		Photo#		13	
Start 27.61313, -82.73699 End 27.61248, -82.73697: Sea Wall, sea wall, 238 FT long, storm surge and rising waters, 0% work completed.

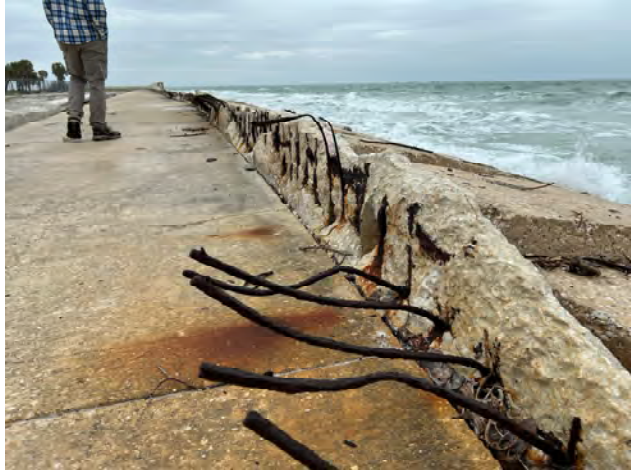
Damage Description:		Photo#		14	
Start 27.61313, -82.73699 End 27.61248, -82.73697: Sea Wall, sea wall, 238 FT long, storm surge and rising waters, 0% work completed.

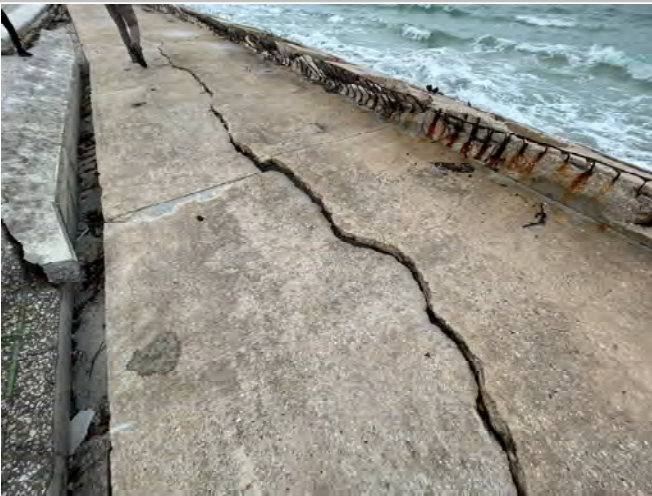
Damage Description:		Photo#		15	
Start 27.61313, -82.73699 End 27.61248, -82.73697: Sea Wall, sea wall, 238 FT long, storm surge and rising waters, 0% work completed.

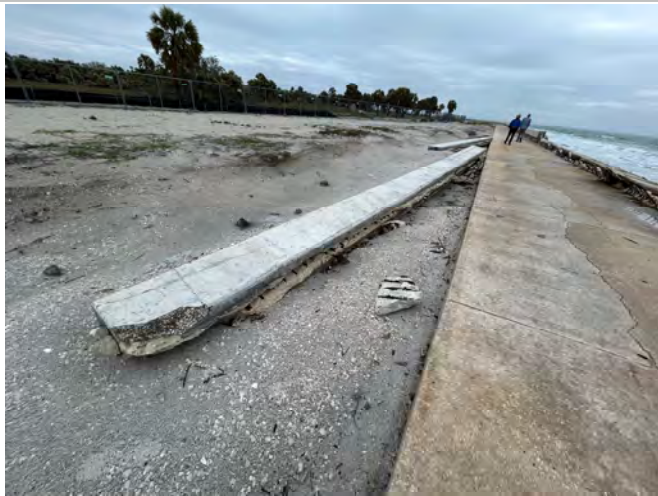
Damage Description:		Photo#		16	
Start 27.61313, -82.73699 End 27.61248, -82.73697: Sea Wall, sea wall, 238 FT long, storm surge and rising waters, 0% work completed.

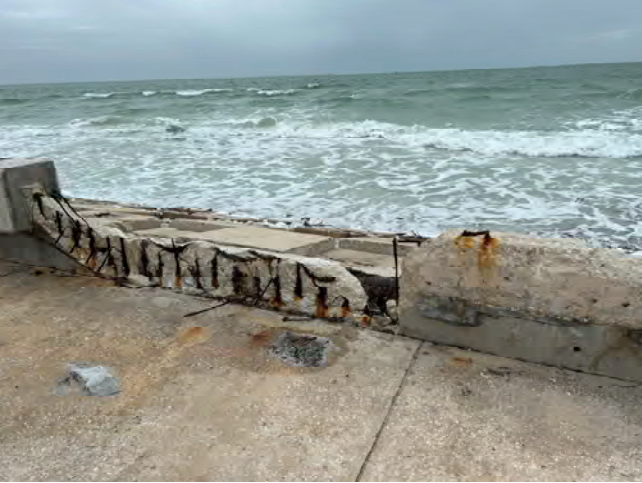
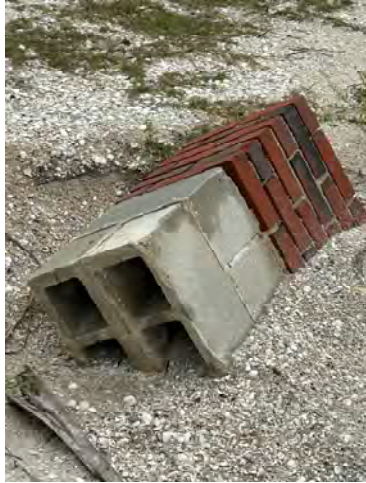
Damage Description:		Photo# 17		Damage Description:		Photo# 18	
Start 27.61313, -82.73699 End 27.61248, -82.73697: Sea Wall, sea wall, 238 FT long, storm surge and rising waters, 0% work completed.				Start 27.61313, -82.73699 End 27.61248, -82.73697: Sea Wall, sea wall, 238 FT long, storm surge and rising waters, 0% work completed.
