APPLICANT (FIPS#): DISASTER: SITE INSPECTION PHOTO PAGE 4828DR-FL 103-99103-00 INSPECTION DATE: WORK ORDER: CATEGORY: COUNTY: APPLICANT ADDRESS: 3/31/25 107122 **Pinellas** 9600 Bay Pines Boulevard, St. Petersburg, FL 33708 DAMAGE # / DAMAGE NAME: SITE INSPECTOR(S): GPS COORDINATES: GILLISON, ZAKITA S.; MCCOGGLE, MARIA R. 1410937 / War Veterans Park 27.48442, -82.46675

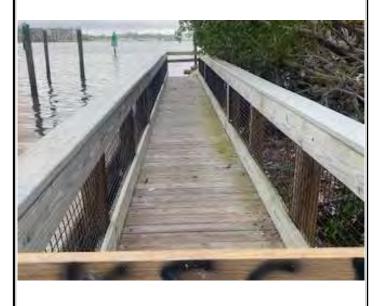
Site 1: Docks, 1 each of Wood Gangway. The GPS coordinates are: 27.81206, -82.76805; 27.48429, -82.46395; 27.48436, -82.46442., 40 FT long x 5 FT wide, Storm surge caused inundation and destabilization of the structure through increased water levels, and forceful wave action., 0% work completed.

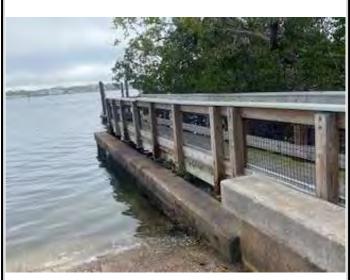
Site 1: Docks, 1 each of Wood Gangway. The GPS coordinates are: 27.81206, -82.76805; 27.48429, -82.46395; 27.48436, -82.46442., 40 FT long x 5 FT wide, Storm surge caused inundation and destabilization of the structure through increased water levels, and forceful wave action., 0% work completed.

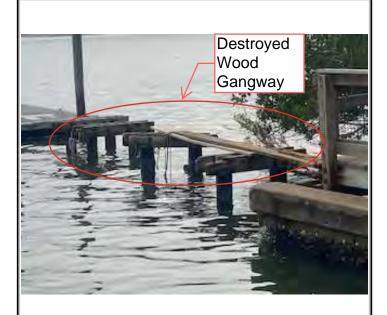
Site 1: Docks, 1 each of Wood Gangway. The GPS coordinates are: 27.81206, -82.76805; 27.48429, -82.46395; 27.48436, -82.46442., 40 FT long x 5 FT wide, Storm surge caused inundation and destabilization of the structure through increased water levels, and forceful wave action., 0% work completed.

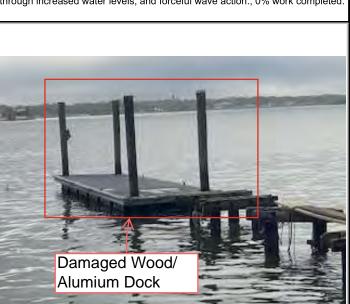
Site 1: Docks, 1 each of Wood/Aluminum Floating Dock. Wood & aluminum deck with corrugated metal filled pontoons. The GPS coordinates are 27.48423, -82.46395., 30 FT long x 10 FT wide, Storm surge caused inundation and destabilization of the structure through increased water levels, and forceful wave action., 0% work completed.

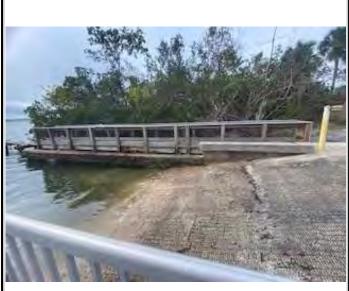
Site 1: Docks, 1 each of Wood Gangway. The GPS coordinates are: 27.81206, -82.76805; 27.48429, -82.46395; 27.48436, -82.46442., 40 FT long x 5 FT wide, Storm surge caused inundation and destabilization of the structure through increased water levels, and forceful wave action., 0% work completed.

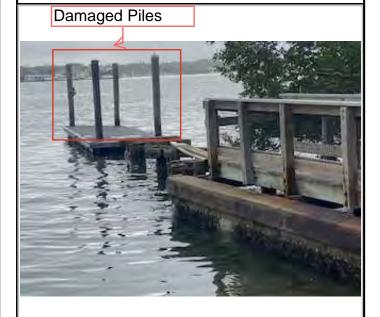
Site 1: Docks, 1 each of Wood/Aluminum Floating Dock. Wood & aluminum deck with corrugated metal filled pontoons. The GPS coordinates are 27.48423, -82.46395., 30 FT long x 10 FT wide, Storm surge caused inundation and destabilization of the structure through increased water levels, and forceful wave action., 0% work completed.

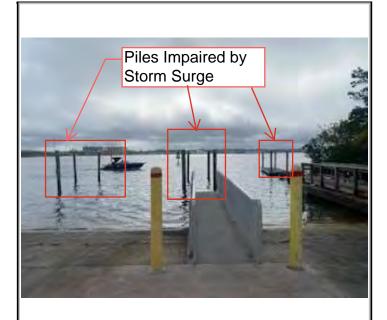
Site 1 Docks, 16 each of Piles, made of wood and are 13 feet high. The GPS coordinates are: 27.48442, -82.46675., 13 FT high, Storm surge caused inundation and destabilization of the structure through increased water levels, and forceful wave action., 0% work completed.

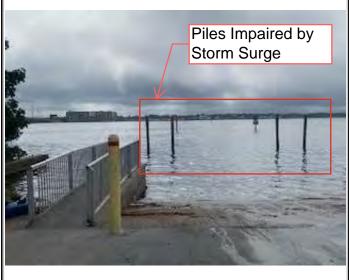
Site 1 Docks, 16 each of Piles, made of wood and are 13 feet high. The GPS coordinates are: 27.48442, -82.46675., 13 FT high, Storm surge caused inundation and destabilization of the structure through increased water levels, and forceful wave action., 0% work completed.

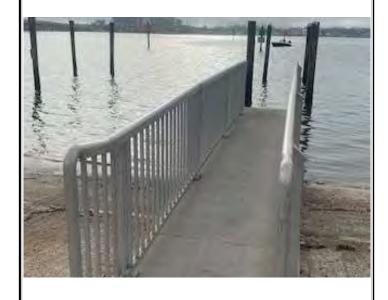
Site 1: Docks, 3 each of Gangways made of aluminum. The GPS coordinates are: 27. 8126, -82.76805; 27.48429, -82.46395; 27.48436, -82.46442., 30 FT long x 4 FT wide, Storm surge caused inundation and destabilization of the structure through increased water levels, and forceful wave action., 0% work completed.

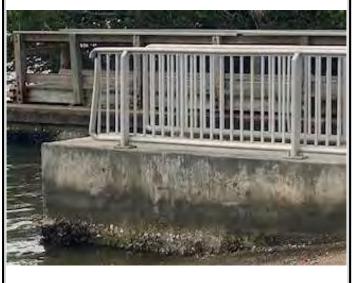
Site 1: Docks, 3 each of Gangways made of aluminum. The GPS coordinates are: 27. 8126, -82.76805; 27.48429, -82.46395; 27.48436, -82.46442., 30 FT long x 4 FT wide, Storm surge caused inundation and destabilization of the structure through increased water levels, and forceful wave action., 0% work completed.

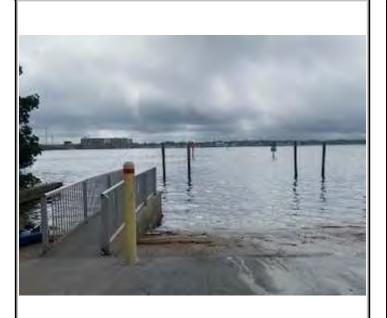
Site 1: Docks, 3 each of Gangways made of aluminum. The GPS coordinates are: 27. 8126, -82.76805; 27.48429, -82.46395; 27.48436, -82.46442., 30 FT long x 4 FT wide, Storm surge caused inundation and destabilization of the structure through increased water levels, and forceful wave action., 0% work completed.

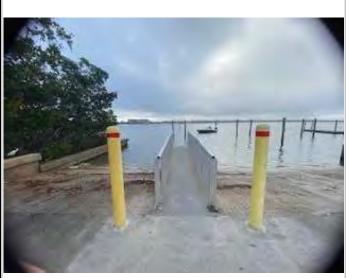
Site 1: Docks, 3 each of Gangways made of aluminum. The GPS coordinates are: 27. 8126, -82.76805; 27.48429, -82.46395; 27.48436, -82.46442., 30 FT long x 4 FT wide, Storm surge caused inundation and destabilization of the structure through increased water levels, and forceful wave action., 0% work completed.

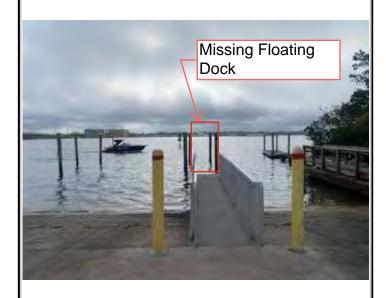
Site 1Docks, 3 each of Missing floating docks made of wood and aluminum. The GPS coordinates are: 27.48428, -82.46421; 27.48432, -82.46424; 27.48435, -82.46404, 30 FT long x 10 FT wide, Storm surge caused inundation and destabilization of the structure through increased water levels, and forceful wave action., 0% work completed.

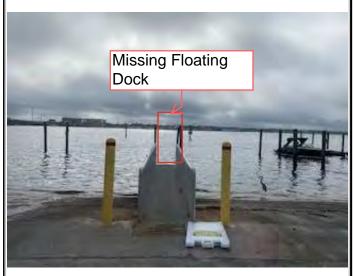
Site 1: Docks, 3 each of Missing floating docks made of wood and aluminum. The GPS coordinates are: 27.48428, -82.46421; 27.48432, -82.46424; 27.48435, -82.46404, 30 FT long x 10 FT wide, Storm surge caused inundation and destabilization of the structure through increased water levels, and forceful wave action., 0% work completed.

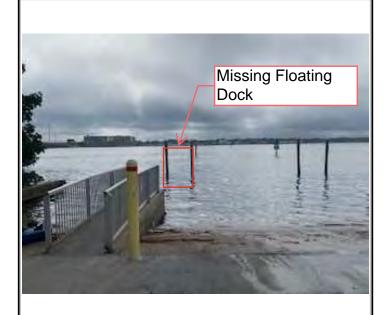
Site 1: Docks, 3 each of Missing floating docks made of wood and aluminum. The GPS coordinates are: 27.48428, -82.46421; 27.48432, -82.46424; 27.48435, -82.46404, 30 FT long x 10 FT wide, Storm surge caused inundation and destabilization of the structure through increased water levels, and forceful wave action., 0% work completed.

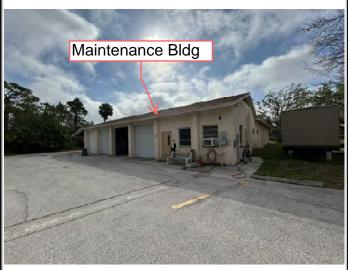
Site 2: Park Buildings, 6 each of C.H.I./3250/Ribbed Steel C.H.I. Overhead Coiling Doors, 10 FT long x 10 FT high, 3 feet of surge water pressure pushed the doors inward into the building., 100% work completed.

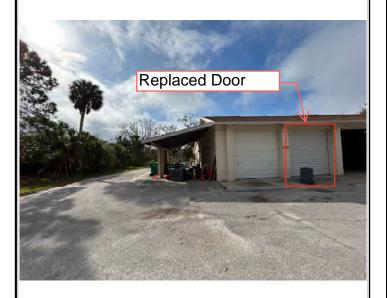
Site 2: Park Buildings, 6 each of C.H.I./3250/Ribbed Steel C.H.I. Overhead Coiling Doors, 10 FT long x 10 FT high, 3 feet of surge water pressure pushed the doors inward into the building., 100% work completed.

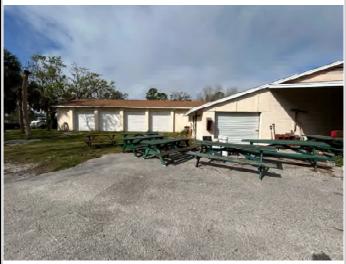
Site 2: Park Buildings, 6 each of C.H.I./3250/Ribbed Steel C.H.I. Overhead Coiling Doors, 10 FT long x 10 FT high, 3 feet of surge water pressure pushed the doors inward into the building., 100% work completed.

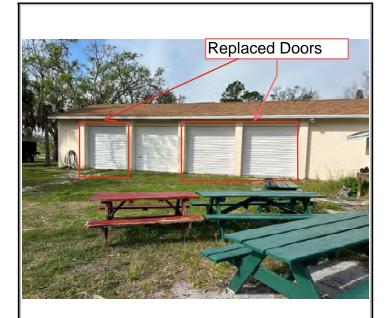
Site 2: Park Buildings, 6 each of C.H.I./3250/Ribbed Steel C.H.I. Overhead Coiling Doors, 10 FT long x 10 FT high, 3 feet of surge water pressure pushed the doors inward into the building., 100% work completed.

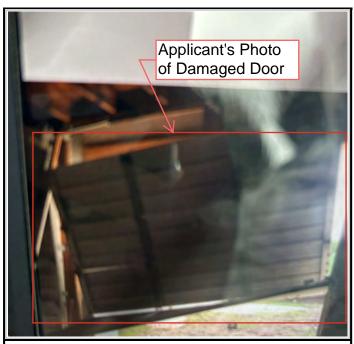
Site 2: Park Buildings, 6 each of C.H.I./3250/Ribbed Steel C.H.I. Overhead Coiling Doors, 10 FT long x 10 FT high, 3 feet of surge water pressure pushed the doors inward into the building., 100% work completed.

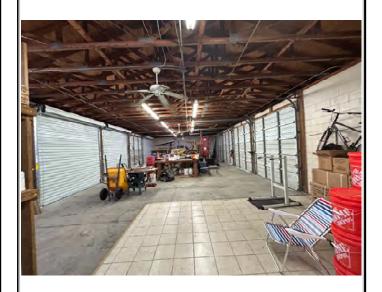
Site 2: Park Buildings, 6 each of C.H.I./3250/Ribbed Steel C.H.I. Overhead Coiling Doors, 10 FT long x 10 FT high, 3 feet of surge water pressure pushed the doors inward into the building., 100% work completed.

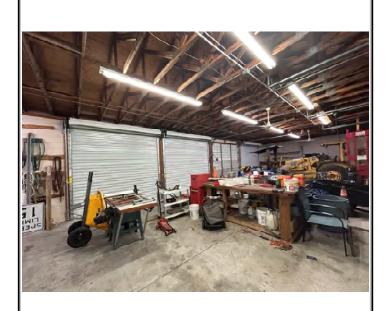
Site 2: Park Buildings, 6 each of C.H.I./3250/Ribbed Steel C.H.I. Overhead Coiling Doors, 10 FT long x 10 FT high, 3 feet of surge water pressure pushed the doors inward into the building., 100% work completed.

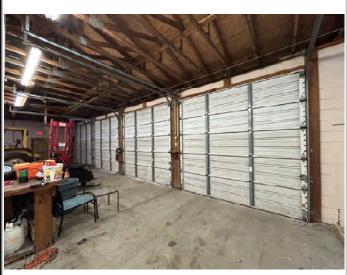
Site 2: Park Buildings, 6 each of C.H.I./3250/Ribbed Steel C.H.I. Overhead Coiling Doors, 10 FT long x 10 FT high, 3 feet of surge water pressure pushed the doors inward into the building., 100% work completed.

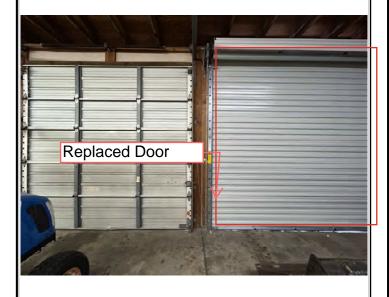
Site 2: Park Buildings, 6 each of C.H.I./3250/Ribbed Steel C.H.I. Overhead Coiling Doors, 10 FT long x 10 FT high, 3 feet of surge water pressure pushed the doors inward into the building., 100% work completed.

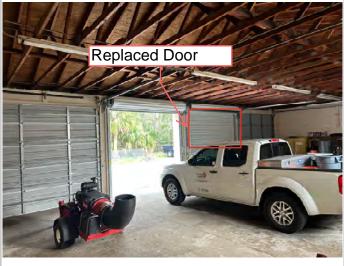
Site 2: Park Buildings, 6 each of C.H.I./3250/Ribbed Steel C.H.I. Overhead Coiling Doors, 10 FT long x 10 FT high, 3 feet of surge water pressure pushed the doors inward into the building., 100% work completed.
