PROJECT INFORMATION REPORT

REHABILITATION EFFORT FOR THE PINELLAS COUNTY, FLORIDA – COASTAL STORM RISK MANAGEMENT (CSRM) PROJECT

October 2016

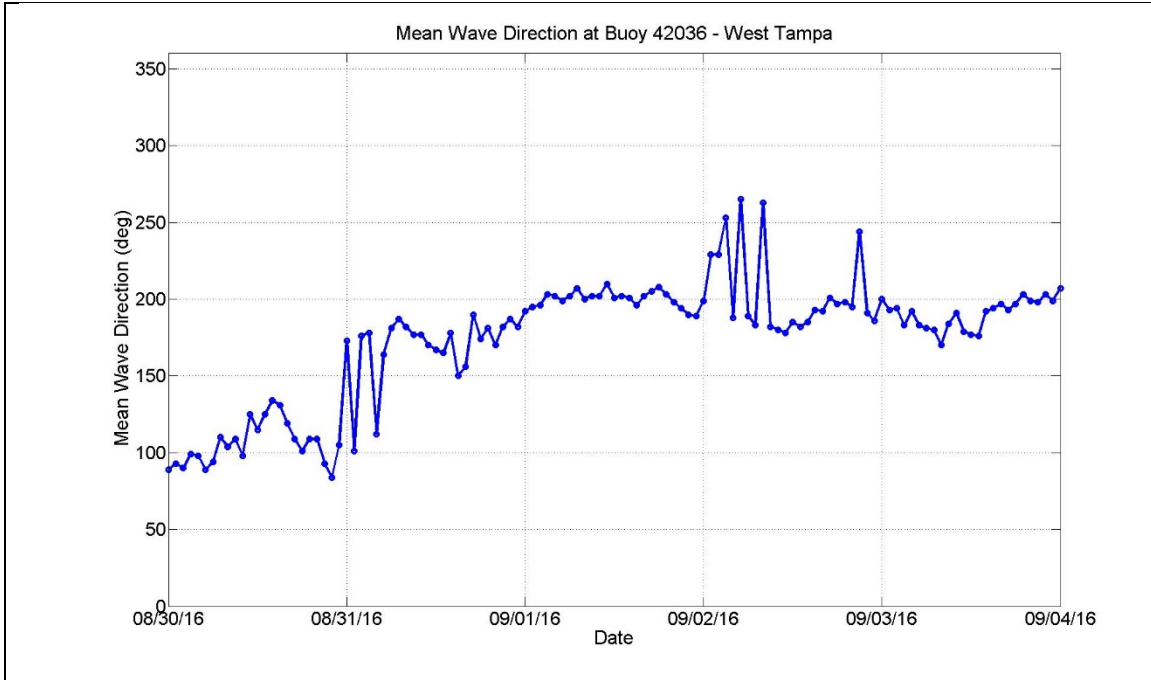
Figure 10-5: Wave heights, period, and direction during Hurricane Hermine at NBDC station 42036 at location 28.5 deg N, 84.517 deg W.

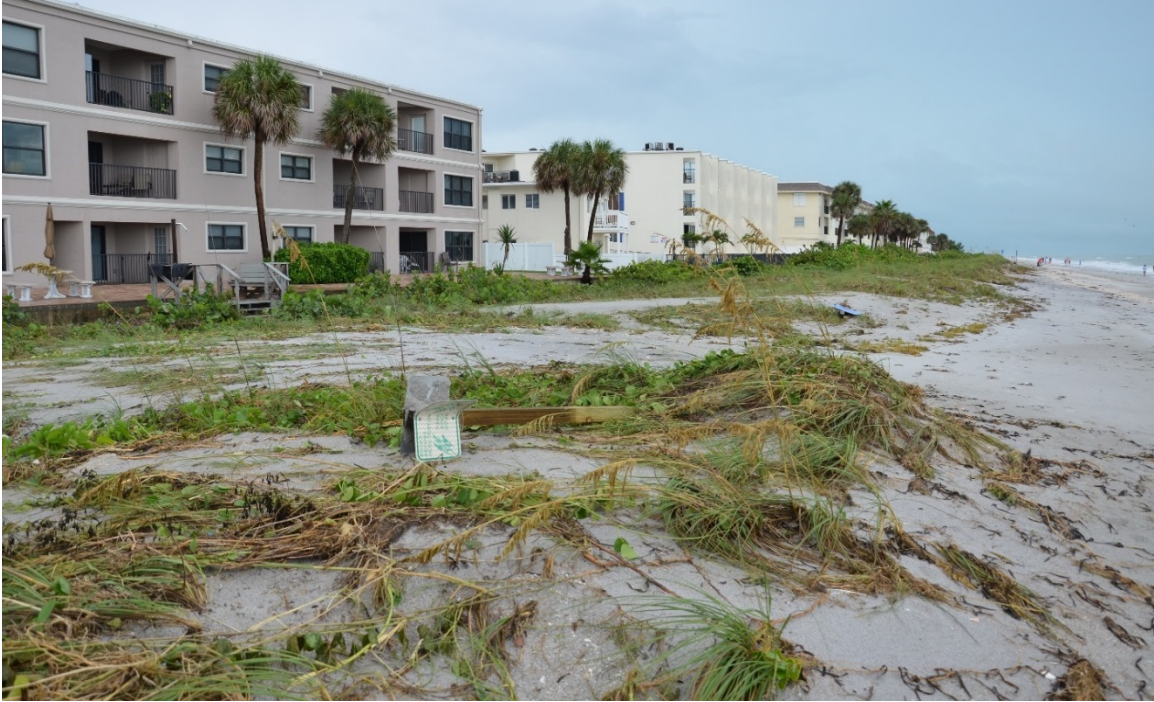
Damage within the Sand Key, Treasure Island, and Long Key project areas includes scarped dunes, deflation of the berm, and loss of dune grass (**Figure 11-1**). These damages have lessened the project's ability to provide the designed coastal storm damage reduction.

Figure 11-1: Storm overwash deposits in the dune field, landward of the seawall (Photo from USF)

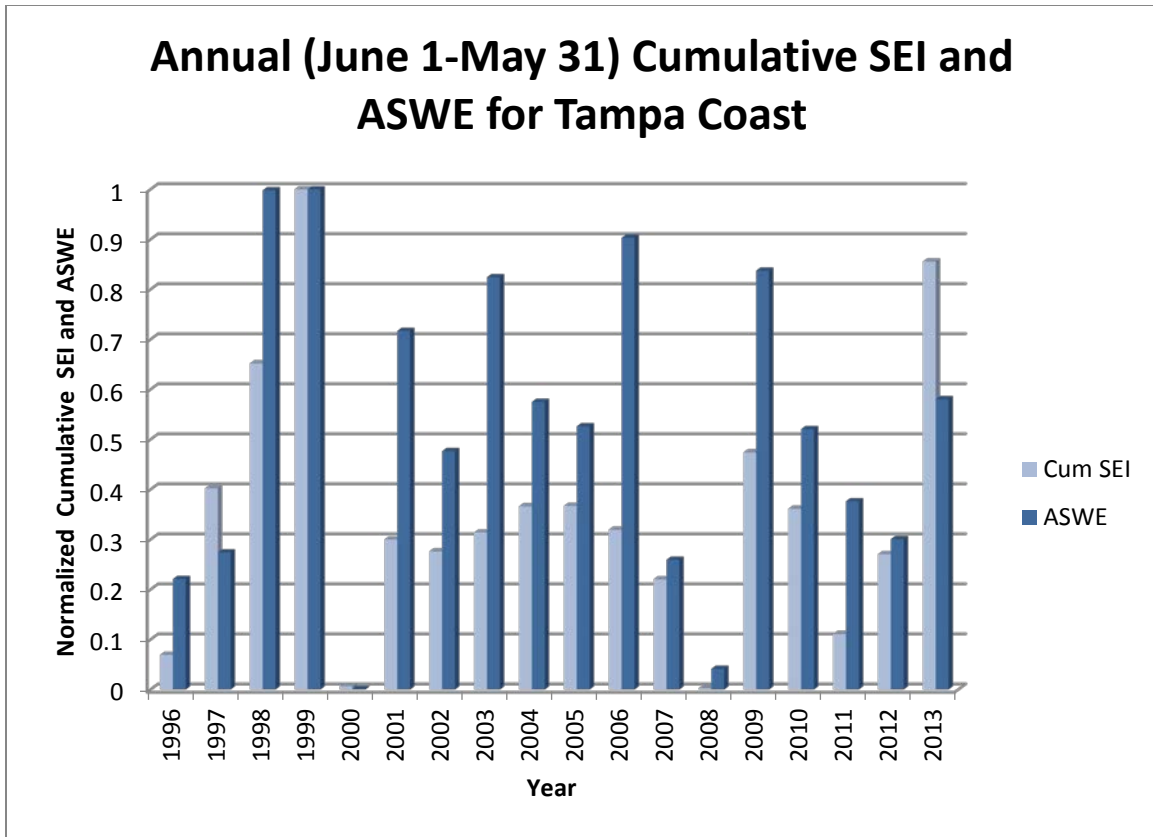
Figure 3: Comparison of annual cumulative SEI for the Tampa coast.

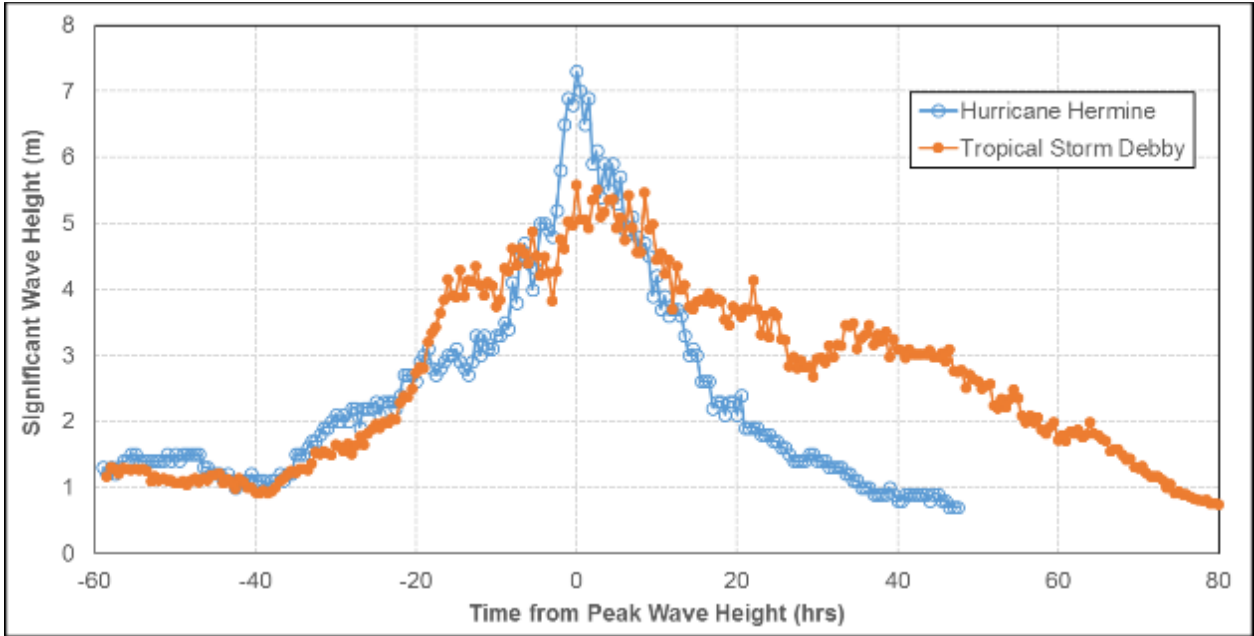
Figure 4 illustrates the measured offshore wave conditions during the two storms. It is worth noting that this wave gauge is about 90 miles from the shoreline. Nearshore waves should be lower than those measured at this location. The peak significant wave height during the passage of Hurricane Hermine reached 7.3 m (24 ft), which is about 30% higher than the highest wave of 5.6 m (18 ft) during Tropical Storm Debby. However, similar to the situation of storm surge, the high wave conditions of over 3 m (10 ft) lasted much longer during Tropical Storm Debby, 60 hours for Debby versus 35 hours for Hermine. Therefore, Hurricane Hermine is a more energetic storm than Tropical Storm Debby, but Debby was a longer lasting storm (Figure 4).

Figure 4. Measured significant wave height at NOAA wave buoy 42099 about 90 miles west of the mouth of Tampa Bay. Negative hours represent time before wave peak. Positive hours represent time after wave peak.

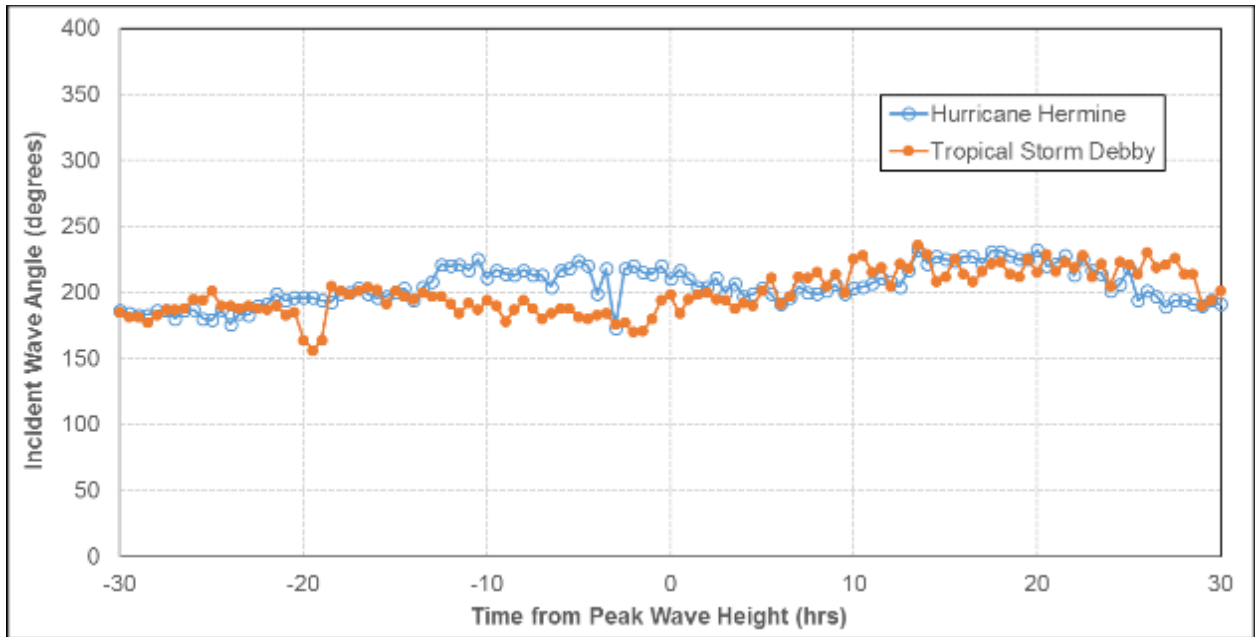
Figure 5. Measured incident wave angle at NOAA wave buoy 42099 about 90 miles west of the mouth of Tampa Bay. Negative hours represent time before wave peak. Positive hours represent time after wave peak.

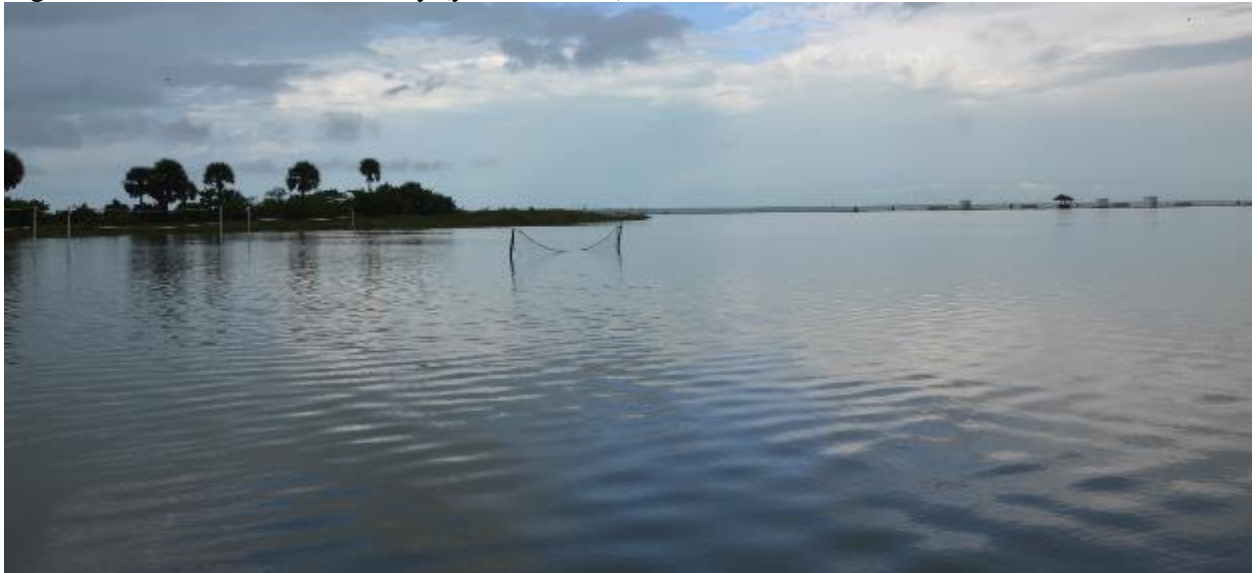
The north end of Sand Key, directly south of the Clearwater Pass south jetty, is characteristic of a wide beach, partly due to the sand impoundment at the jetty (Figure 6, yellow circle). Due to the very wide beach, the sand dune did not suffer any storm damage. The storm impact to this section of the beach is the flooding and ponding of the low-lying portion of the back beach (Figure 7). Similar flooding also occurred during Tropical Storm Debby.

Figure 7. Flooding of the low-lying portion of the back beach at the northern end of Sand Key.

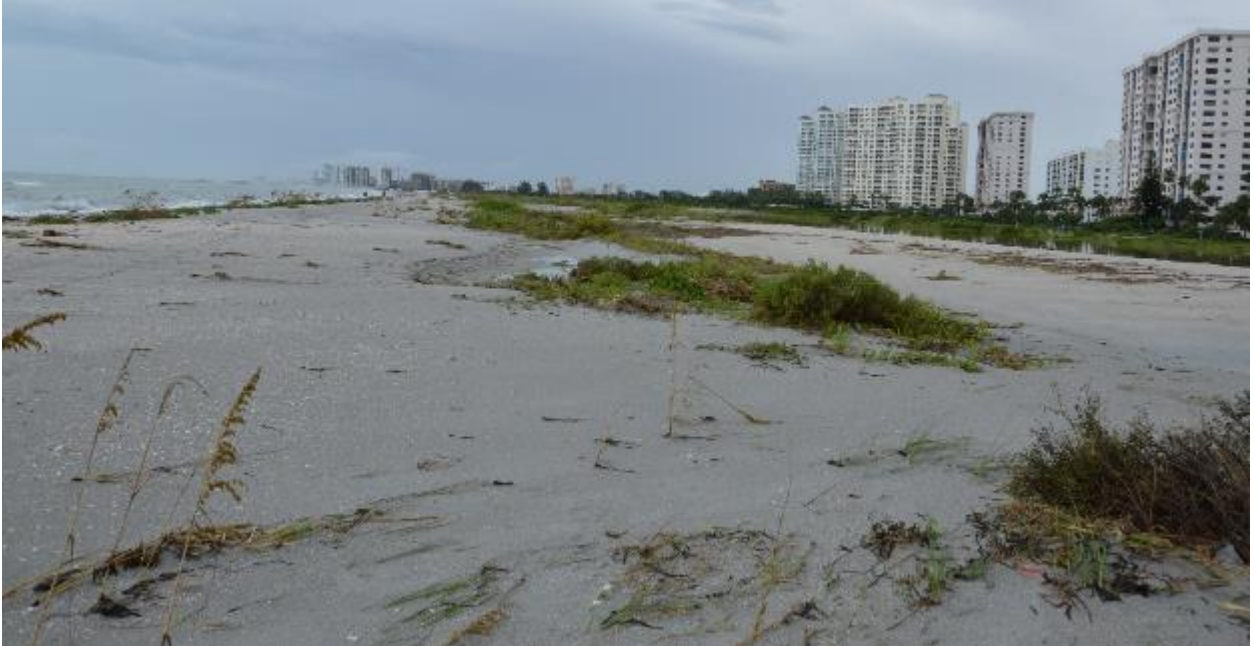
The pre-storm active berm crest has experienced some erosion. At least part of the eroded sand was transported landward, forming a higher storm berm. Some of the vegetation on the back beach was covered by the “back-beach overwash” (Figure 8).

Figure 8. Development of the storm berm (or back-beach overwash) burying the vegetation there. The vegetation (top left) just landward of the pre-storm active berm experienced erosion.

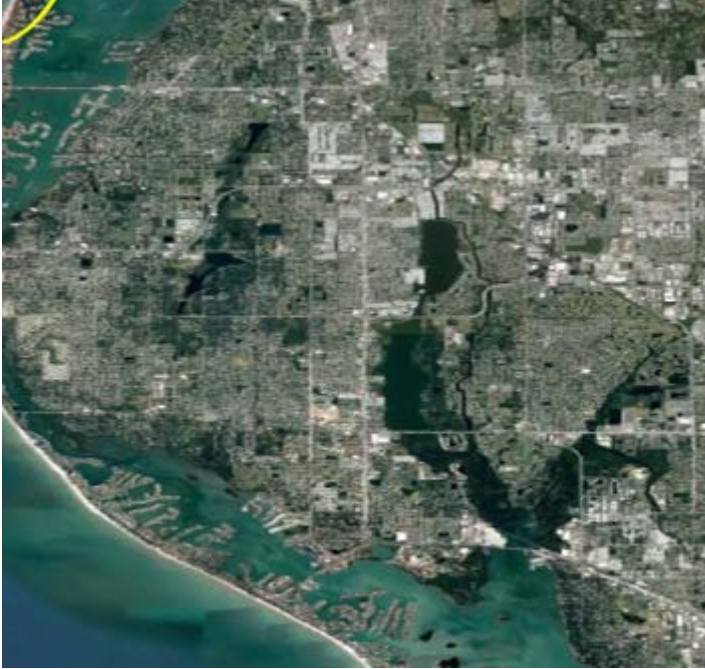
Belleair Beach (Figure 9) is an erosional hot spot on Sand Key. This section of the beach was rather narrow before the storm with an erosional scarp at the edge of the dune. The storm has pushed the dune scarp further landward. At the northern end of this section between R60 and R61, the dune is almost completely eroded, exposing the seawall at the landward limit of the back beach (Figure 10). Some sand was washed over the seawall covering some of the grass type vegetation landward. Along most section of this beach, it seems that the pre-storm dune scarp was pushed landward of an estimated 3-10 m (10-30 ft). Sand deposition occurred at the dune scarp, resulting in a much shorter scarp, as compared to the pre-storm scarp. As a matter of fact, overwash over the low dune system is observed in many places (Figure 11). Many dune and vegetation signs were scoured and fell down (Figure 12).

Overall, this section of the beach has a fairly continuous dune scarp of 1-4 ft tall, with sand deposition directly seaward of the scarp. At places when the dunes are relatively low, overwash into the dune field occurred. The impact by Hurricane Hermine here is more severe than that from Tropical Storm Debby which did not induce dune overwash.

Figure 9. Belleair Beach section (yellow circle).

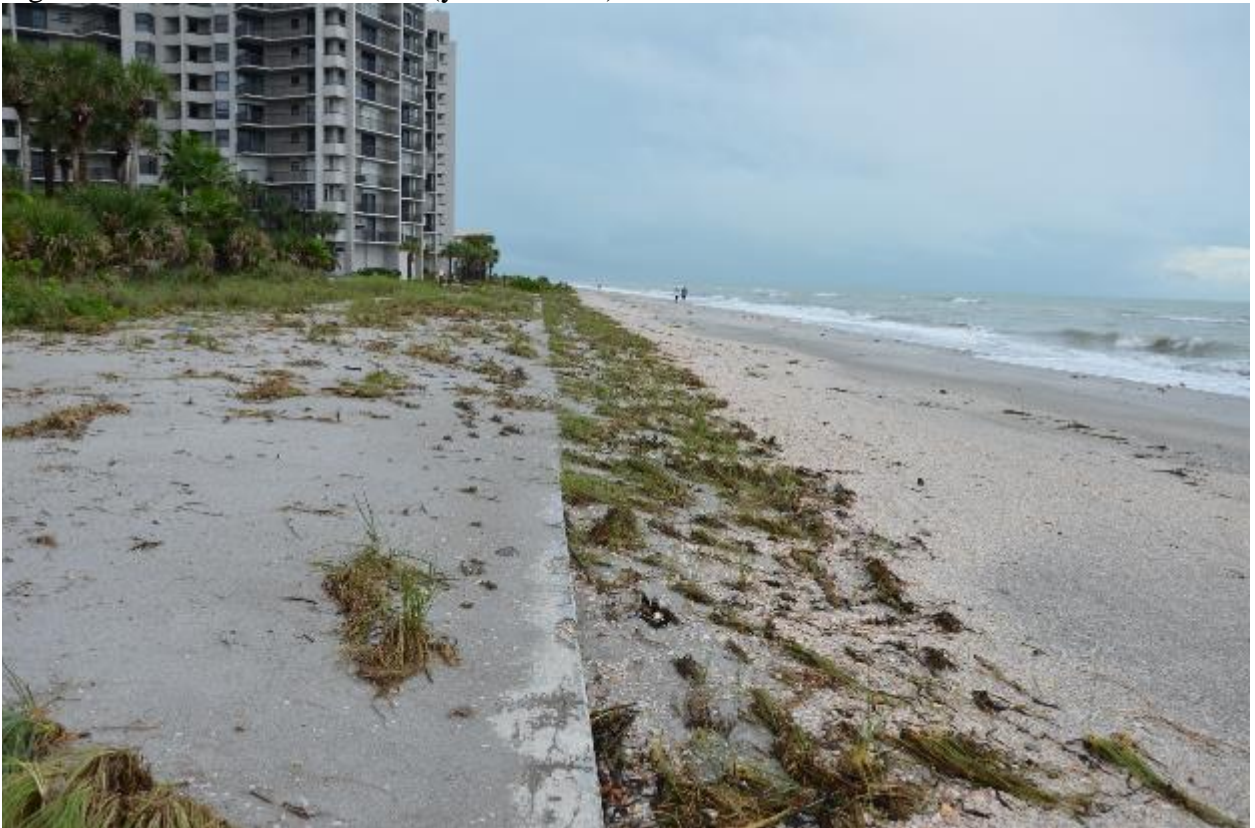
Figure 10. The narrow pre-storm dune was completely eroded, exposing the seawall at the landward limit of the back beach.

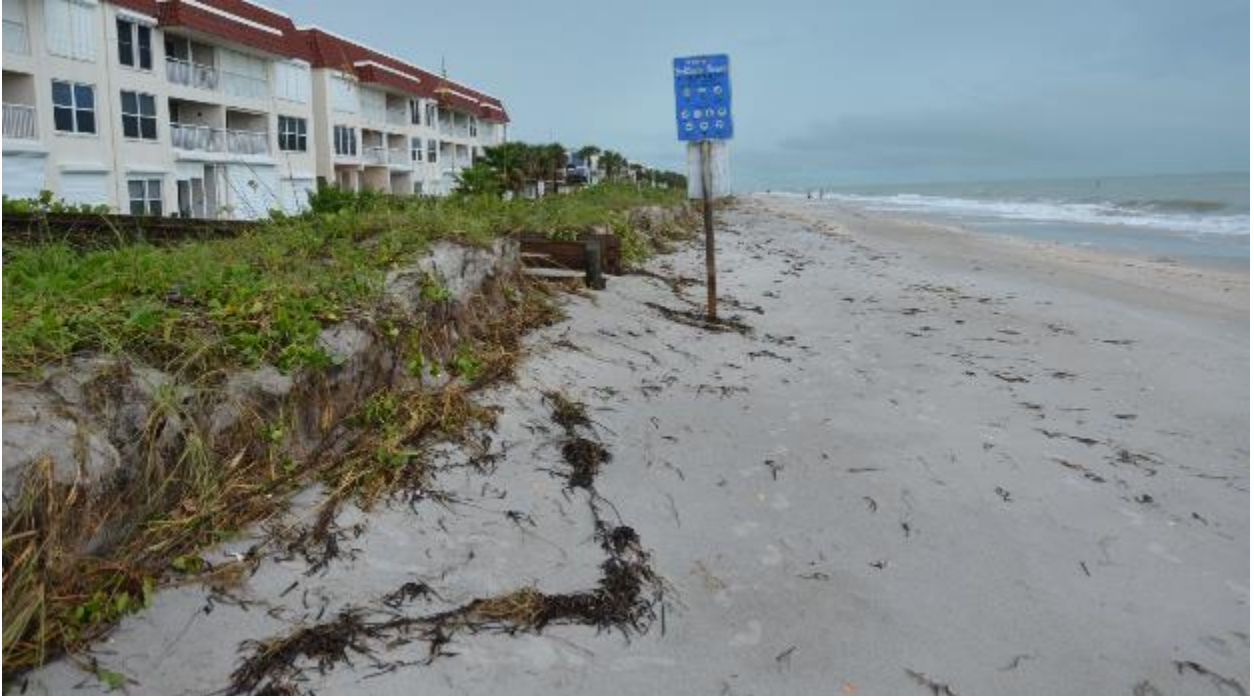
Figure 11. Pre-storm dune scarp was pushed further landward. Sand deposit occurred at the dune scarp.

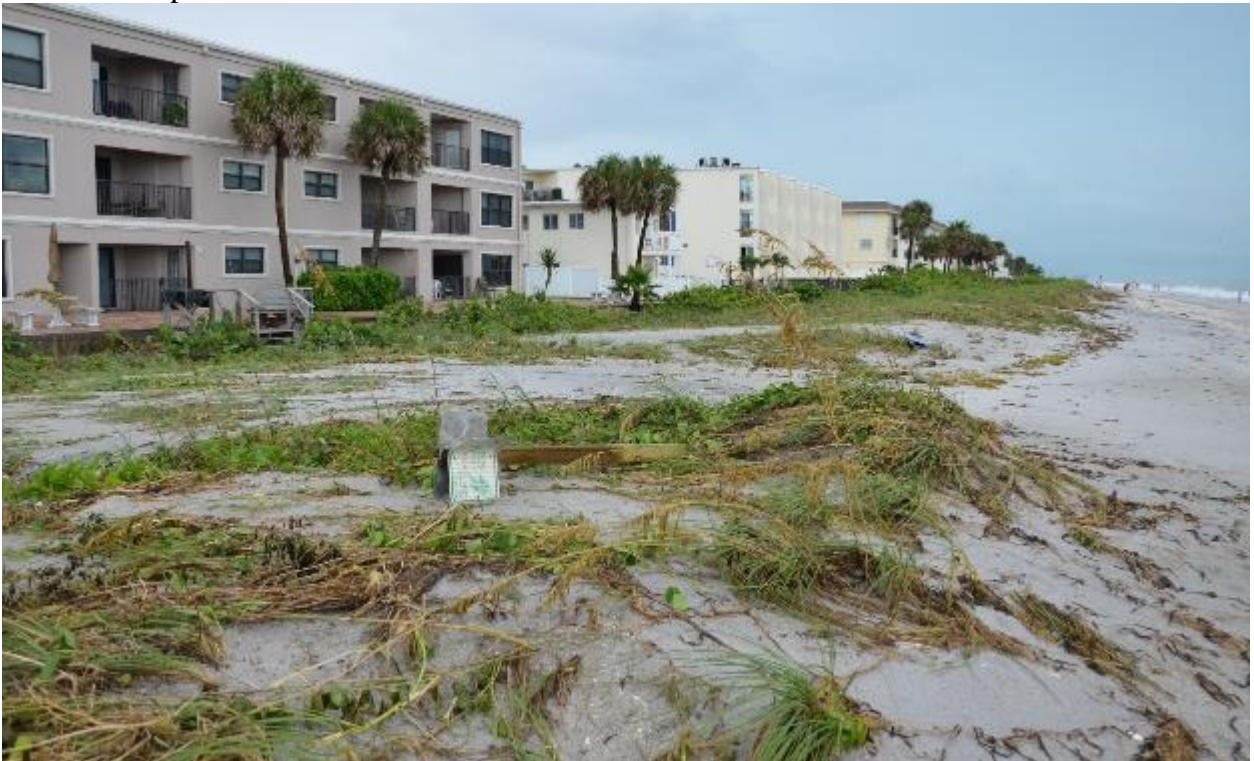
Figure 12. The low dune was overtopped by the storm water, resulting in overwash deposit in the dune field and many fell-down signs.

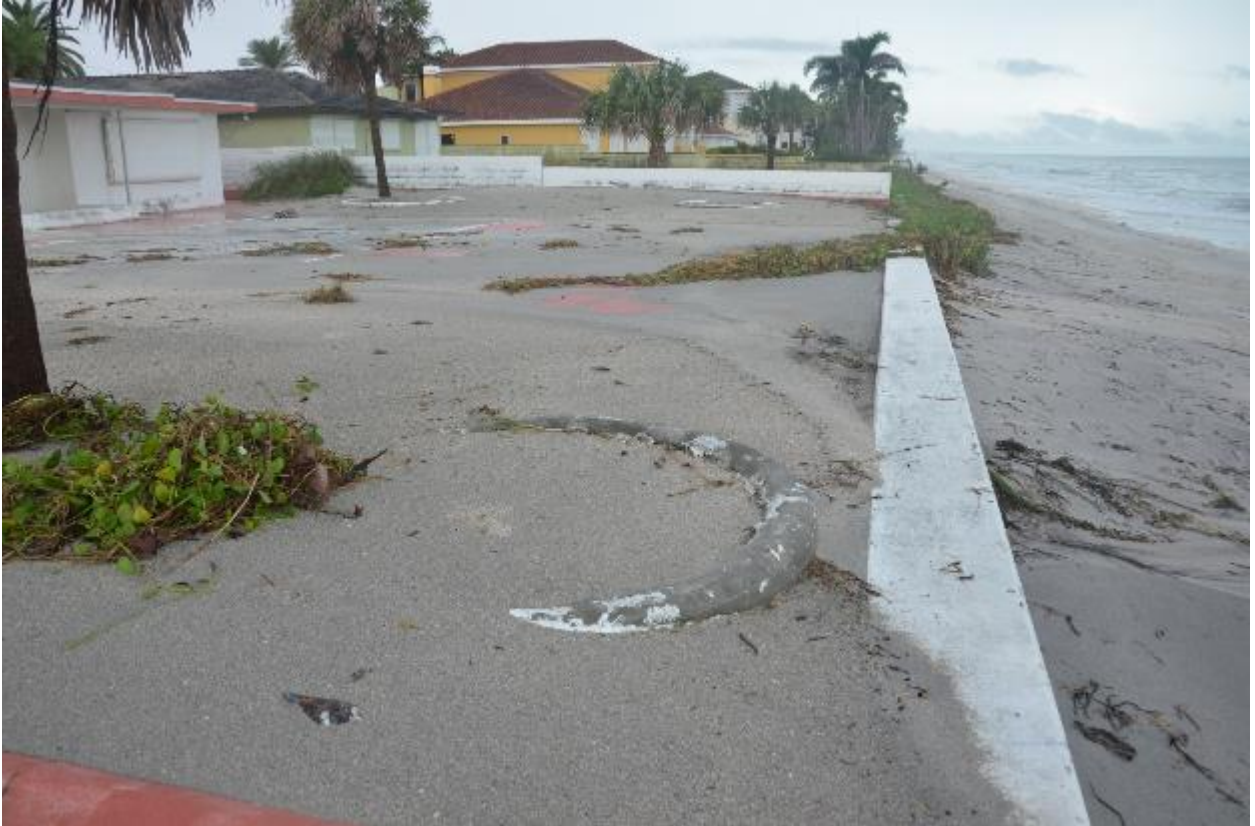
Overall, along this section, the narrow beach and dune were completely eroded, exposing the seawall to direct wave attack. Considerable amount of sand was washed over the seawall. Scour at the seawall occurred at various places. The impact by Hurricane Hermine along this stretch is considerably more severe than that from Tropical Storm Debby which did not induce overwash over the seawall and did not cause severe scour along the wall.

Figure 14. Sand was washed over the seawall. The narrow pre-storm beach and dune were almost completely eroded.

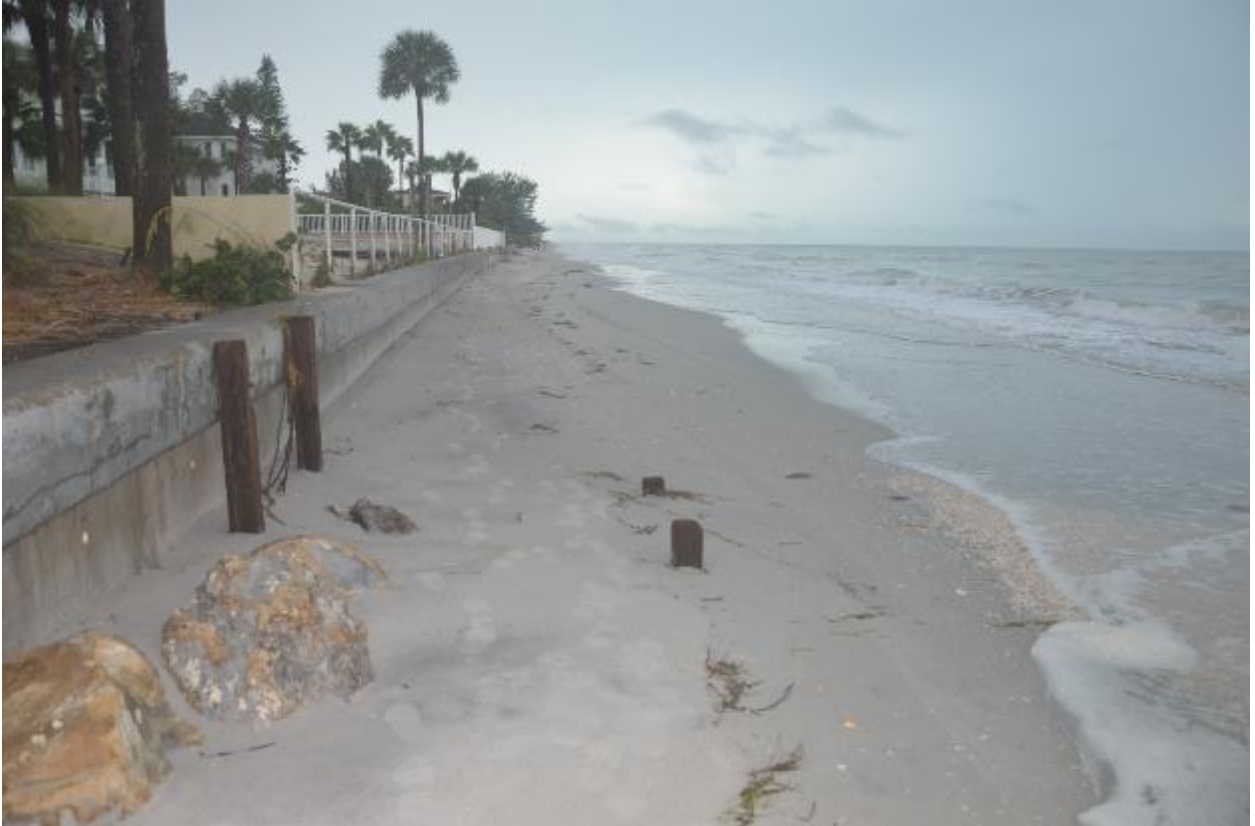
Figure 15. Scour at the seawall, damaging the wood stairs and exposing the riprap.

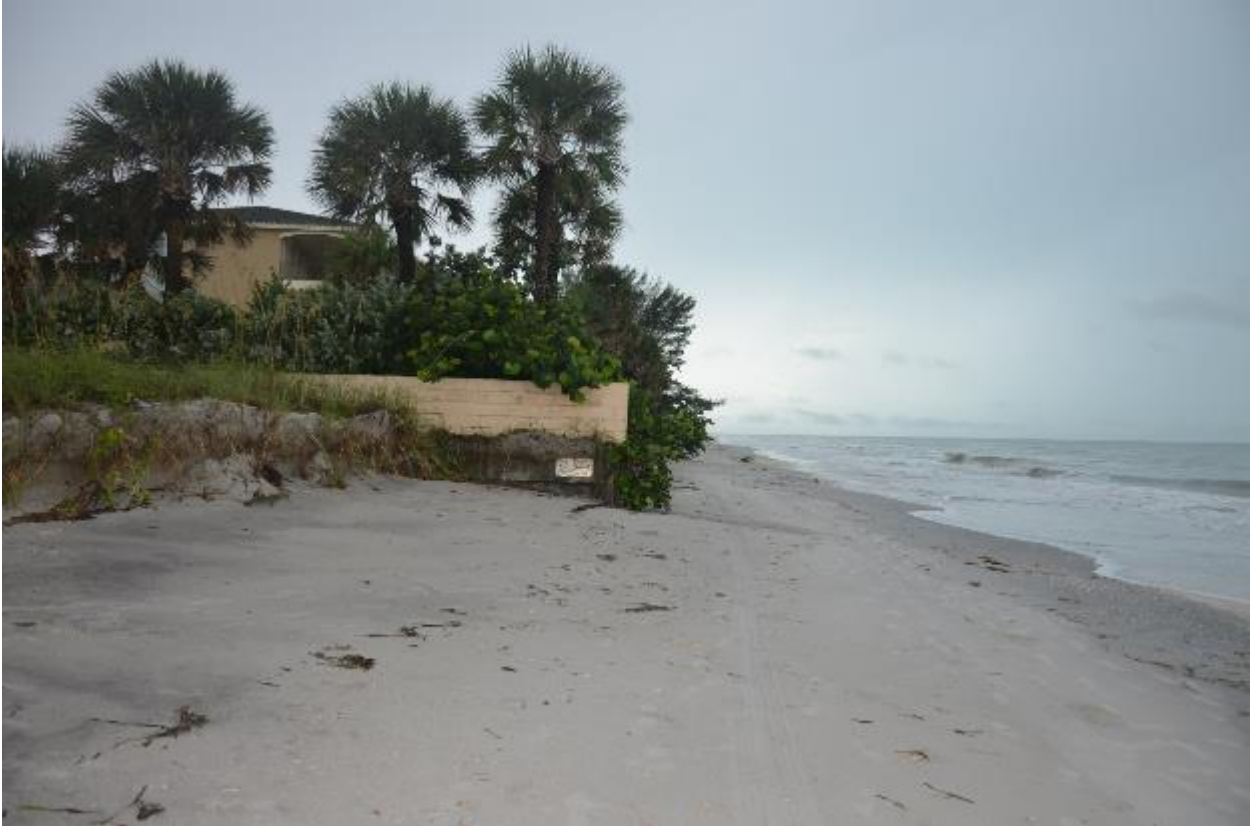
Figure 16. Erosion at a section (a neighborhood park) without seawall.

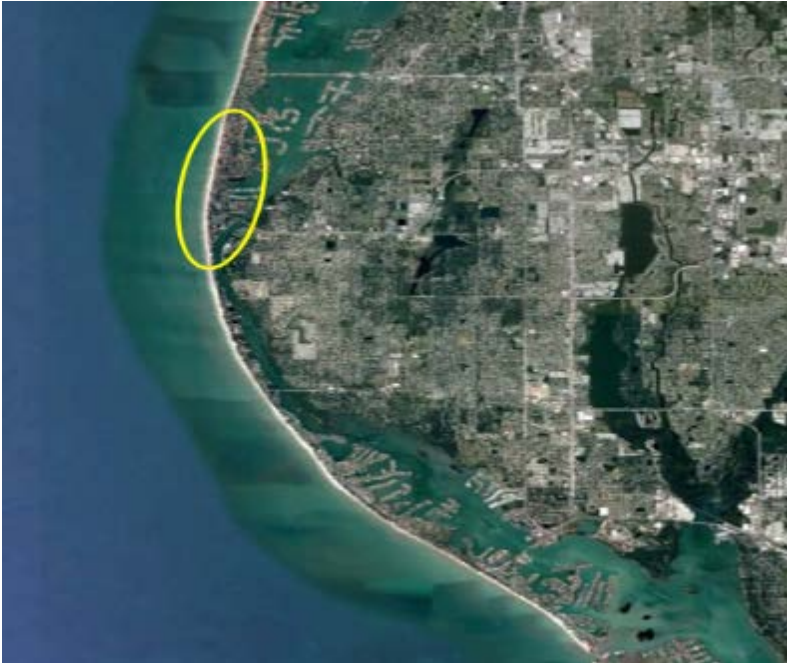
Indian Rocks Beach (Figure 17) experienced significant beach and dune erosion. The entire flat portion of the back beach was eroded. A continuous 2-5 ft tall dune scarp extends along the entire stretch (Figure 18). Similar to the Belleair Beach to the north, some deposition occurred directly in front of the scarp. At most places, the dunes are relatively high, little to no sand was washed over the dunes. Overwash did occur at places with no sand dune.

Figure 17. Indian Rocks Beach section (yellow circle).

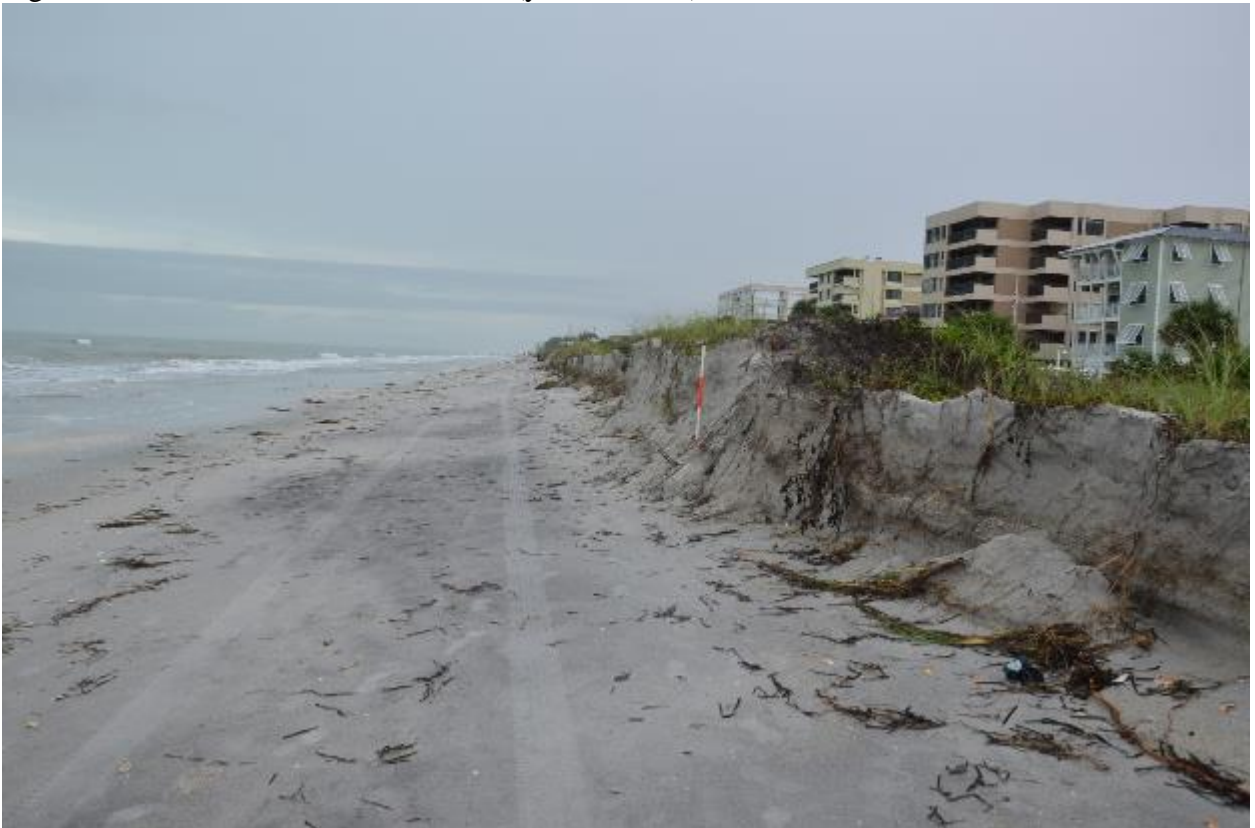
Figure 18. Extensive dune scarping along Indian Rocks Beach.

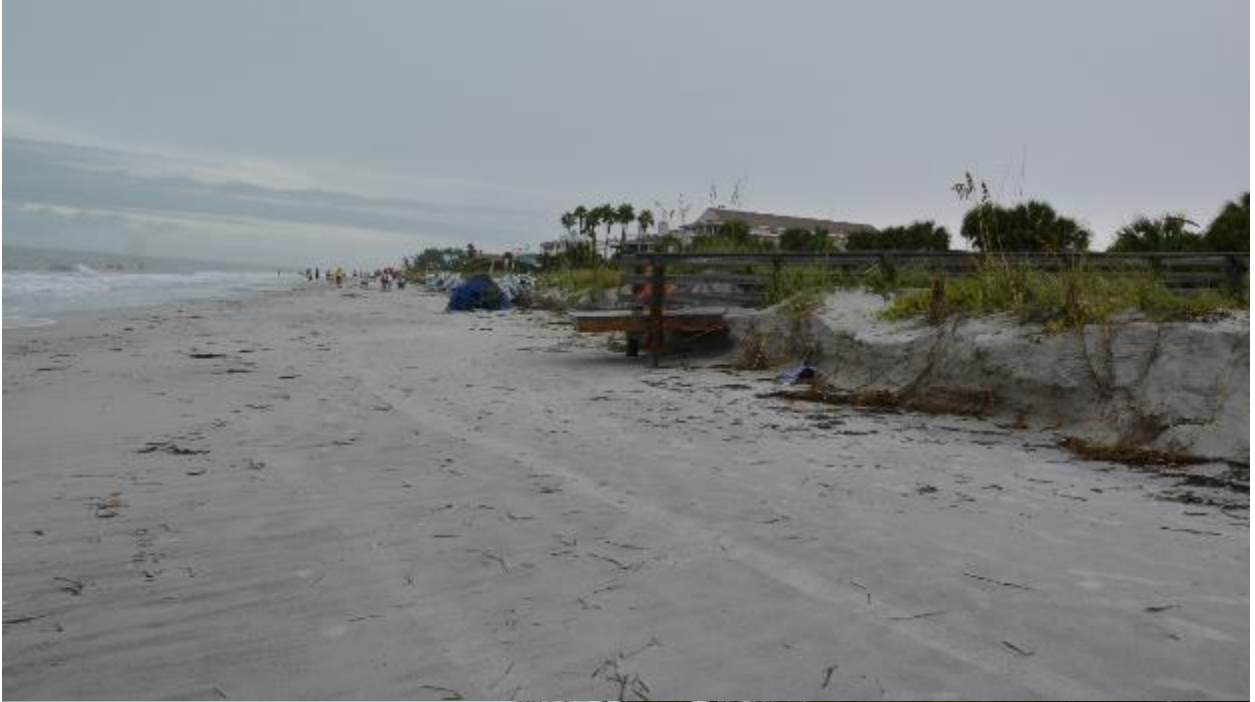
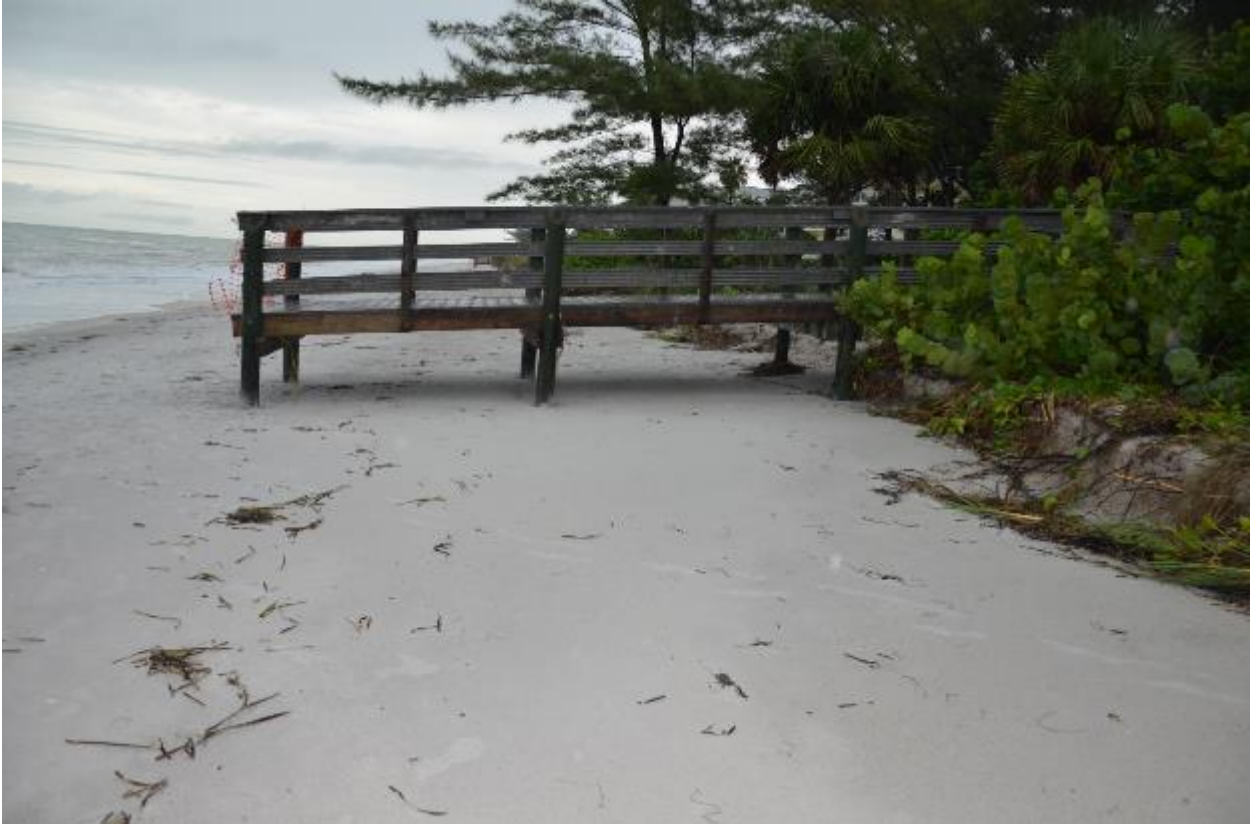
Nearly all the dune walkovers have experienced scour underneath. For several walkovers with the stairs leading the beach, the stairs portion of the dune walkover was washed away (Figure 19). Compared to the damage by Tropical Storm Debby, Hurricane Hermine has caused considerably more damage to the dune walkovers. Dune erosion also seems to be more severe. This will be confirmed quantitatively by post-storm beach survey.

Figure 19. Most of the dune walkovers suffered damage. Upper: dune walkover at Indian Rocks Beach Park, the stairs leading to the beach was washed away. Lower: significant scour underneath and dune erosion of about 10 m (30 ft) at around R72.

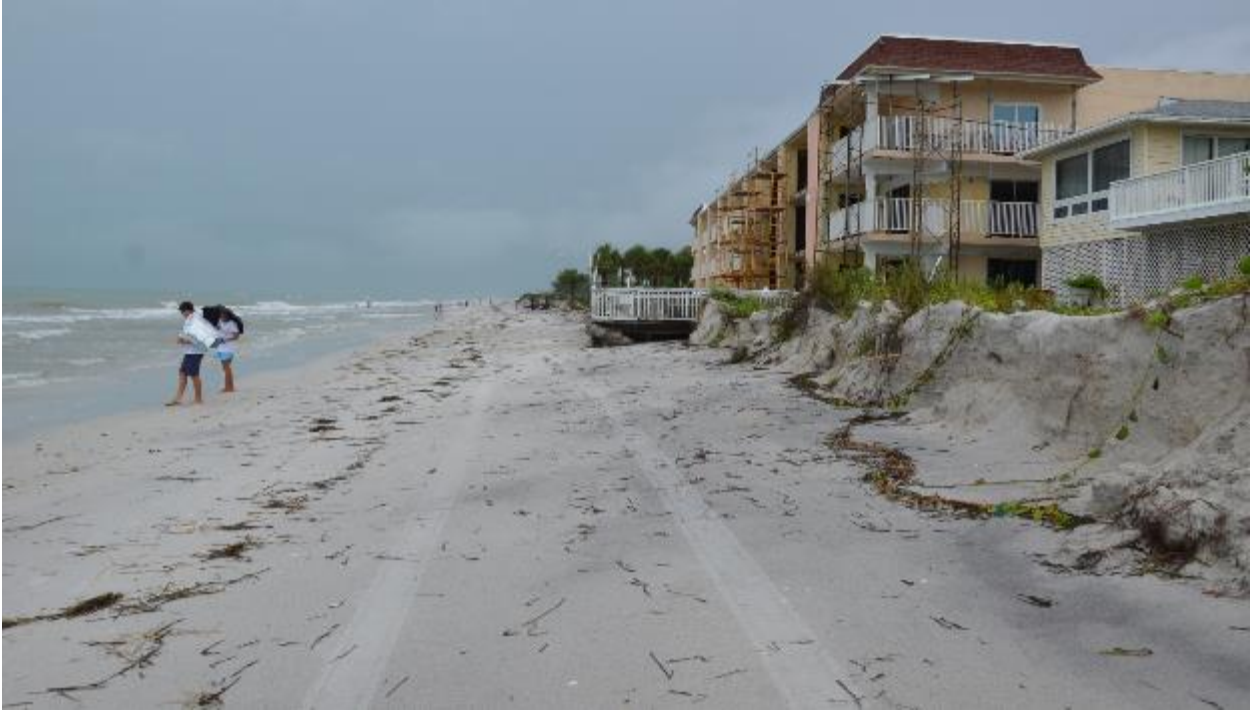
Beach and dune erosion continued along this section of the beach (Figure 20). At the northern end of this section, scour underneath the dune walkovers and buildings occurred (Figure 21). For most of this stretch, the pre-storm beach was considerably wider than that along the stretches to the north. Dune erosion was not as severe since it was protected by a wider beach (Figure 22). Dune scarping occurred at various locations but is not as continuous and as tall as along the beaches to the north. In the vicinity of the breakwater, the wide back beach seems to have received some sand deposition in the form of “back beach overwash” or development of storm berm.

Figure 21. Severe beach and dune erosion at R84.

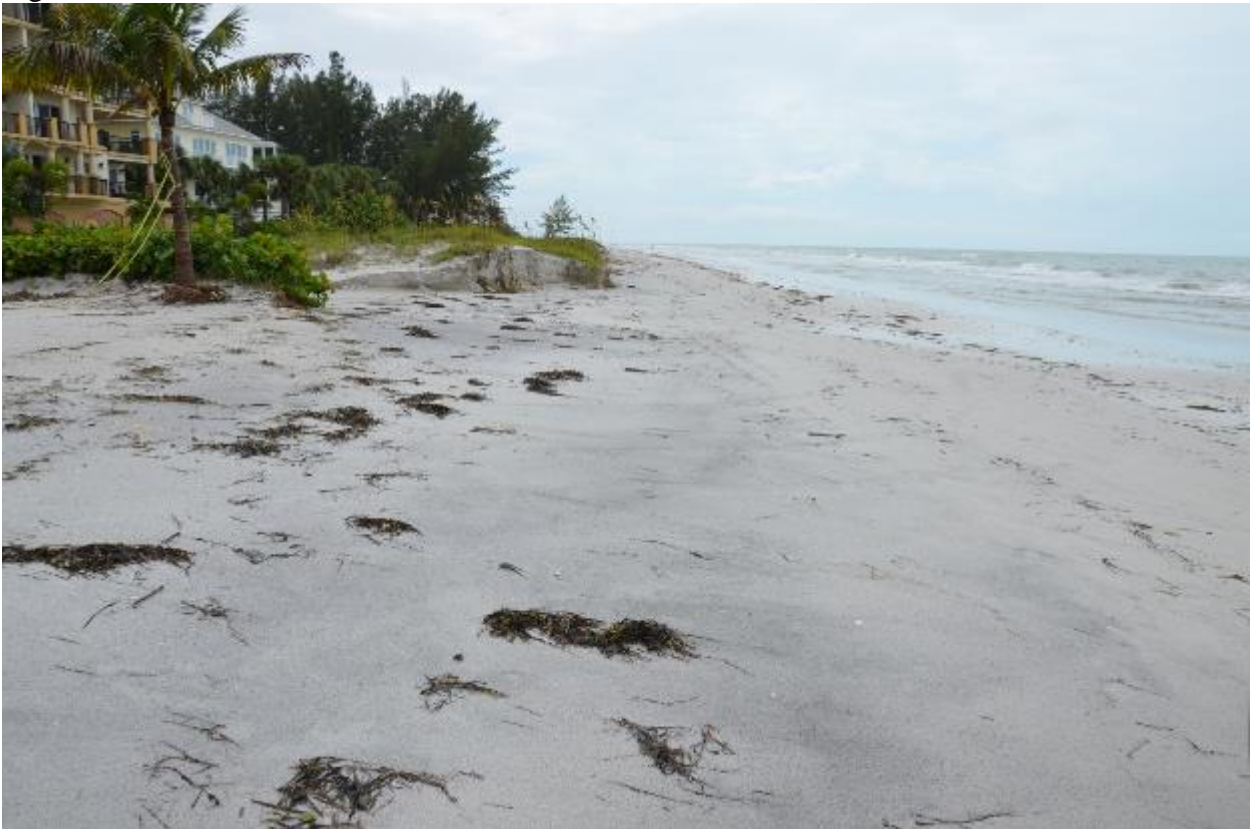
Figure 22. Discontinuous dune scarping along Indian Shores.

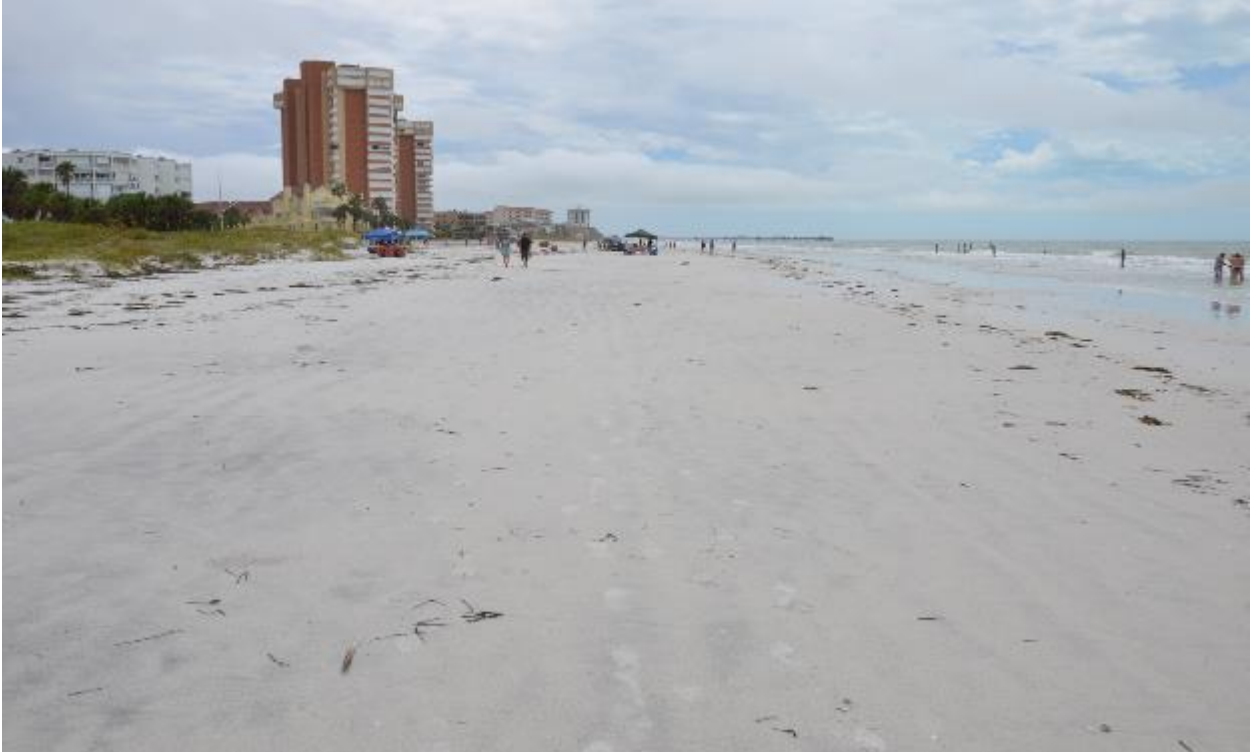
Figure 23. Sand deposition on the wide back beach at the breakwater.

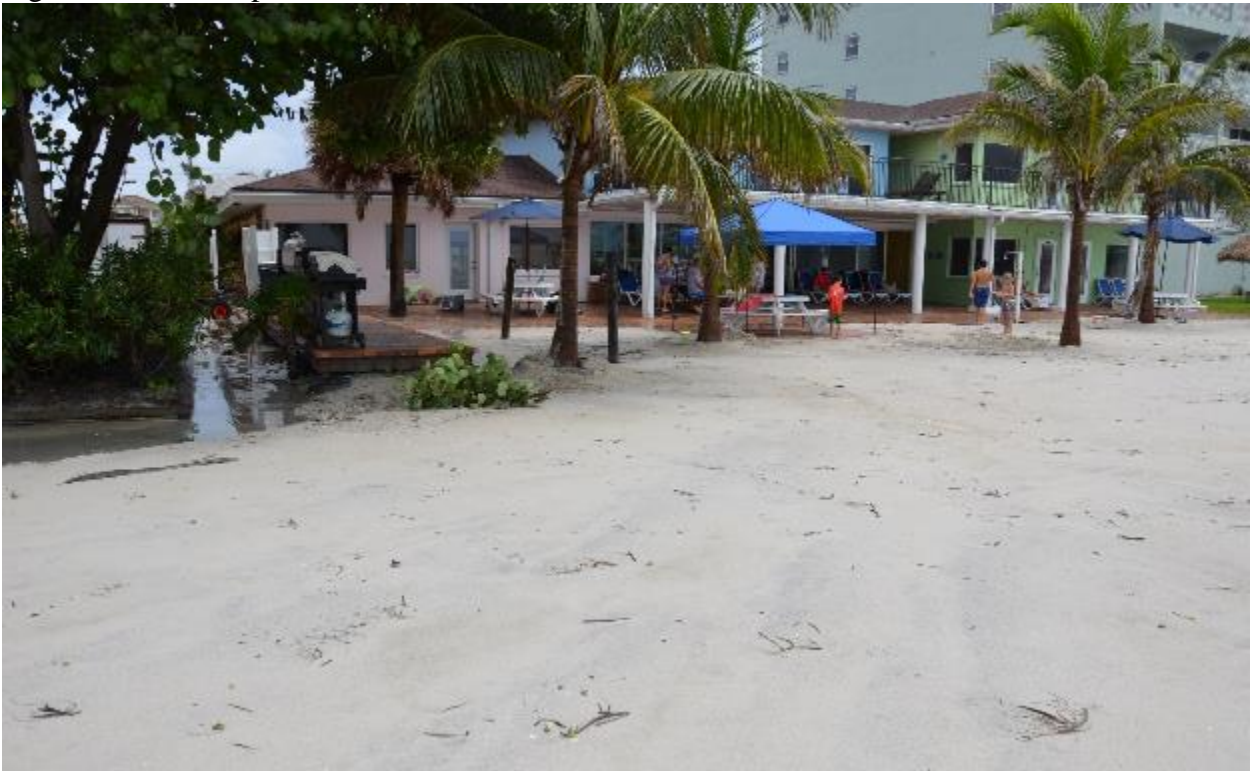
Figure 24. Sand washed over seawall along stretches without dunes.

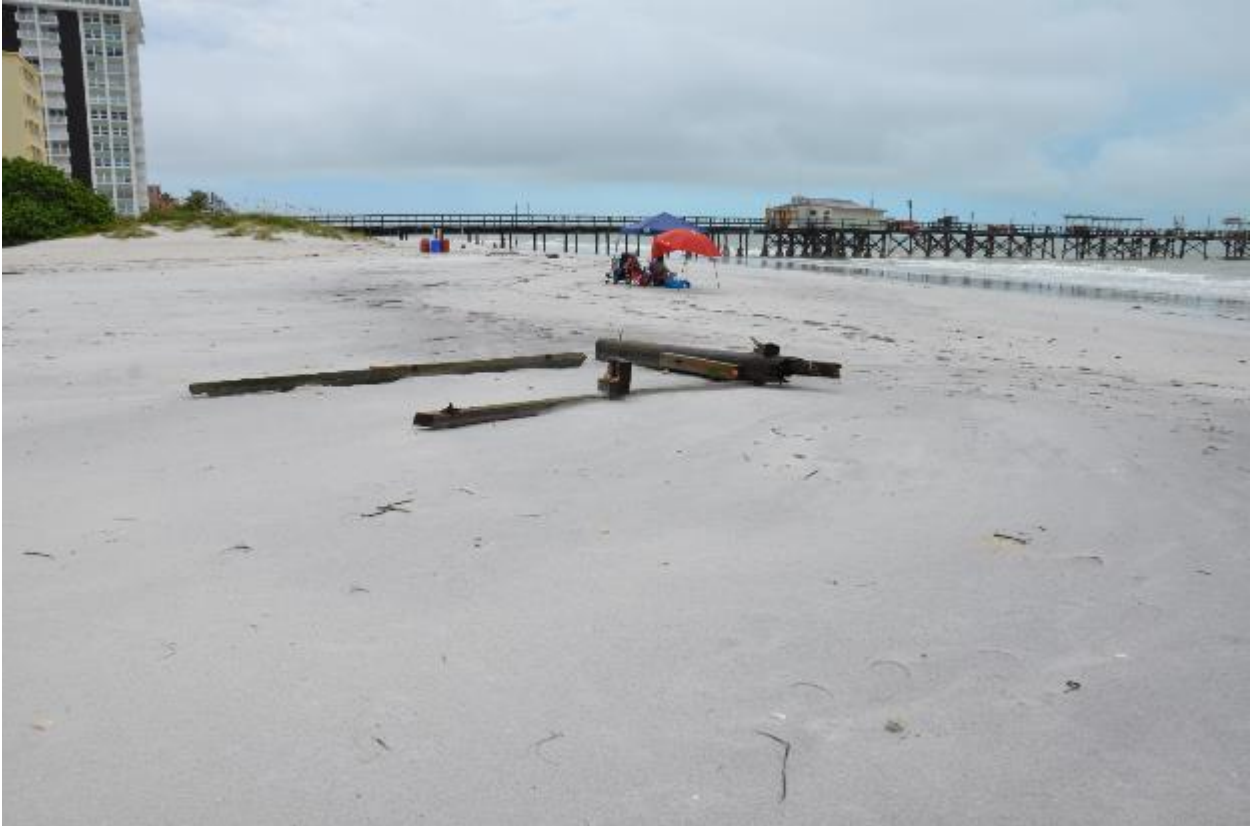
Figure 25. Wood debris near the Redington Fishing Pier, likely broken off from the pier.
