PROJECT INFORMATION REPORT

REHABILITATION EFFORT FOR THE PINELLAS COUNTY, FLORIDA – COASTAL STORM RISK MANAGEMENT (CSRM) PROJECT

October 2016

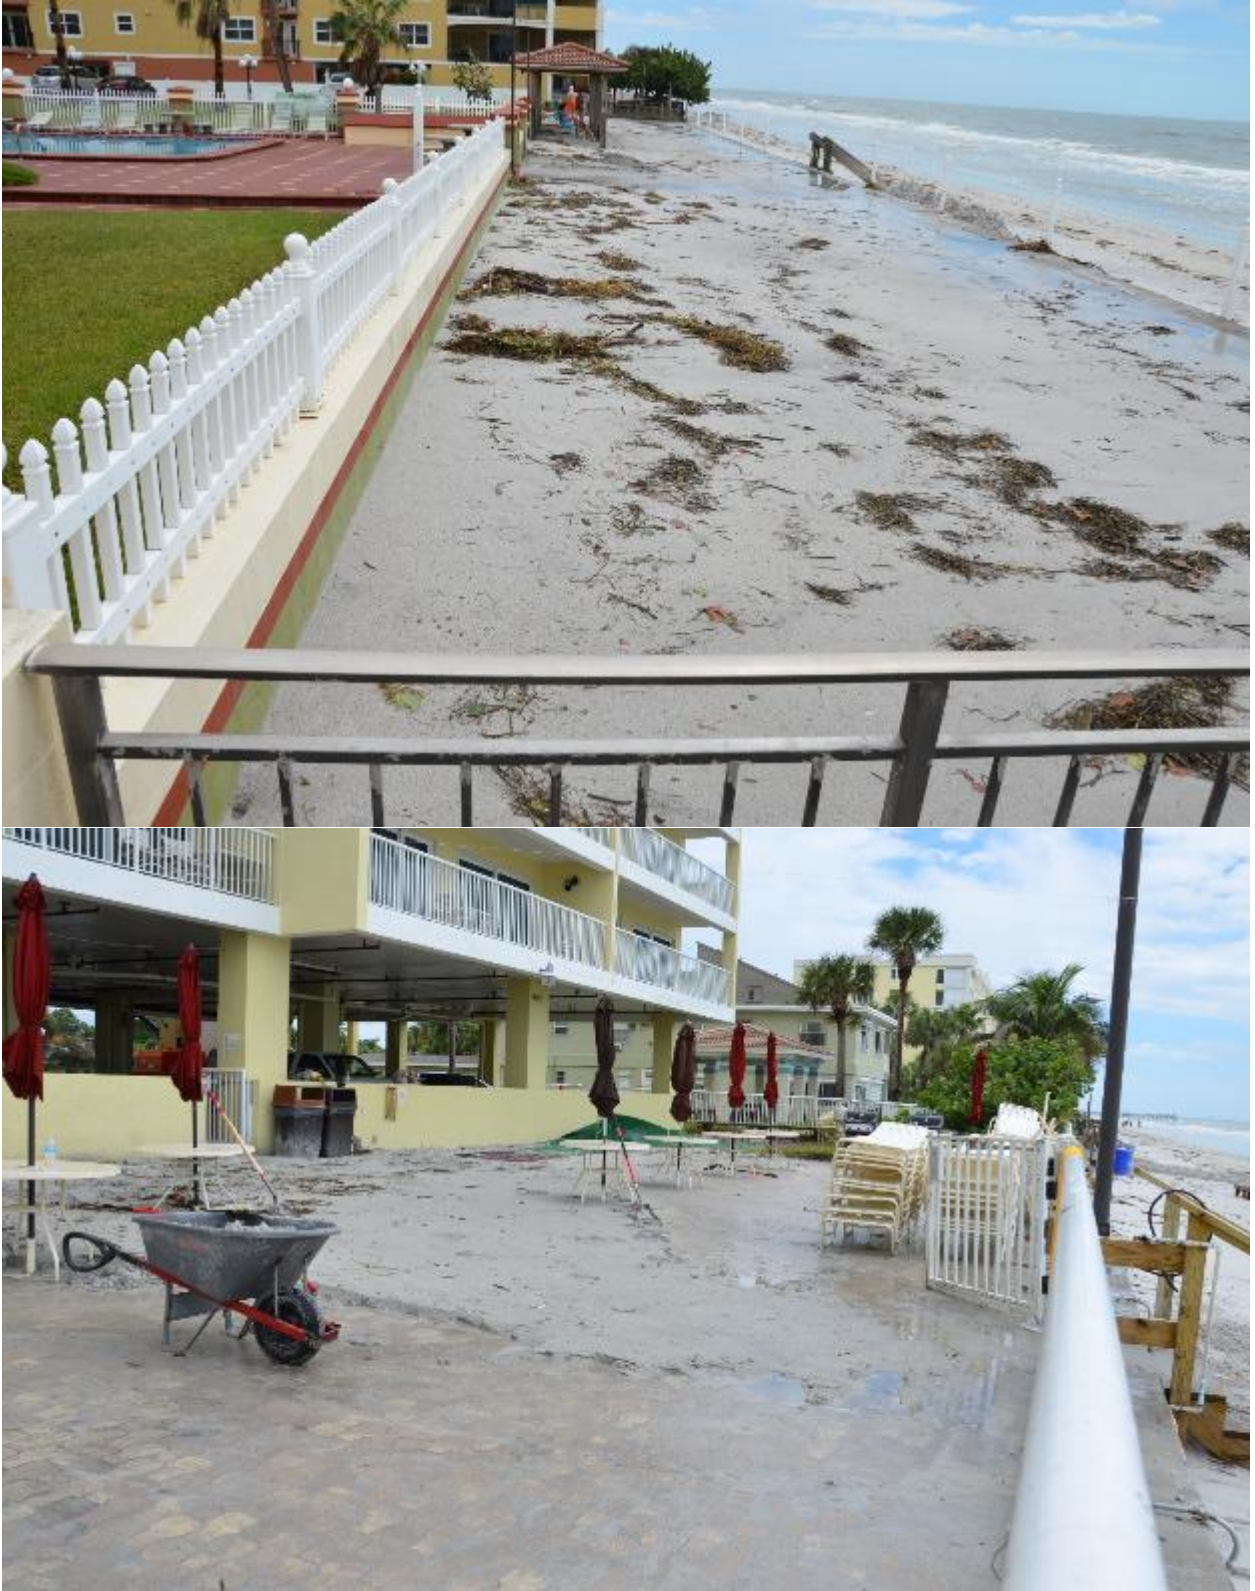
Figure 27. Sand washed onto the decks of beach front properties.

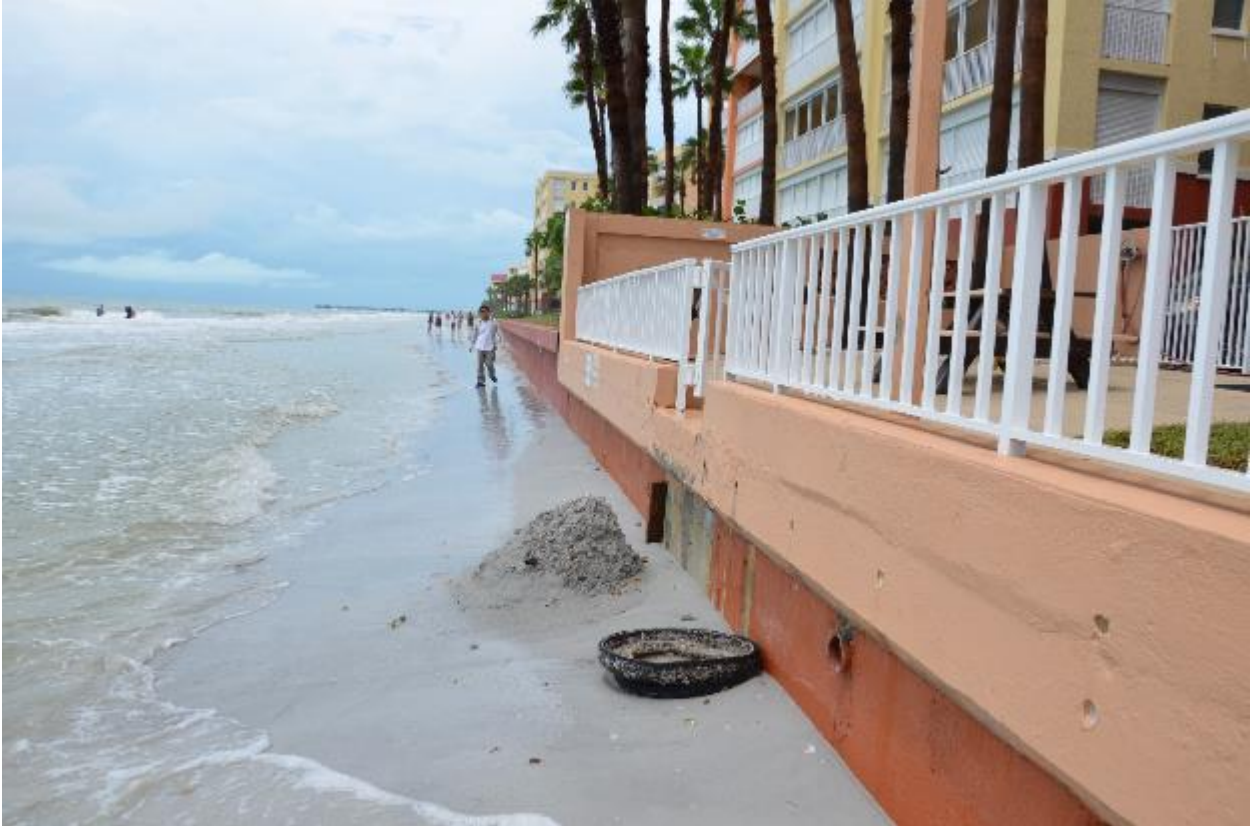
Figure 28. Severe scour along a stretch of seawall. The storm had overtopped the wall and deposited sand landward.

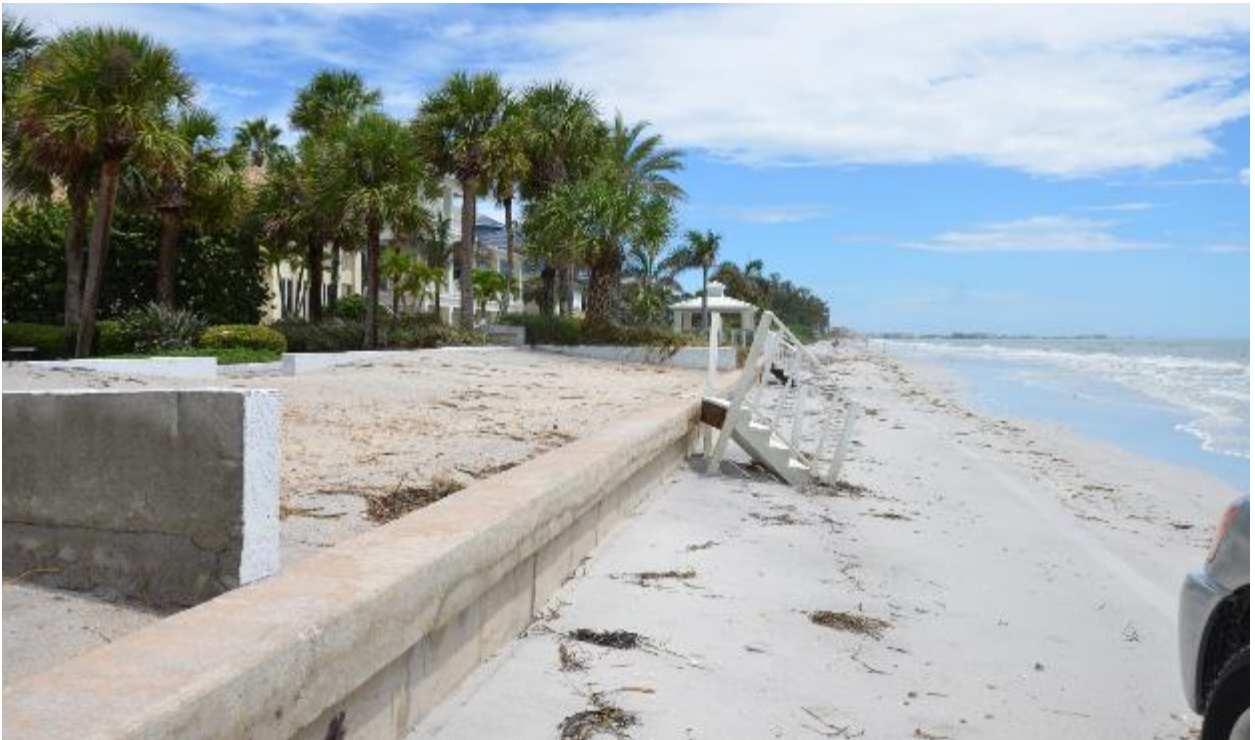
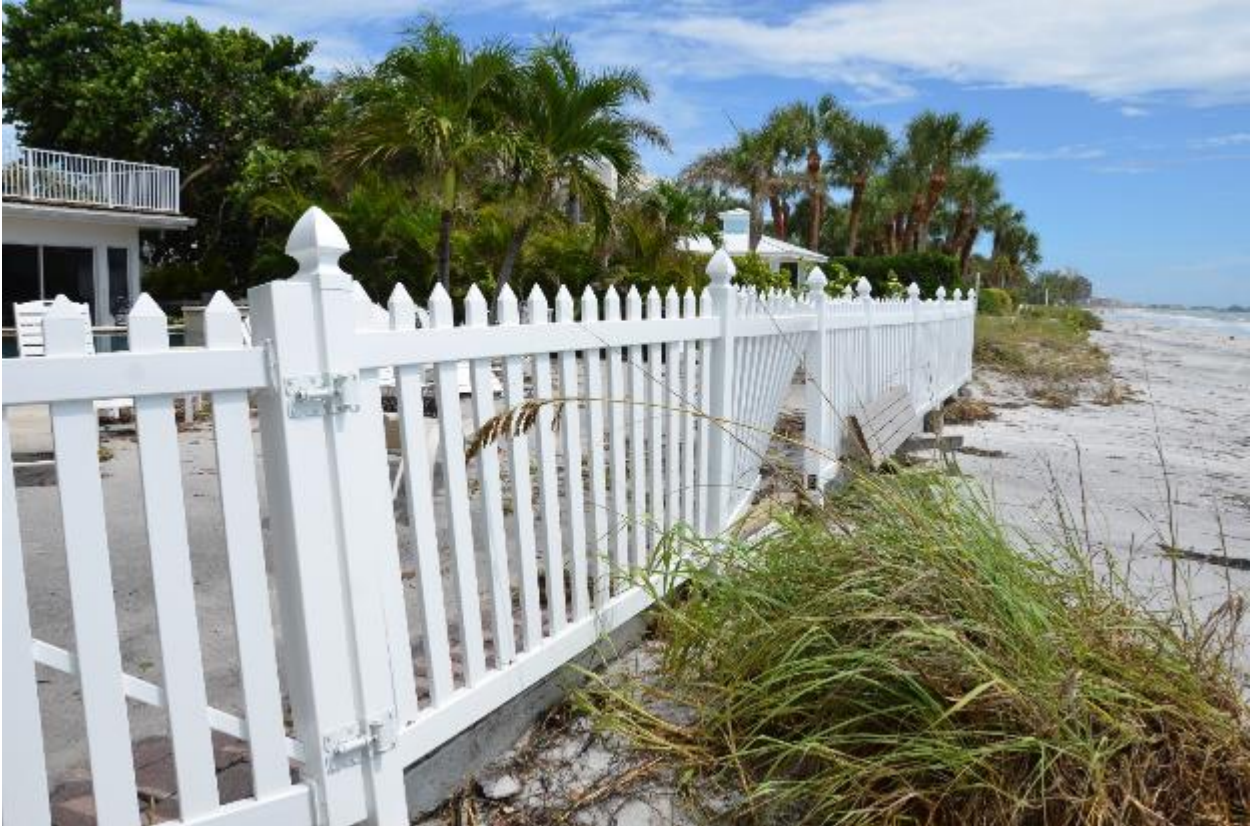
Figure 29. Some structural (fence and beach access stairs) damage with sand washed over the seawall.

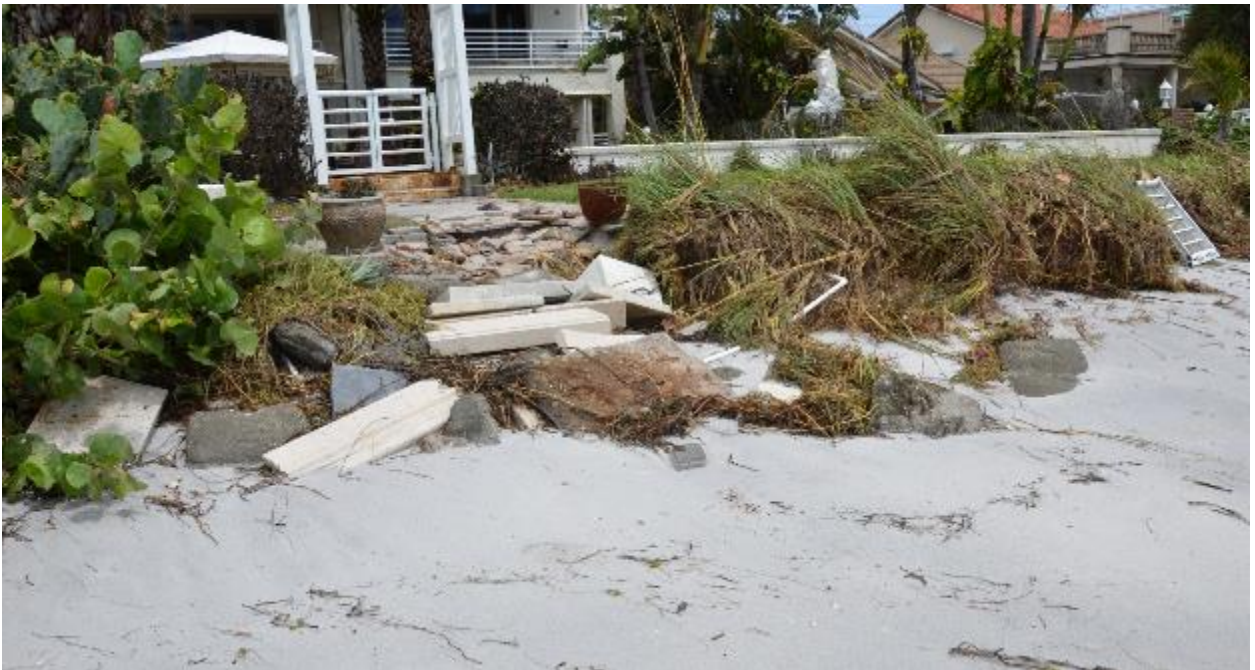
Figure 30. Pavers collapsed due to scour underneath.

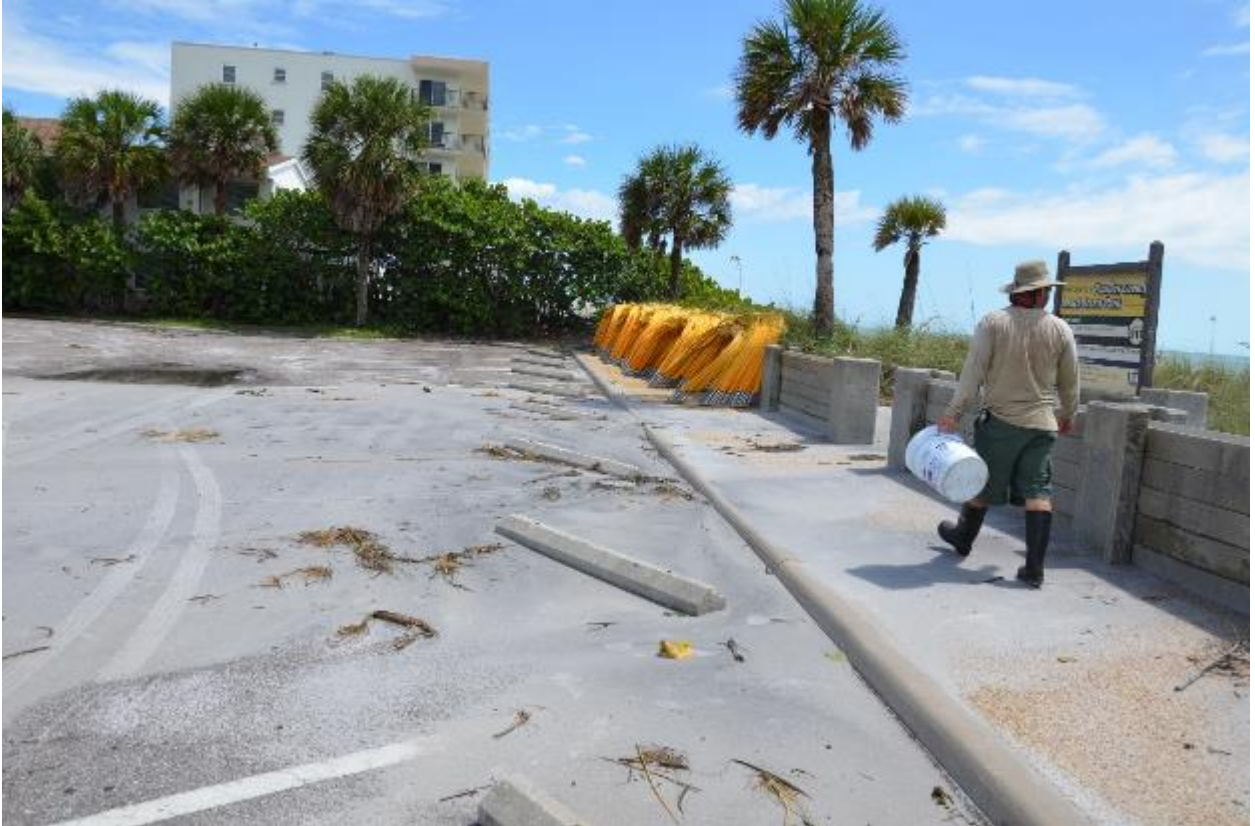
Figure 31. Sand washed into the parking lot of the Madeira Beach Park through the beach access.

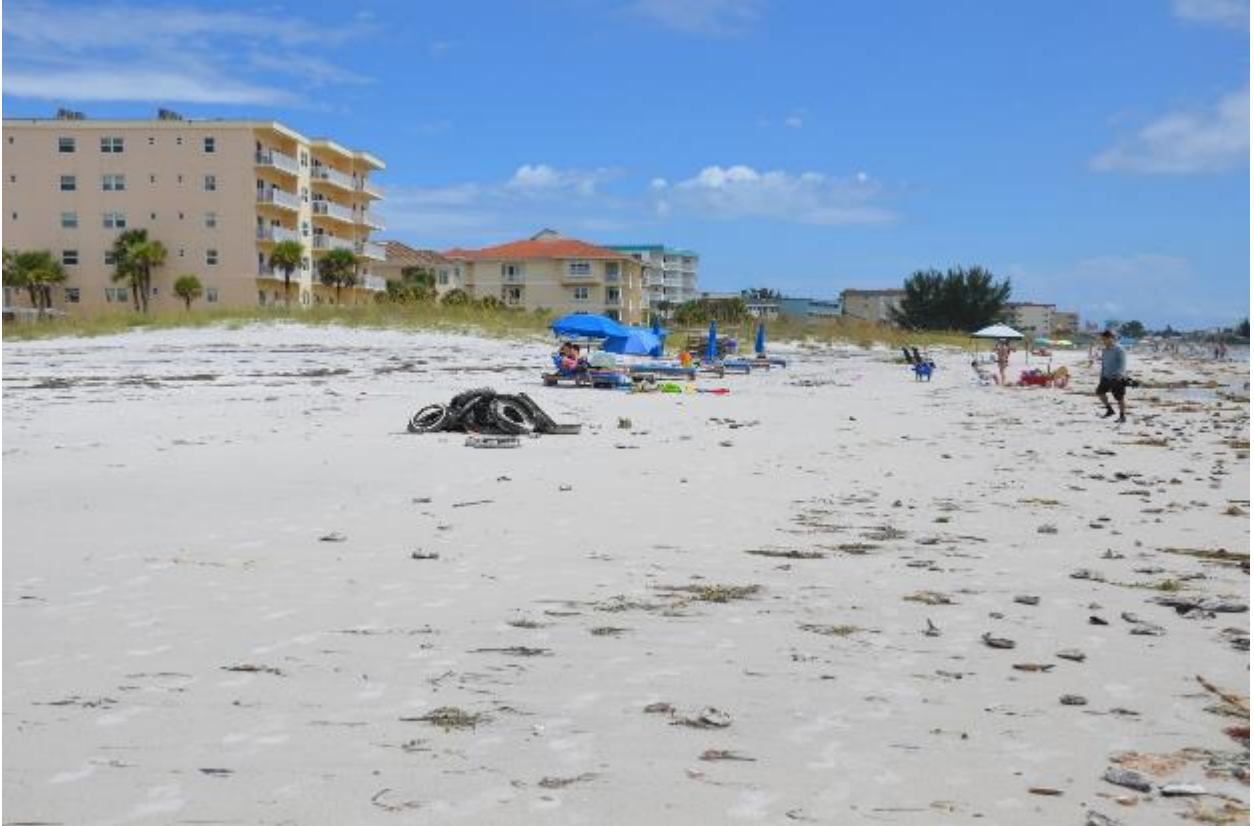
Figure 32. Debris, both natural (shells) and artificial (tires), washed onto the beach near John's Pass inlet.

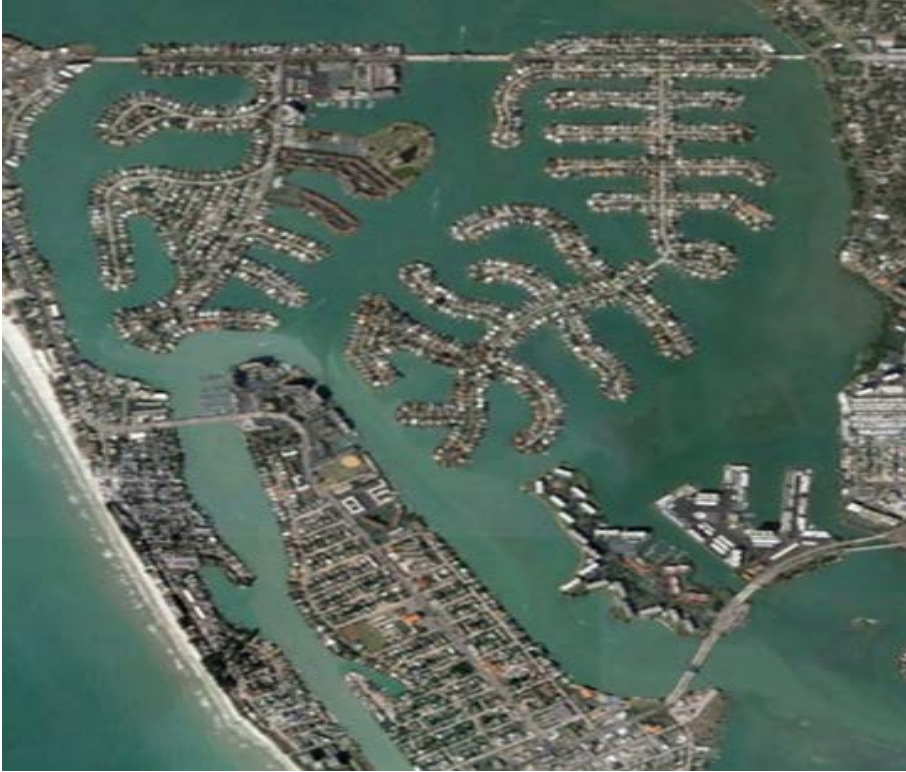
The Sunshine Beach at the northern end of Treasure Island (Figure 33) had a relatively wide pre-storm beach. No dune erosion or scarping occurred along this stretch of the

Figure 33. Sunshine Beach at the northern end of Treasure Island (yellow circle).

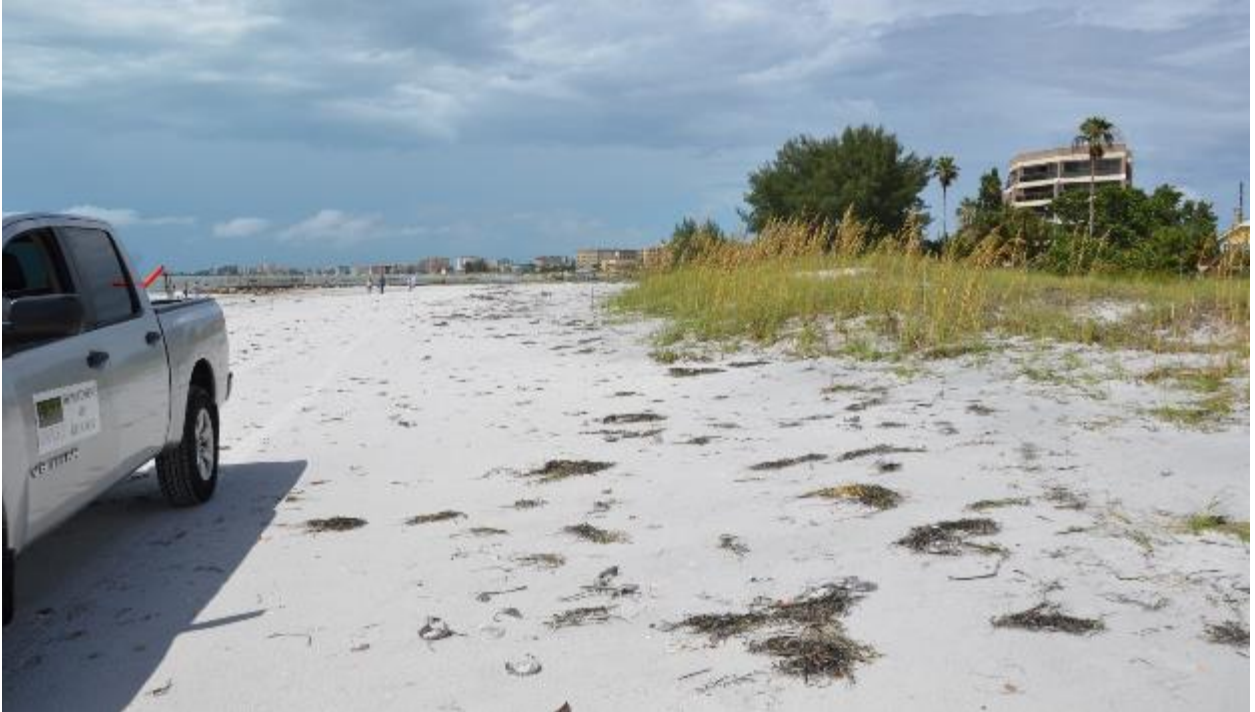
beach. As a matter of fact, considerable sand accumulation occurred directly along the seaward edge of the dune (Figure 34). The post-storm beach is still relatively wide (Figure 35). The back-beach elevation seems to have increased due to the “back beach overwash”. The sedimentation on this beach is likely relatively to the southerly approaching storm forcing (Figure 5).

Figure 34. Sand accumulation at the toe of dune at Sunshine Beach (upper panel). Considerable sand accumulation also occurred at the dune walkover (lower panel).

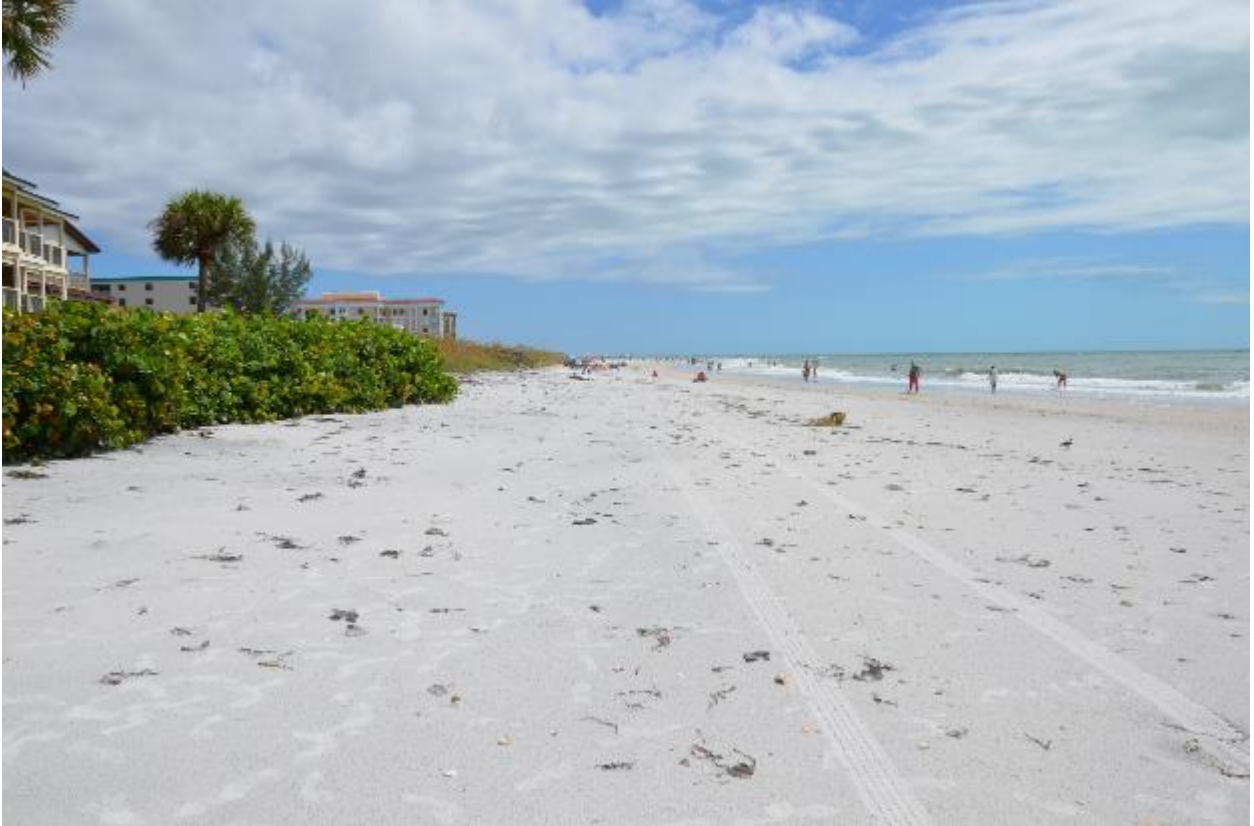
Figure 35. The post-storm beach is still relatively wide with sand deposition along the edge of vegetation.

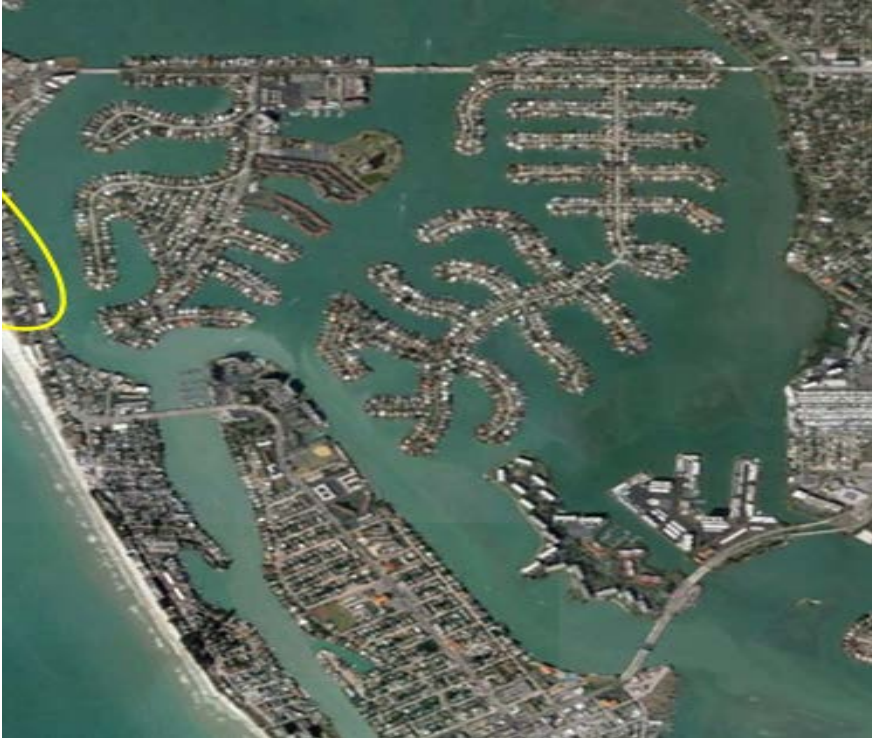
The middle section of Treasure Island is characteristic of a wide beach (Figure 36). Little to no dune erosion or scarping occurred. The storm impact to this section of the beach is mostly in the form of flooding of the low-lying portion of the back beach and accumulation of a storm berm, or “back beach overwash” (Figure 37).

Figure 36. Middle section of Treasure Island with wide beach.

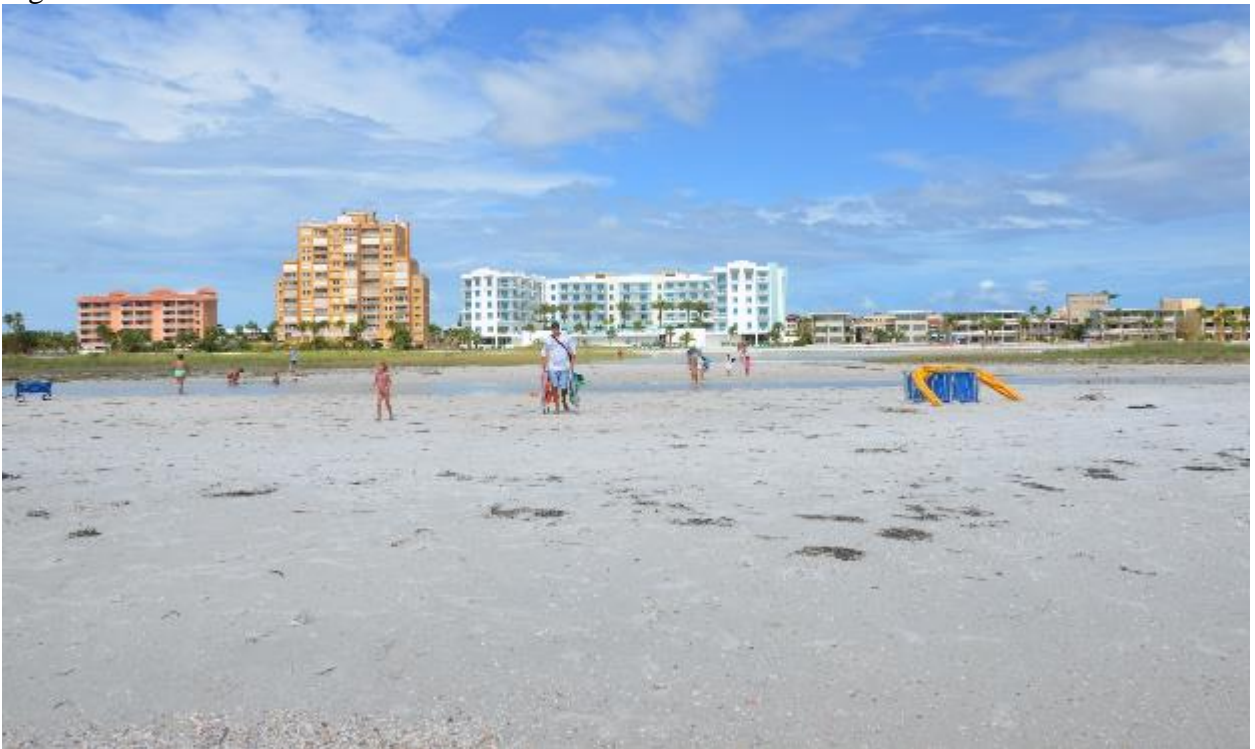
Figure 37. Flooding of the low-lying portion of the back beach and the back beach overwash.

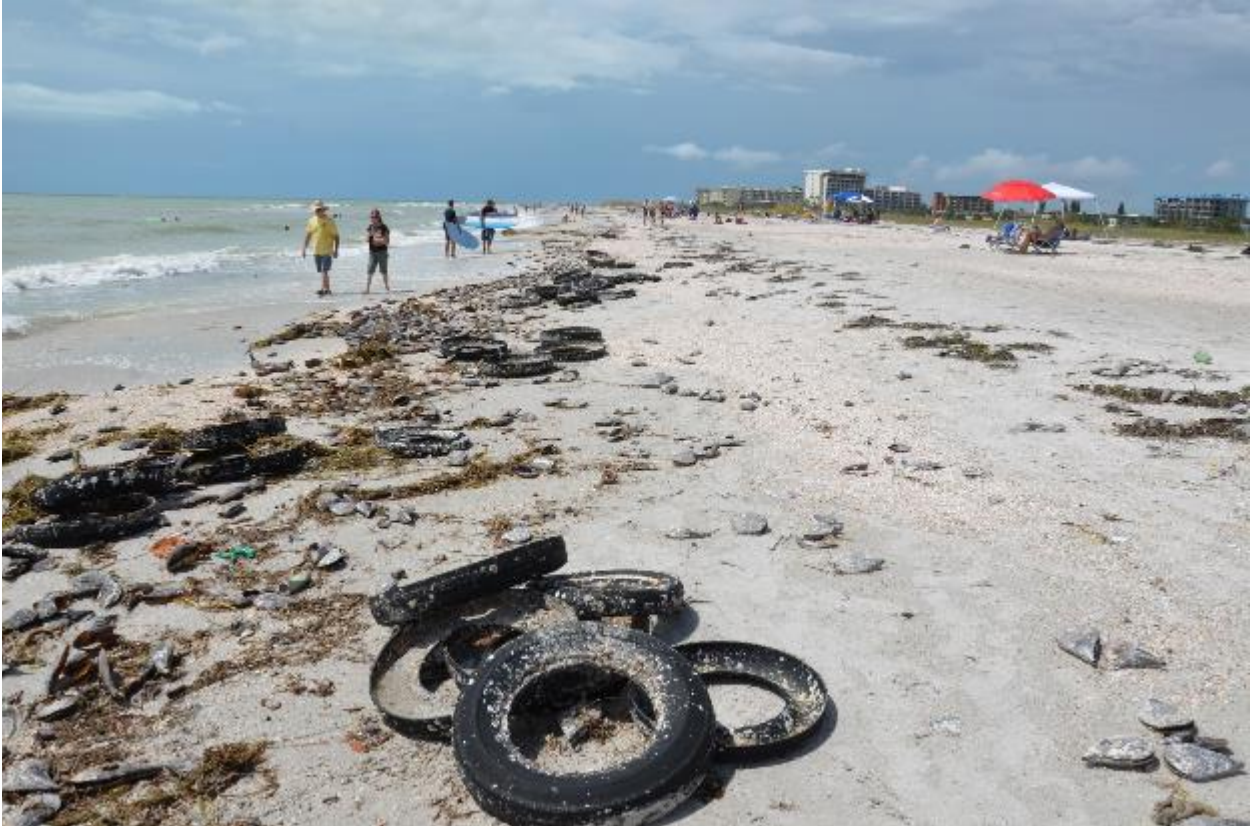
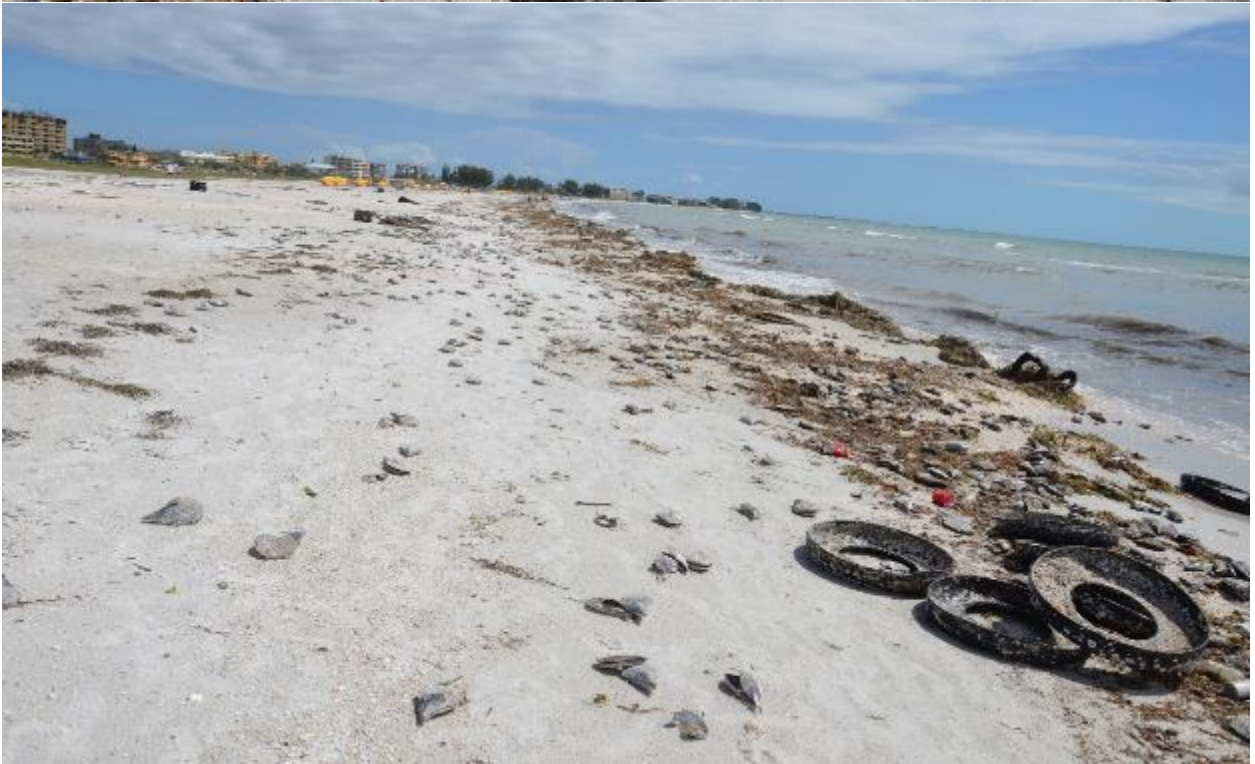
Figure 38. A large amount of debris, both artificial (tires and traps) and natural (shells), washed onto the beach in the middle of Treasure Island.

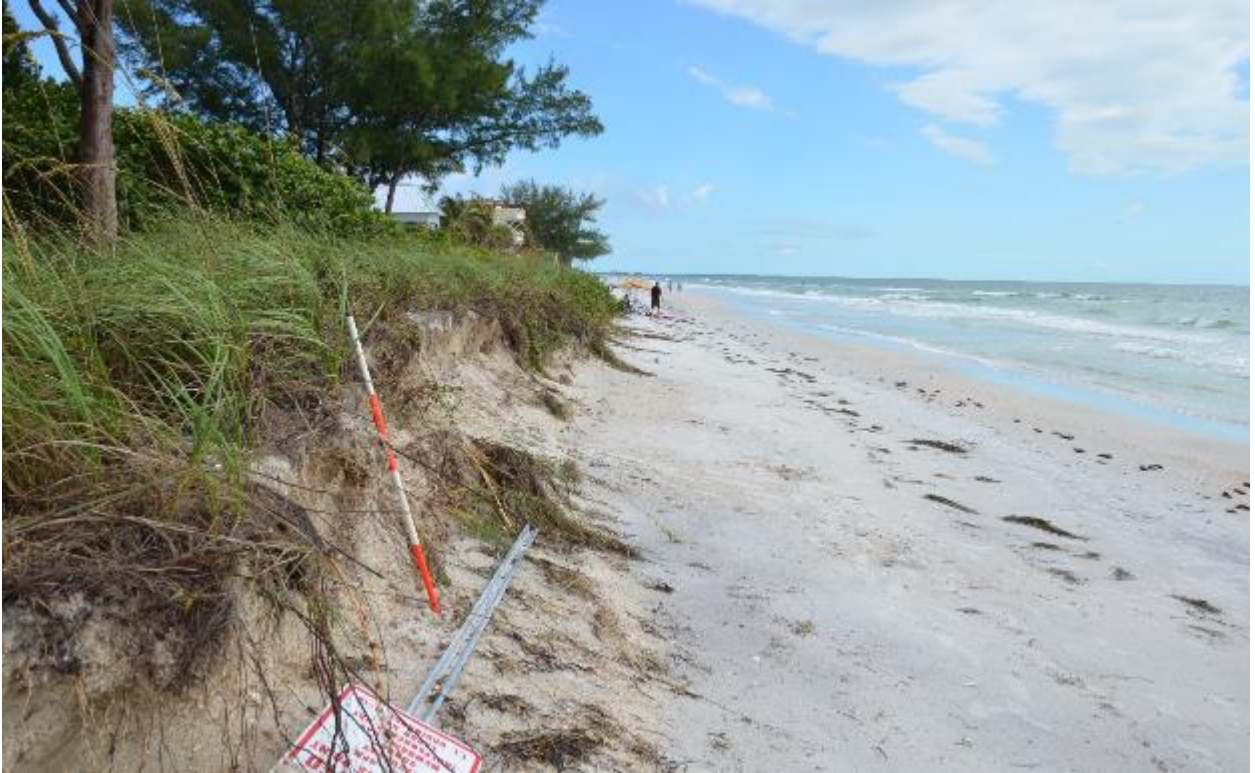
Sunset Beach along the southern portion of Treasure Island (Figure 39) is a persistent erosional hot spot. The pre-storm beach was relatively narrow. Extensive and continuous dune scarping of 2 to 4 ft high occurred along this stretch of the beach (Figure 40). Beach access stairs and fences were damaged at several locations (Figure 41). At locations where dunes are absent or been eroded, sand was washed over the seawall and deposited in the parking lot (Figure 42). The impact of Hurricane Hermine is slightly more severe than that during Tropical Storm Debby. Debby caused severe beach erosion and dune scarping but did not overtop the seawall and therefore did not induce overwash. Infrastructure damage also seems to be slightly more severe for Hurricane Hermine.

Figure 40. Continuous dune scarping along Sunset Beach.

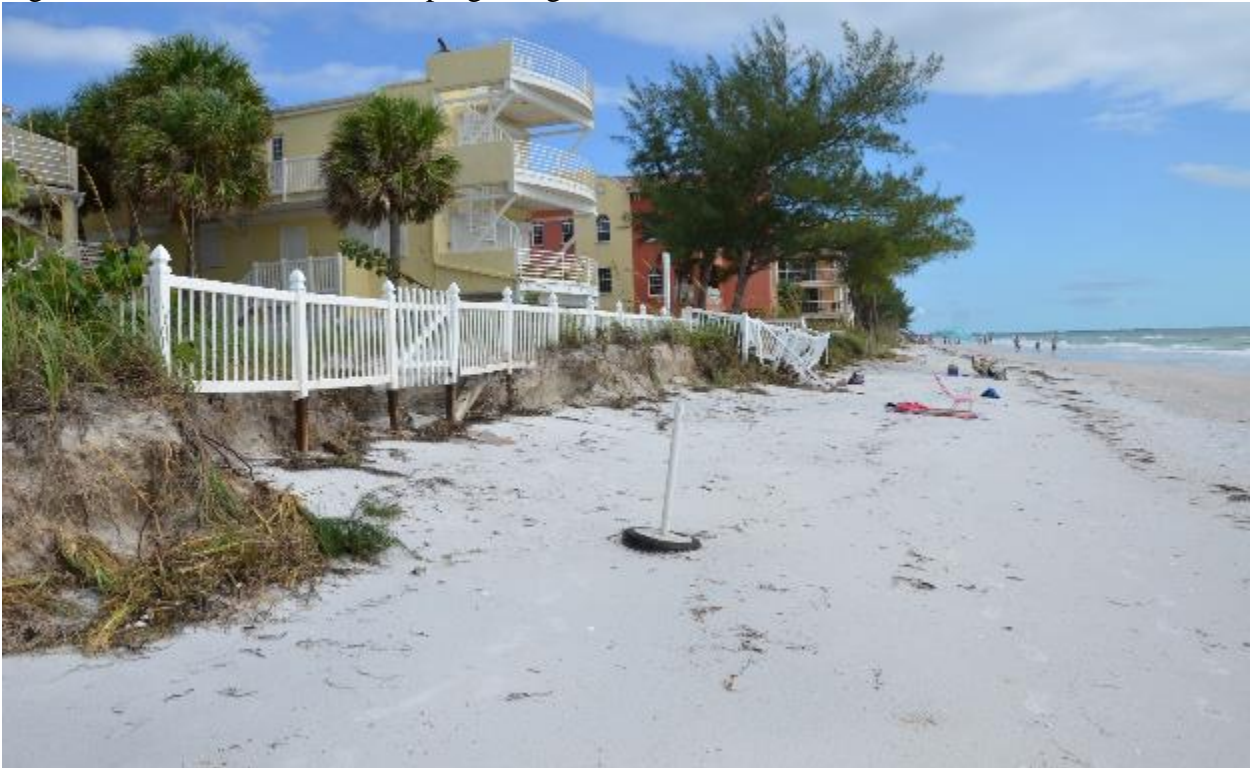
Figure 41. Fence and beach access damage along Sunset Beach.

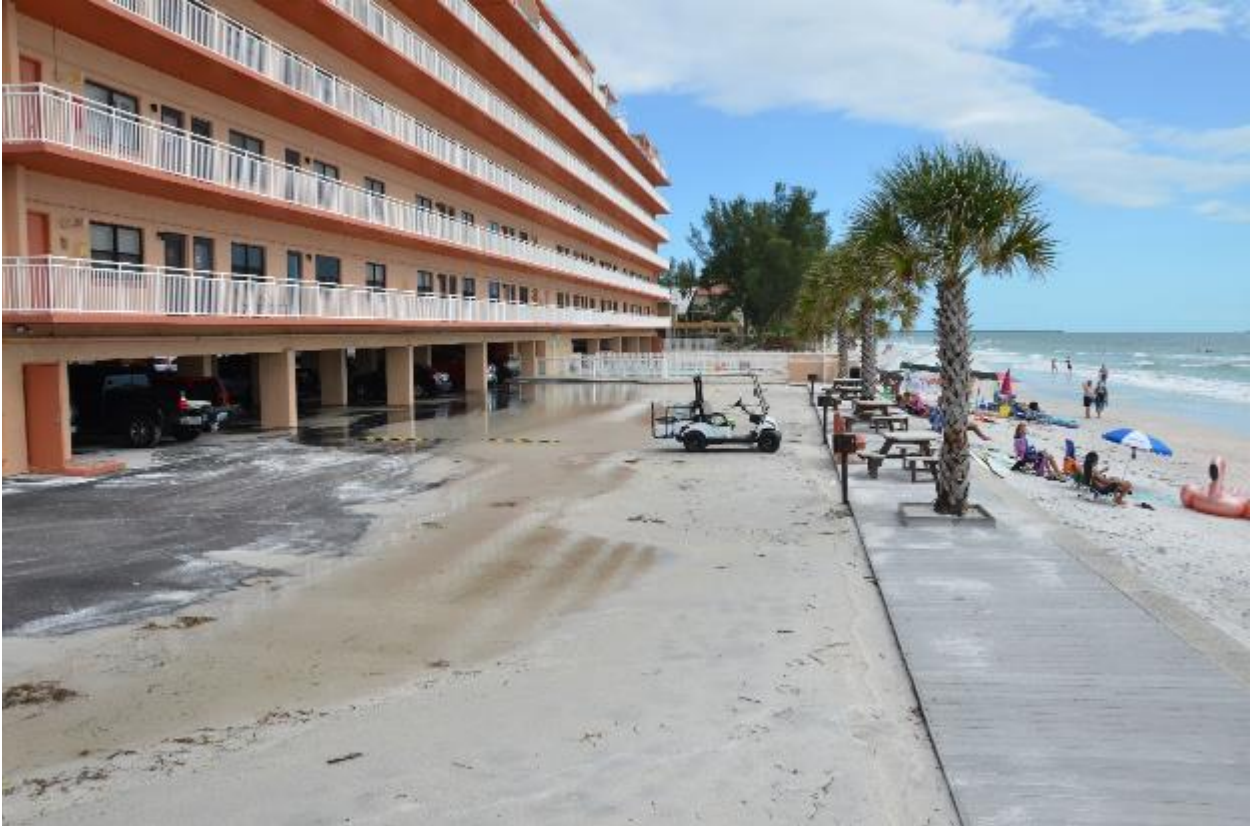
Figure 42. The seawall was overtopped and sand was washed into the parking lot.

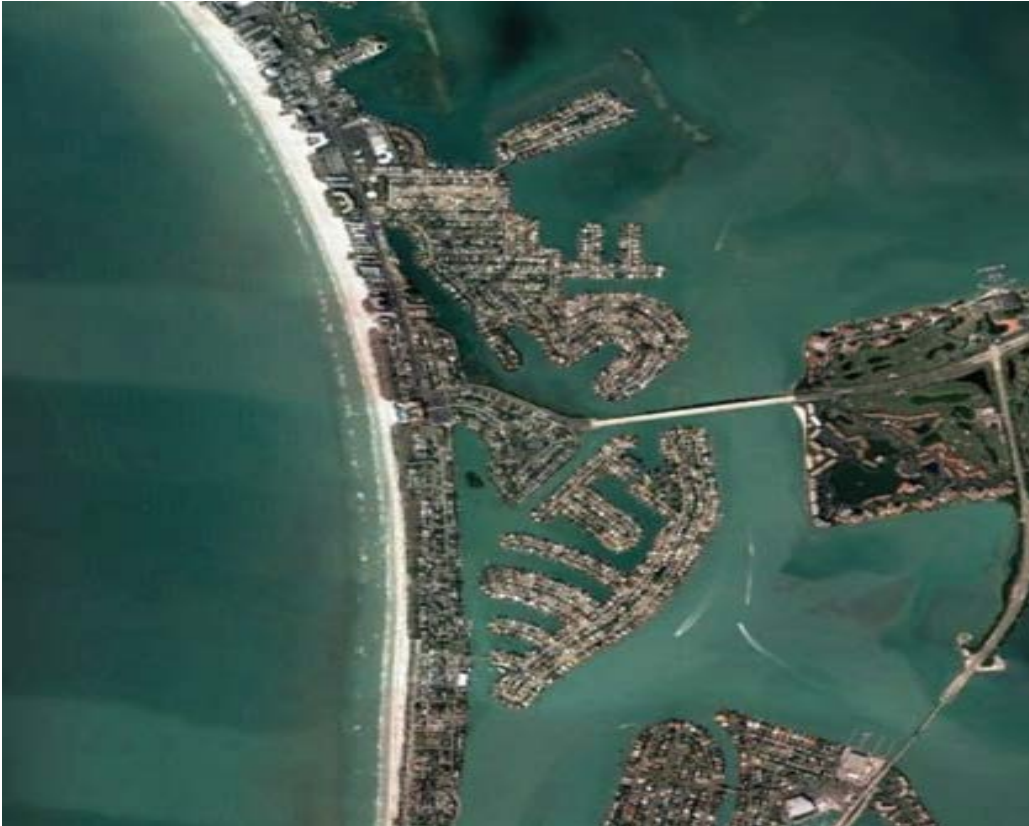
The Upham Beach at the northern end of Long Key (Figure 43) had a relatively wide pre-storm beach except at the very north end. Although severe beach erosion had occurred, little to no dune erosion or scarping occurred along this stretch of the beach (Figure 44). The seawall at the very north end was exposed before the storm impact. Additional scour at the base of the seawall seems to have occurred. A large amount of sand was washed

Figure 43. Upham Beach at the northern end of Long Key (yellow circle).

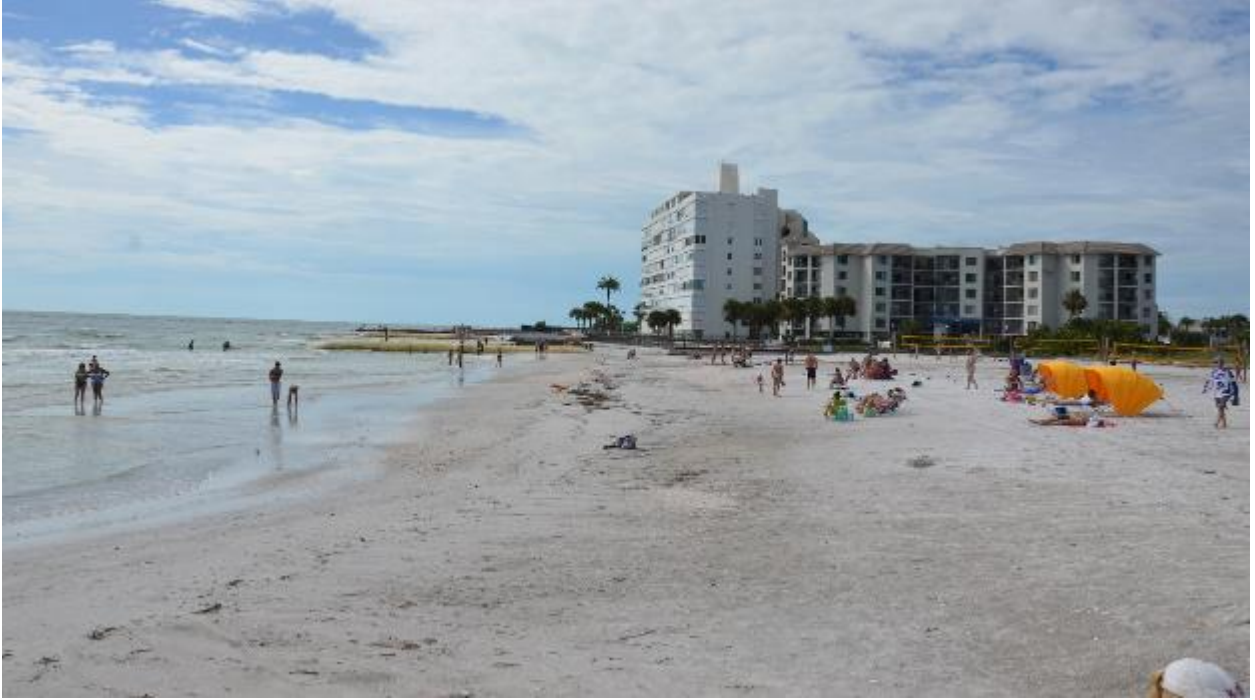
Figure 44. Beach erosion along the northern portion of Upham Beach.

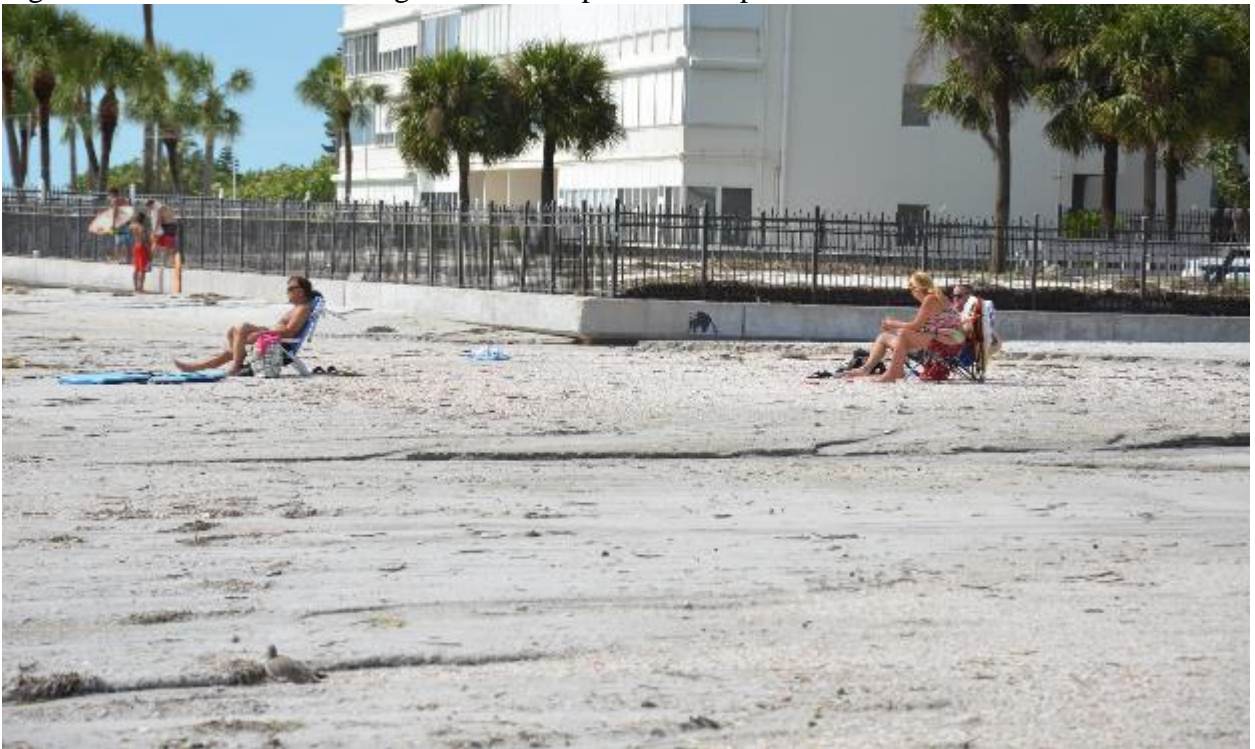
over the seawall and deposited over the grass (Figure 45). T-groin #4 becomes exposed due to severe beach erosion (Figure 46). However, T-groin #5 which was exposed before the storm had become completely buried due to the considerable deposition over the back beach (Figure 47). Overwash sand accumulation on the back beach was observed along the wide portion of Upham Beach. Similar to the case along the wide portions of Sand Key and Treasure Island, flooding and ponding at the lower portion of the back beach occurred at various locations (Figure 48). Compared to the impact of Tropical Storm Debby, the more energetic Hermine washed a large amount of sand over the seawall, which did not happen after Debby.

Figure 45. Large amount of sand was washed over the seawall.

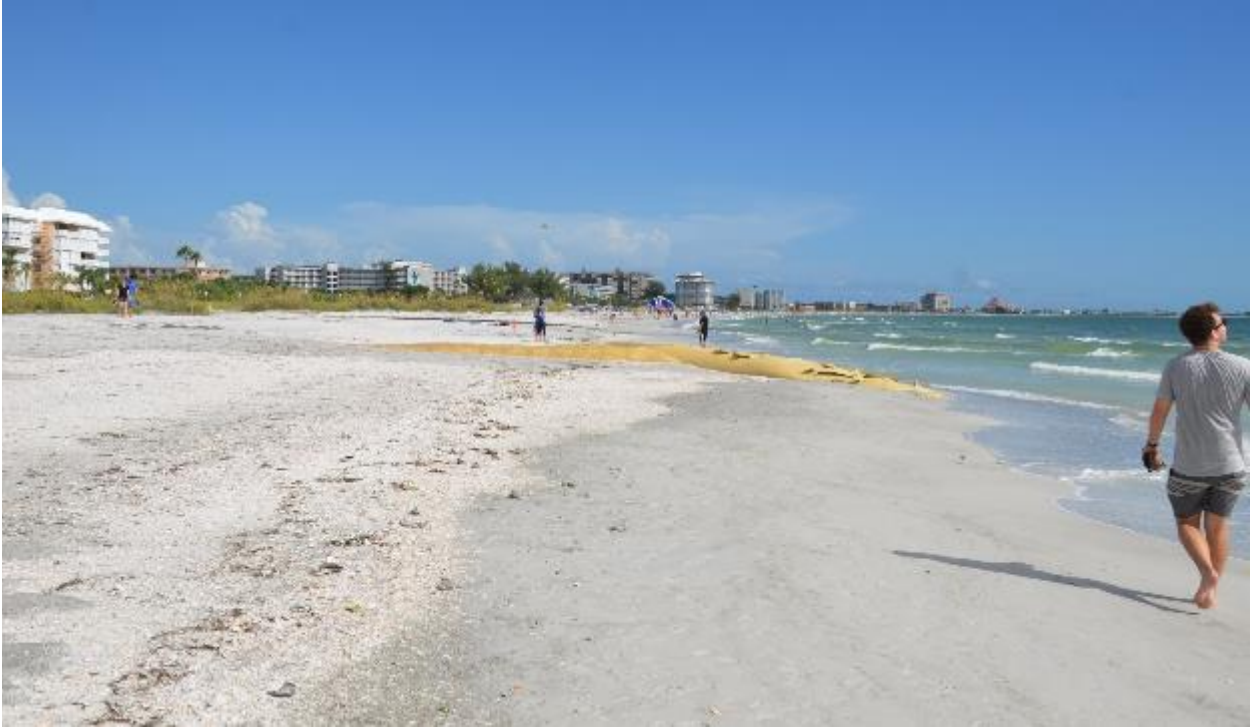
Figure 46. Severe beach erosion exposed T-groin #4, which was completely buried before the storm.

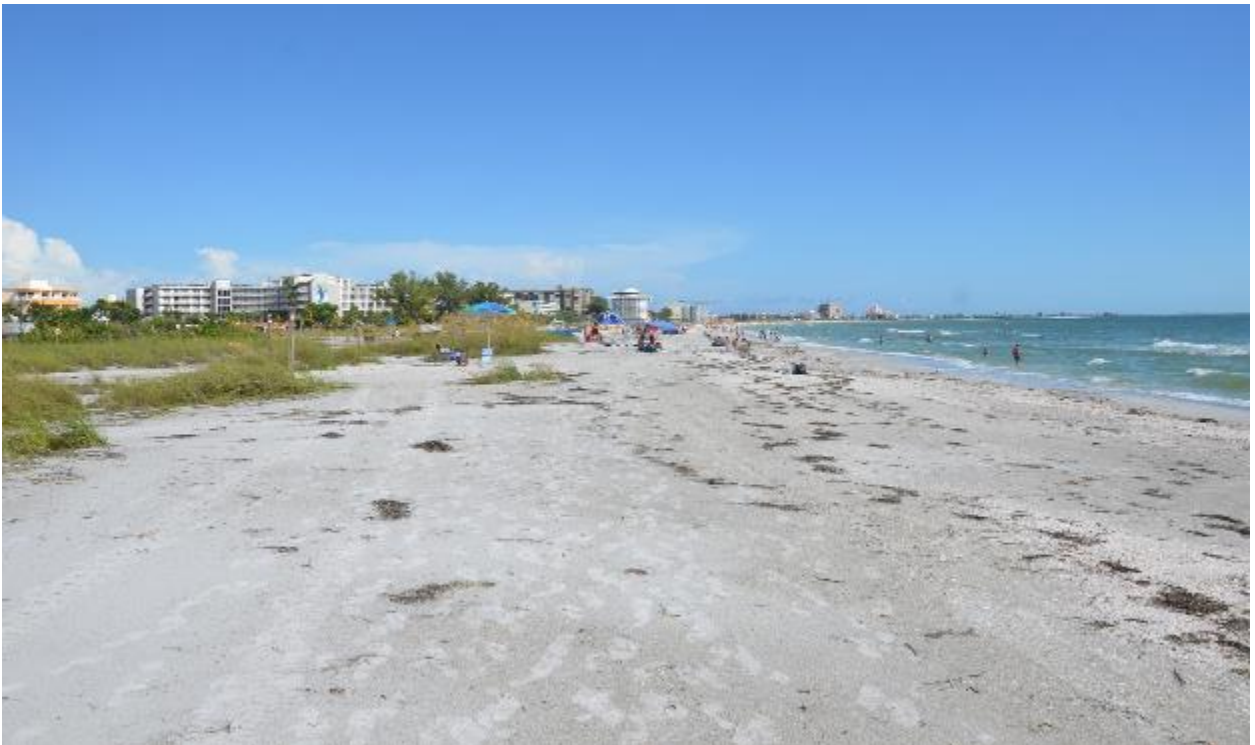
Figure 47. The T-groin #5 which was partially exposed before the storm became completely buried by “back beach overwash”, also notice the partial burial of the sea oaks due to the overwash.
