PROJECT INFORMATION REPORT

REHABILITATION EFFORT FOR THE PINELLAS COUNTY, FLORIDA – COASTAL STORM RISK MANAGEMENT (CSRM) PROJECT

October 2016

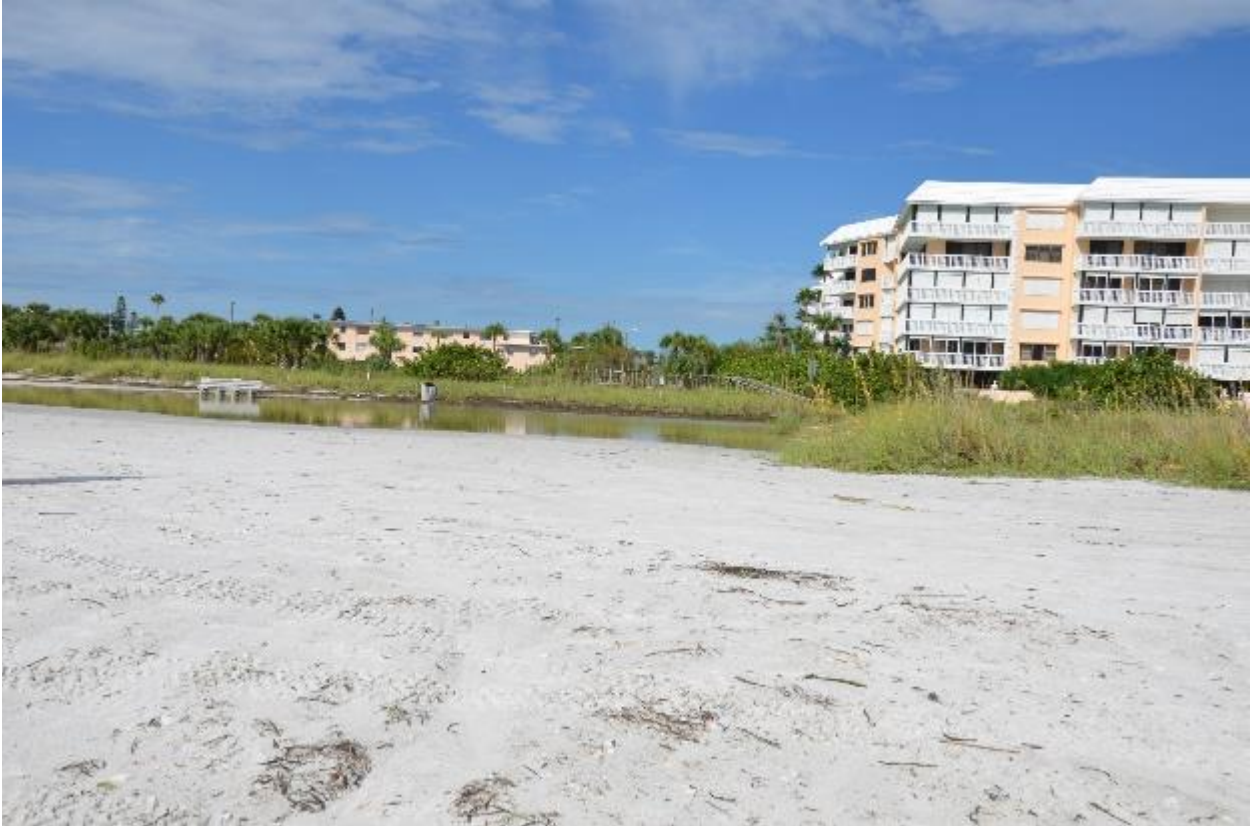
Figure 48. Flooding and ponding at the lower portion of wide back beach.

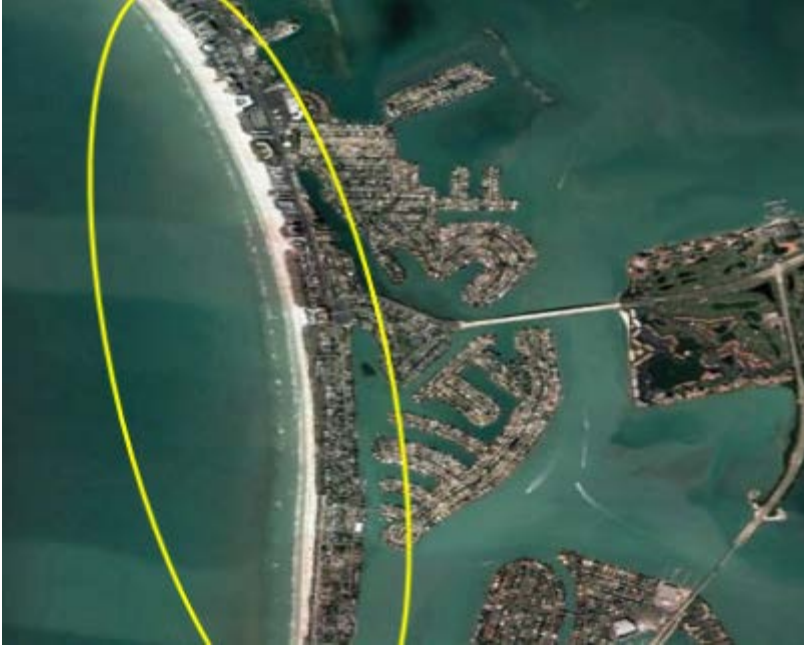
The middle portion of Long Key has quite wide beach before the storm. The southern portion of Long Key, the Pass-A-Grille beach, was nourished in 2014 and the beach has remained relatively wide since then. These two portions are described here together (Figure 49). Flooding and ponding at the lower portion of the back beach were observed along the wide section of the beach (Figure 50). Considerable sand accumulation occurred on the back beach and extended into the low vegetated dunes (Figure 50). This sand deposition is illustrated by the burial of sea oaks and may beach chairs. In other words, the elevation of the back part of the back beach was increased due to storm overwash. Similar case was also observed here after Tropical Storm Debby. It is likely that the sand came from the erosion of the lower beach and the intertidal beach, as for the case of Debby. However, since the beach is quite wide, it is difficult to estimate the amount of landward shoreline retreat. The post-storm survey will quantify the changes. Due to the wide beach, little to no dune erosion and scarping occurred along this stretch of the beach.

Figure 49. Middle and southern portion of Long Key (yellow circle).

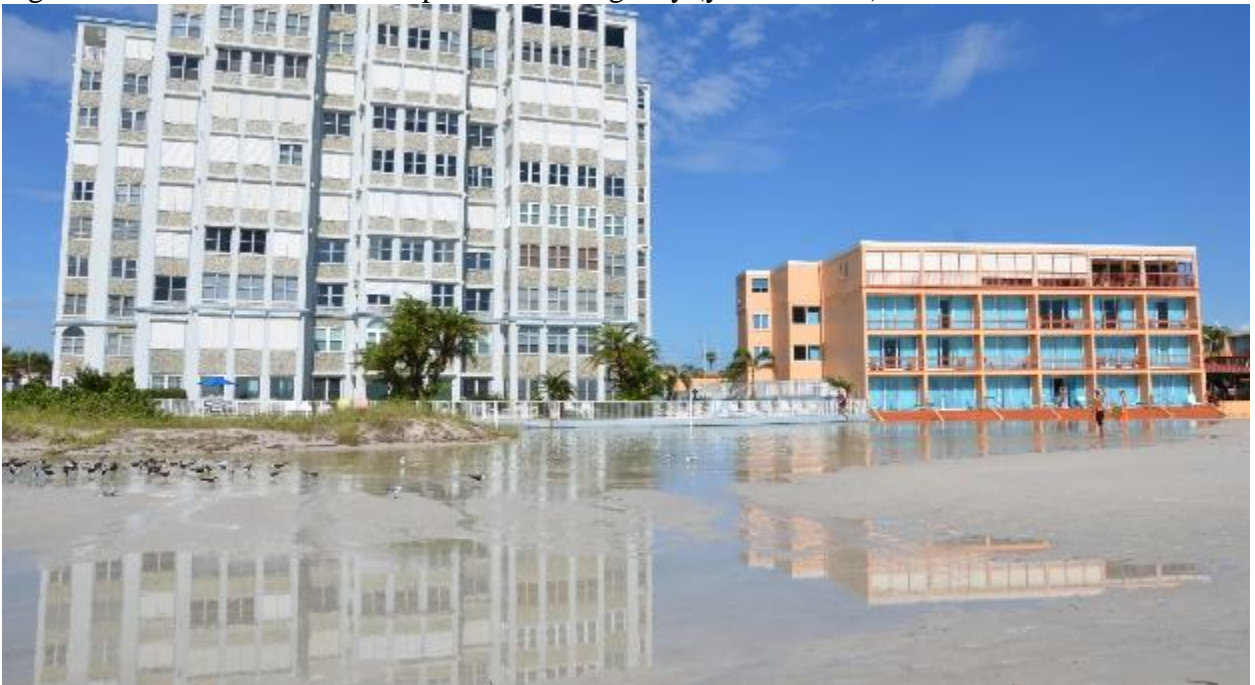
Figure 50. Flooding of the lower portion of the wide back beach in the middle Long Key.

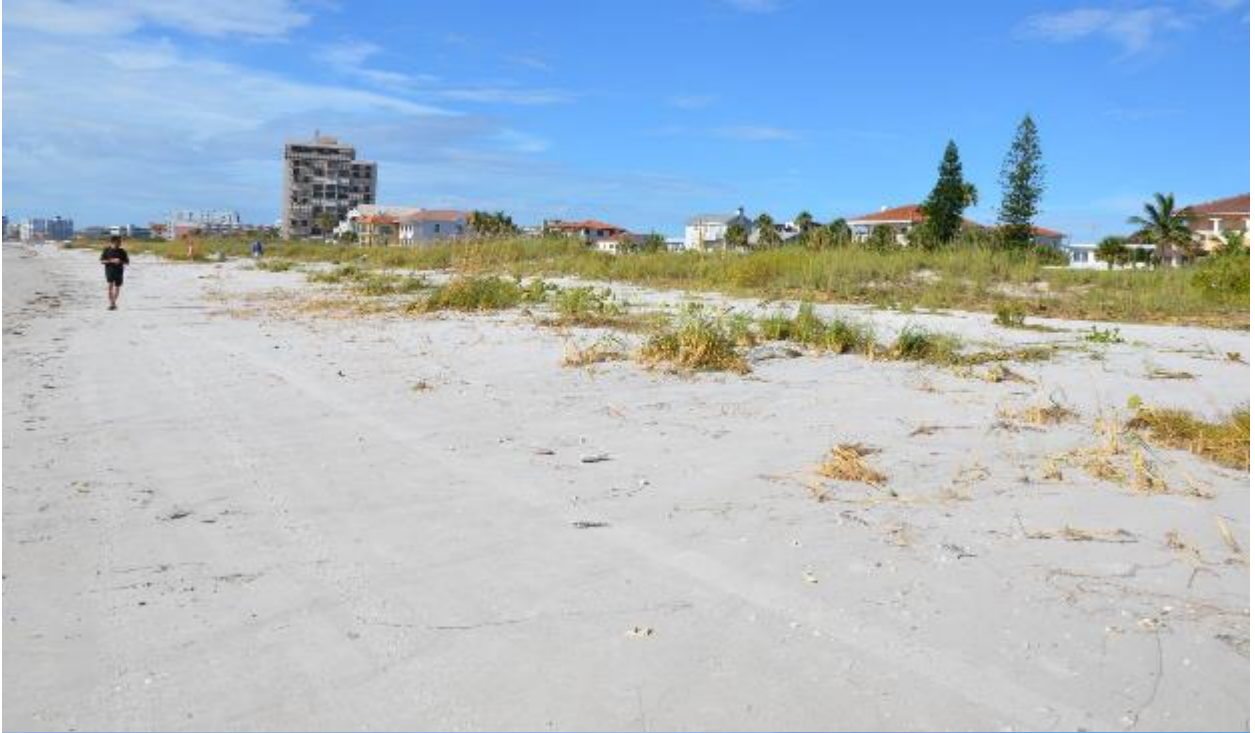
Figure 51. Sand deposition at the toe of the dune, resulting in the burial of some vegetation (upper panel) and beach benches (lower panel). No dune scarping occurred.

Overall, except at the very northern end, the pre-storm beach at Long Key was relatively wide. The wide beach provided protection to the dunes, resulting in little to no dune erosion or scarping. Instead, sand deposition along the toe of the dune occurred, burying some vegetation and beach benches. It is likely that the lower portion of the beach and the intertidal zone have experienced severe erosion. This will be confirmed and quantified by the post-storm beach survey. However, reasonable beach width is maintained after the storm along most of Long Key.

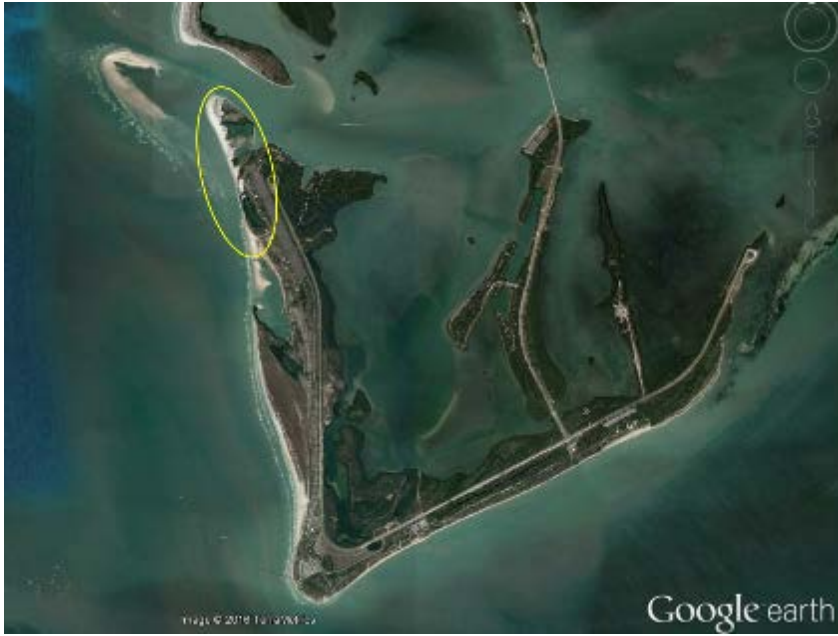
The North Beach on Mullet Key (Figure 52) has been experiencing aggressive beach erosion over the past three years. The beach has been migrating landward recently. Substantial landward beach migration occurred due to the impact of Hurricane Hermine. The landward migration of the beach has resulted in the buried (or partial burial) of some of beach facilities, e.g., a shower (Figure 53). Post-storm survey will quantify the landward migration of the beach. The boardwalk to the beach experienced scour underneath and was damaged in the middle (Figure 54).

Figure 52. The northern end of Mullet Key.

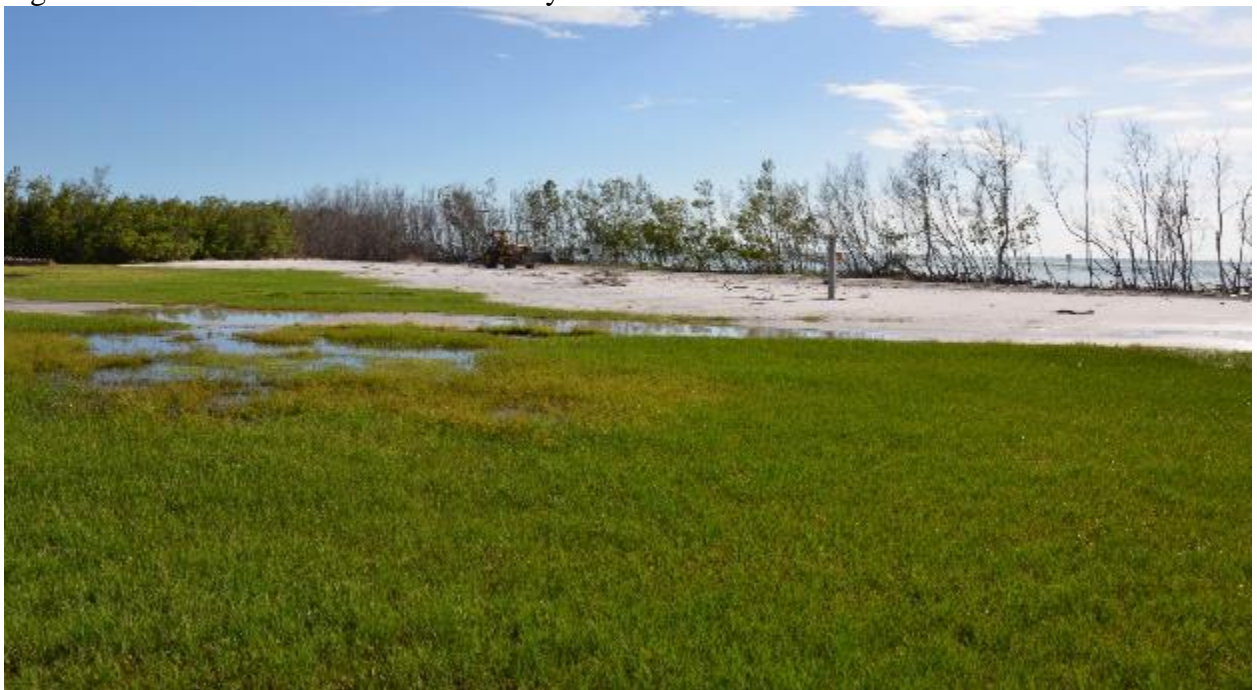
Figure 53. A section of the beach has migrated landward of the previous mangrove swamp. The beach existed before the storm. However, the storm has pushed the beach further landward and partially buried a shower station (lower panel). Note the foot wash faucet is almost at the sand surface.

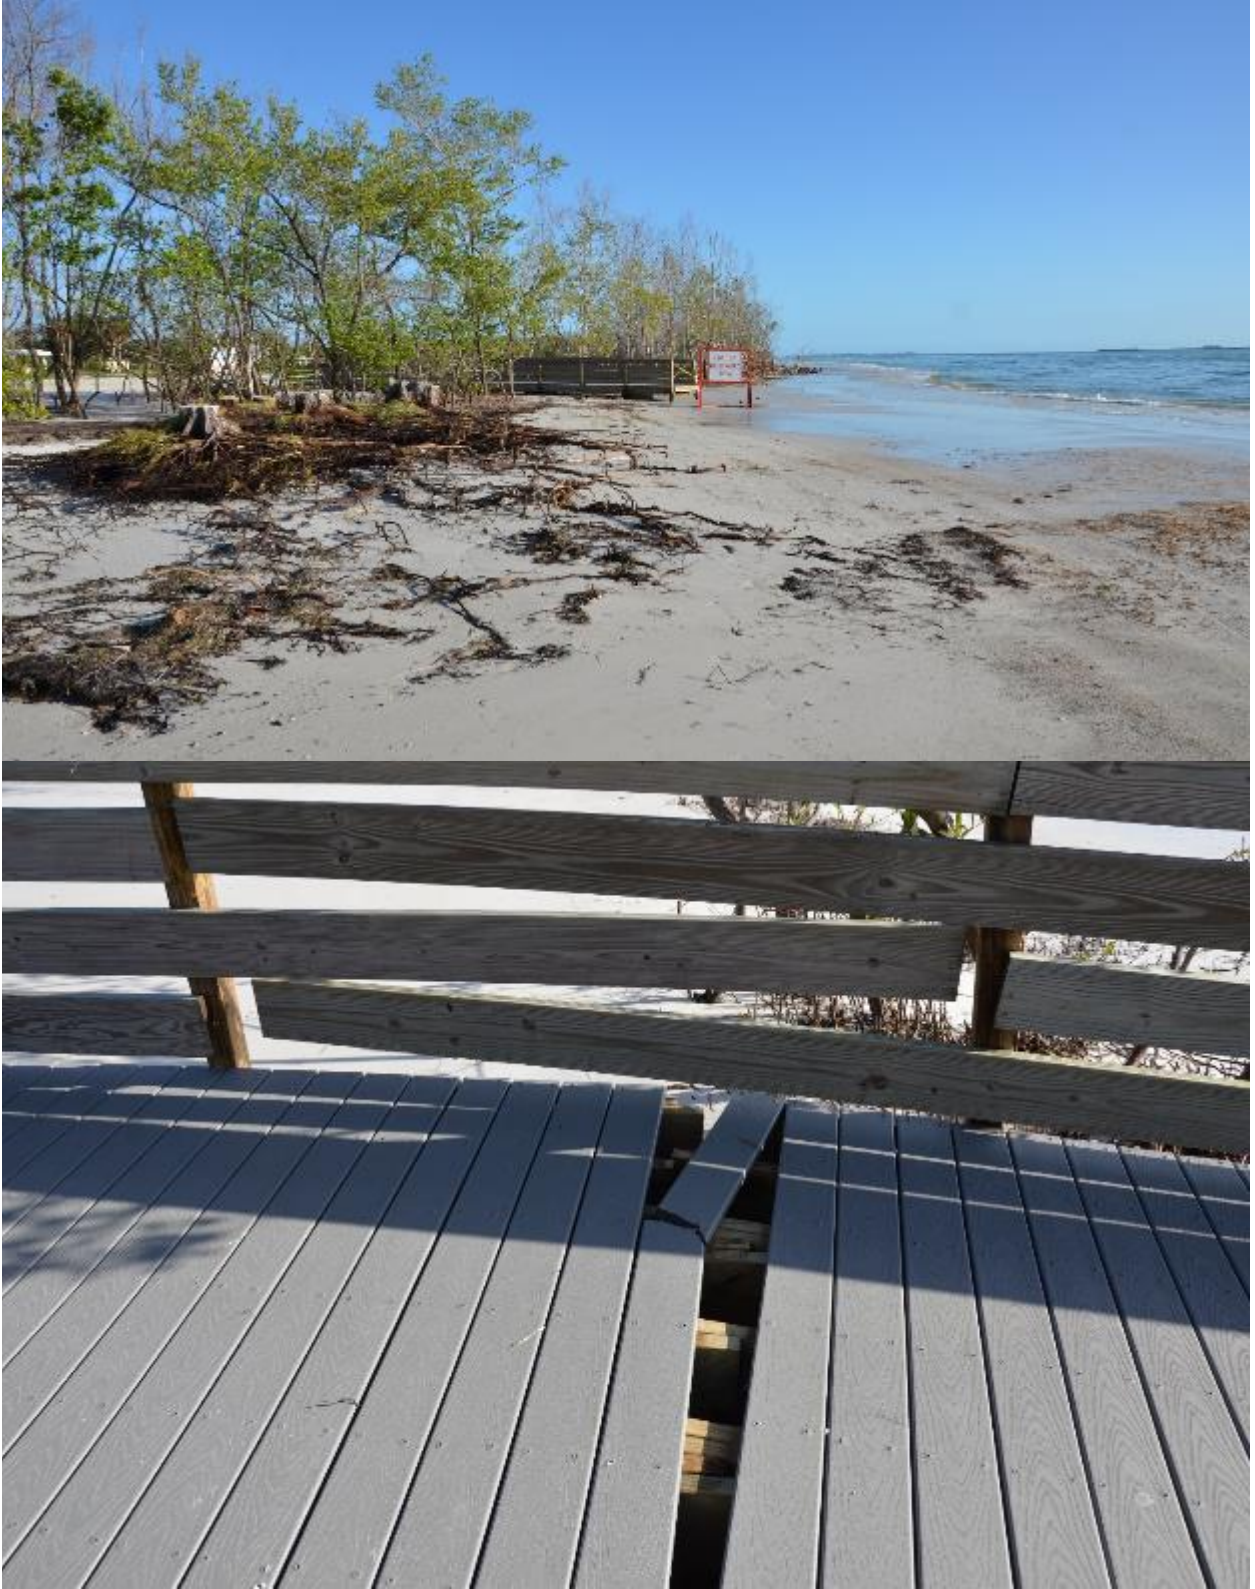
Figure 54. The boardwalk to the beach is severely scoured underneath (upper panel) and was damaged (lower panel).

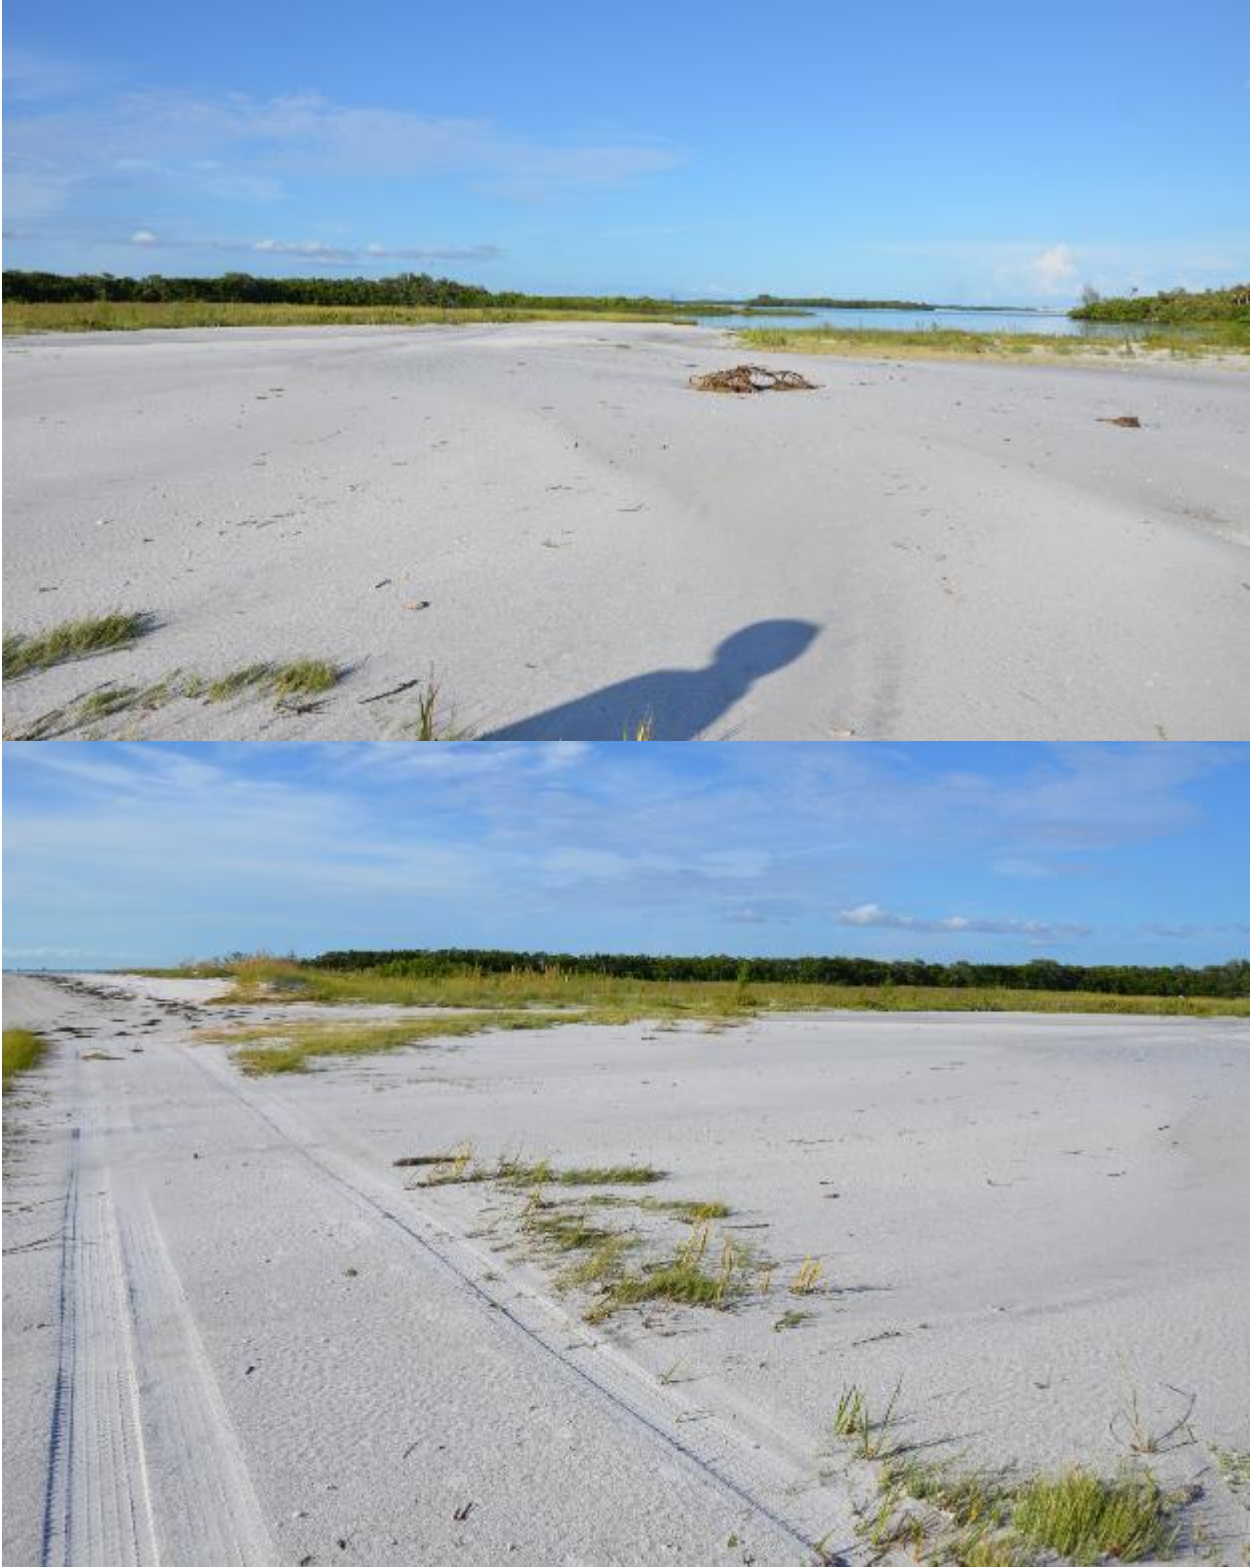
Figure 55. Extensive overwash occurred at the northern end (upper panel) and partially buried some sea oaks.

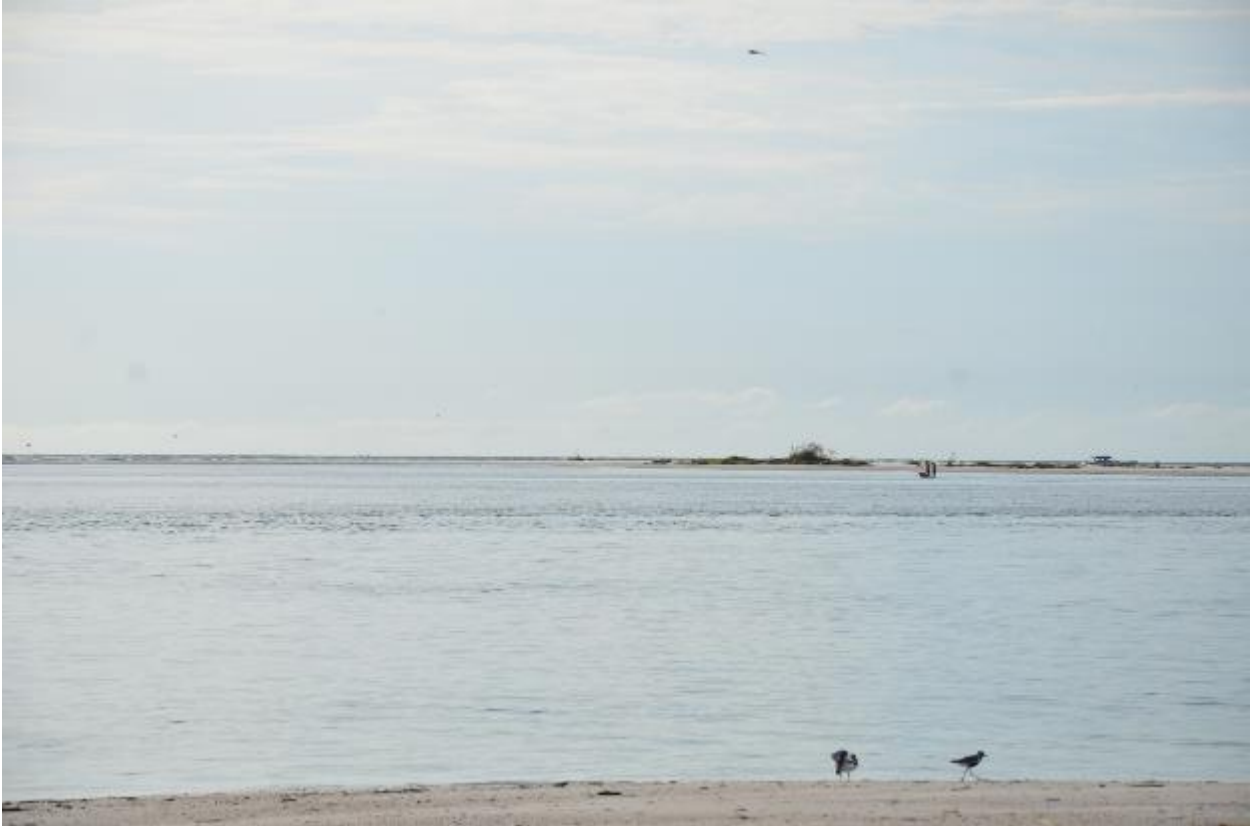
The northern end of Mullet Key experienced extensive overwash. The overwash lobe extended into the back-barrier bay and partially buried some of the sea oaks (Figure 55). However, no breaching occurred. The vegetation on the “outback island” is visible from Mullet Key (Figure 56). The island is not inspected. Post-storm survey will quantify the position change of the island, if any.

Figure 56. Vegetation on the “outback island” is still visible.

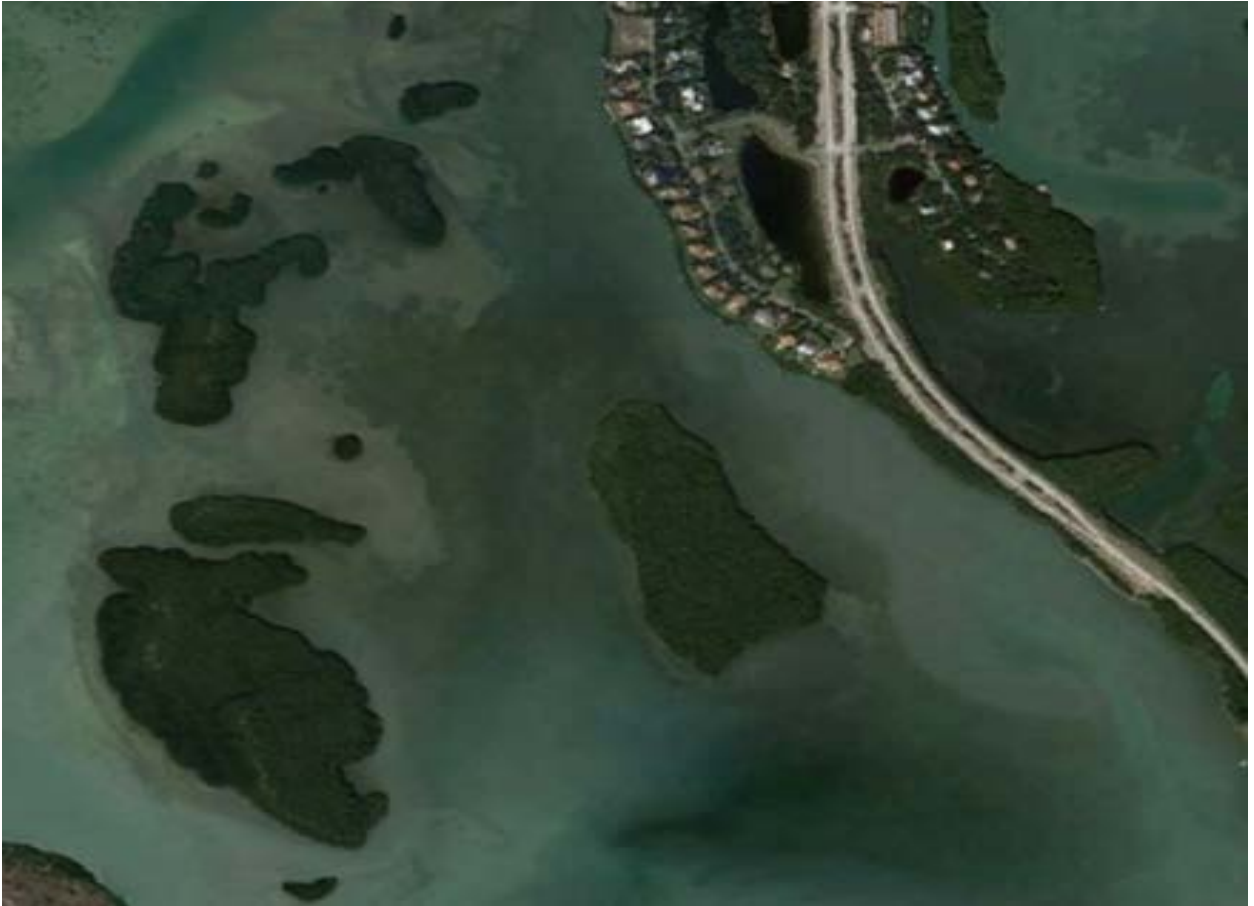
Figure 57. A developing breach at Shell Key.

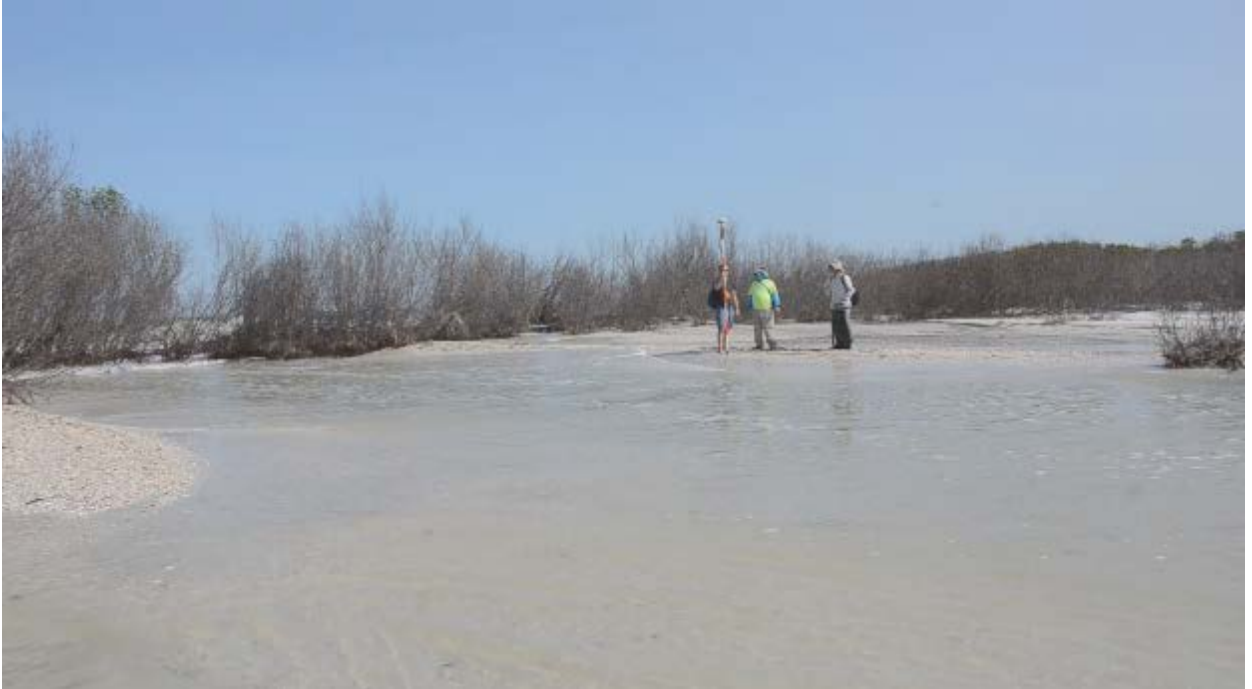
Over the past several months, a breach was developing at Shell Key (Figure 57). Considerable amount of water was flowing into the estuary behind Shell Key during spring high tide (Figure 58 upper panel). It has been hypothesized that the breach may be significantly expanded under energetic storm conditions. This did not happen during the impact of Hurricane Hermine. The breach was not expanded by the storm. Instead, significant overwash deposit landward of the vegetation line (Figure 58 lower panel) has led to the closure of the breach. Based on field estimation, the elevation of the overwash deposit is above the spring high tide level and should block tidal flow through there.

Figure 58. The developing breach at Shell Key was closed by the overwash deposits from Hurricane Hermine. Upper panel: water flowing through Shell Key breach on May 6, 2016. Lower panel: the overwash deposit effectively closed the breach.

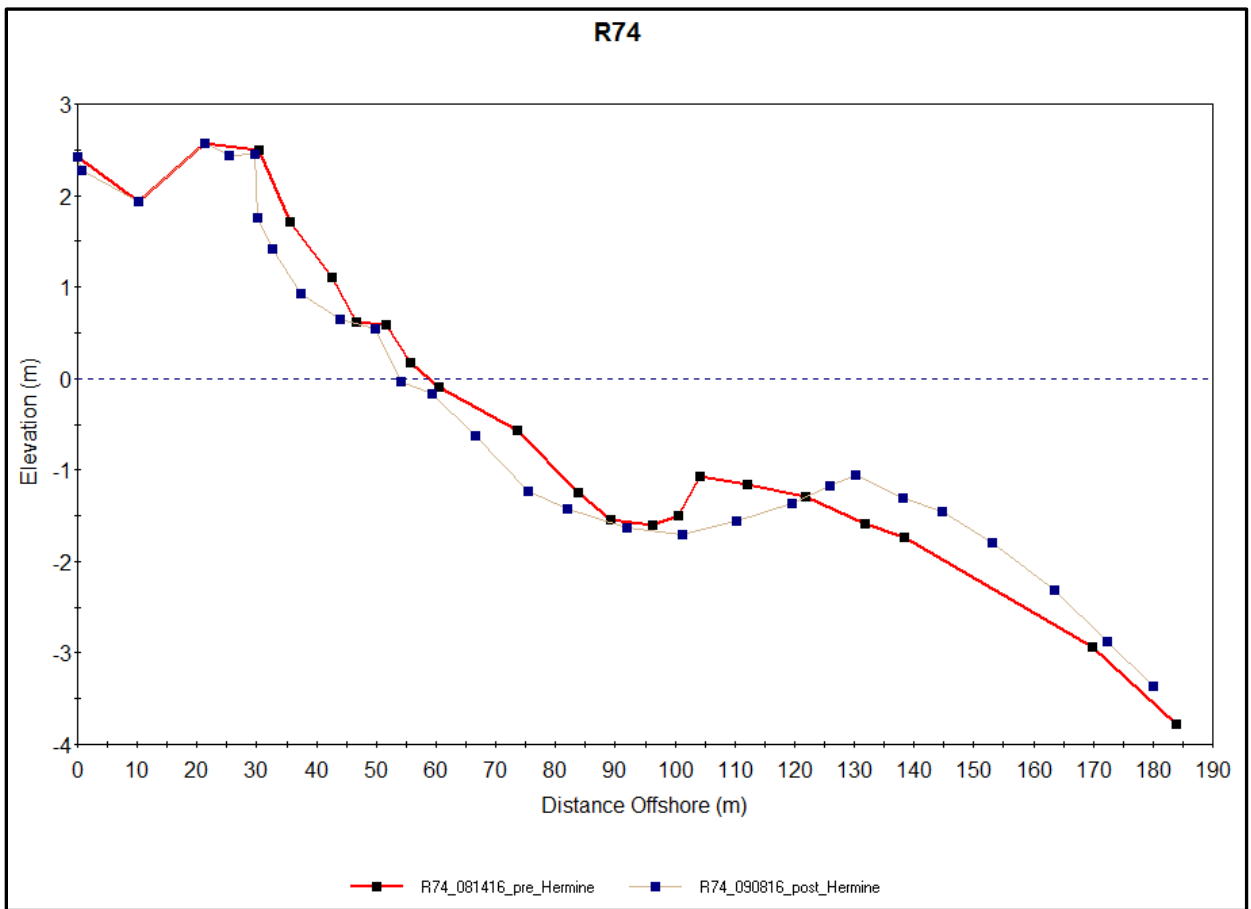
Figure 6. Example profile at R74, illustrating erosion of the dune, dry beach and nearshore area, with deposition over the nearshore bar.

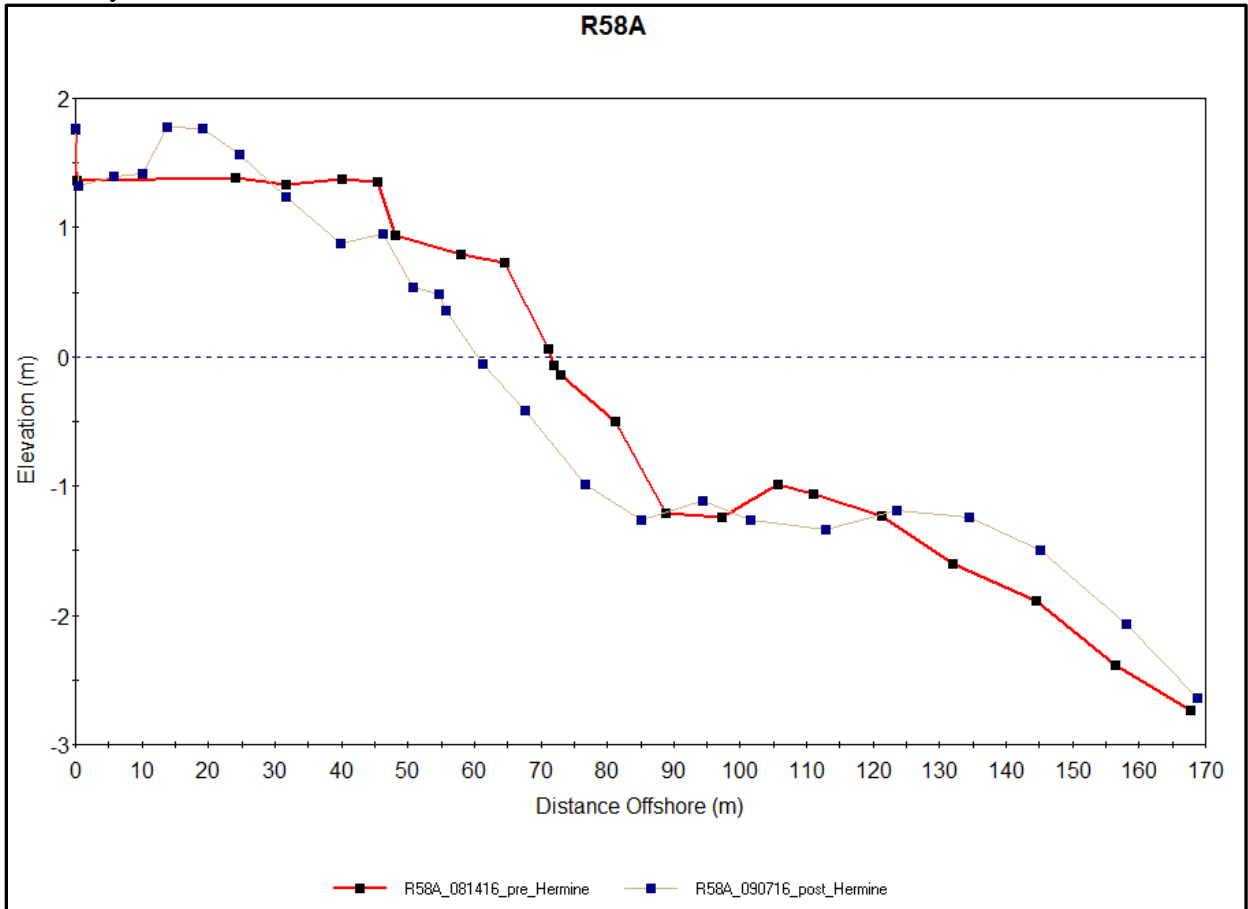
Figure 7. Example profile at R58A, illustrating formation of a storm berm (between 10 m (33 ft) and 30 m (100 ft) cross-shore distance), and erosion of dry beach and nearshore area, with deposition over the nearshore bar.

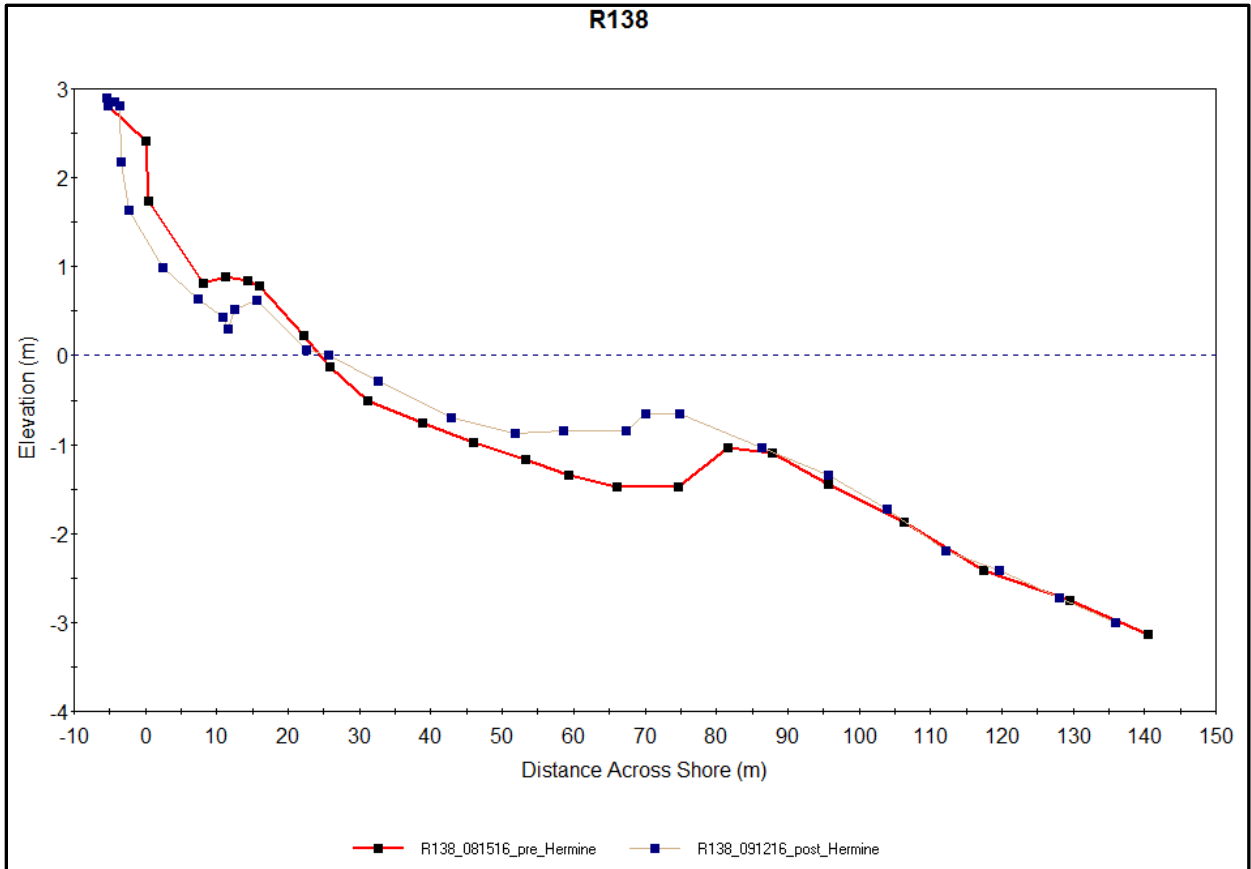
Figure 8. Example profile at R138, illustrating landward movement of dune scarp, erosion of dry beach, and deposition in the nearshore area and onshore migration of the bar.

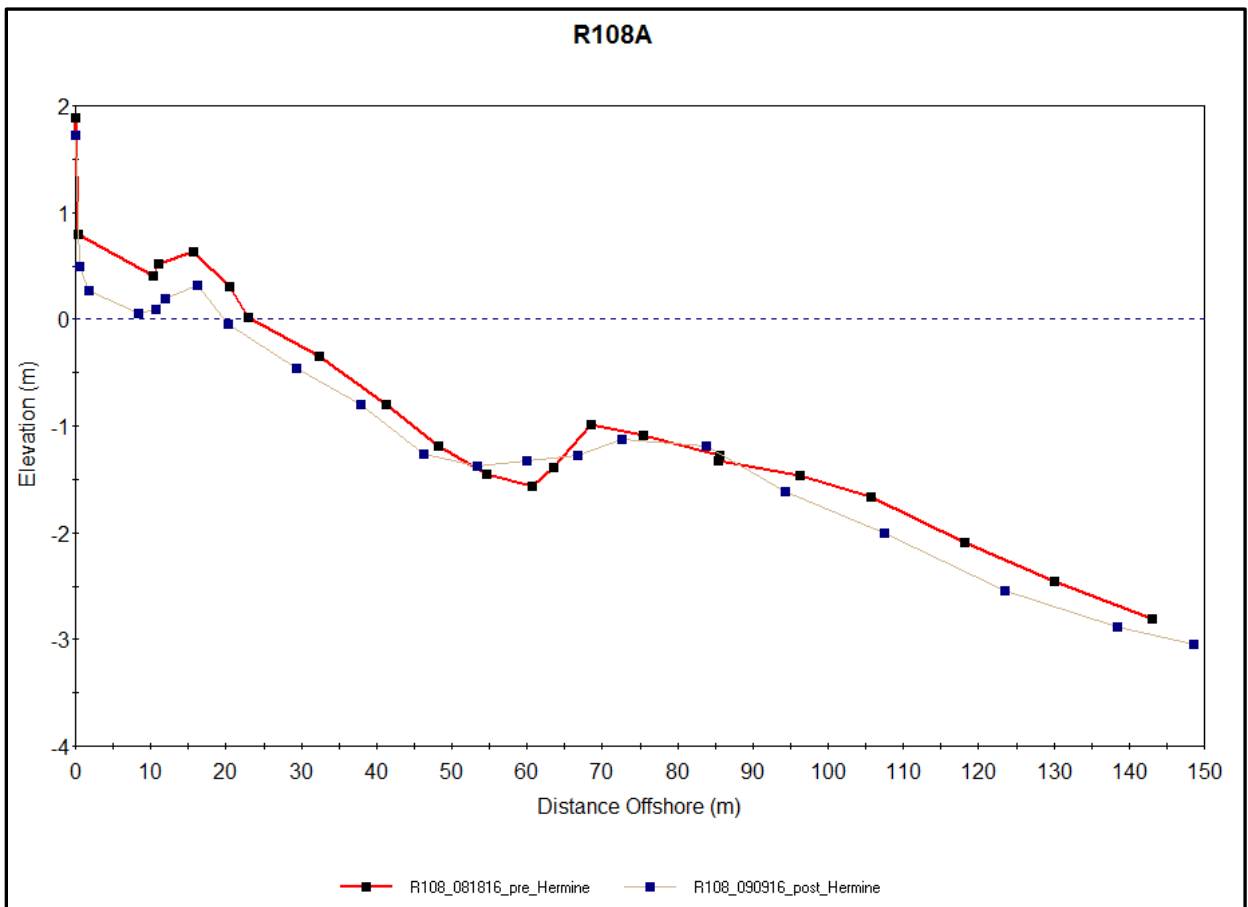
Figure 9. Example profile at R108A, illustrating severe scour in front of the seawall, erosion of nearly the entire profile.

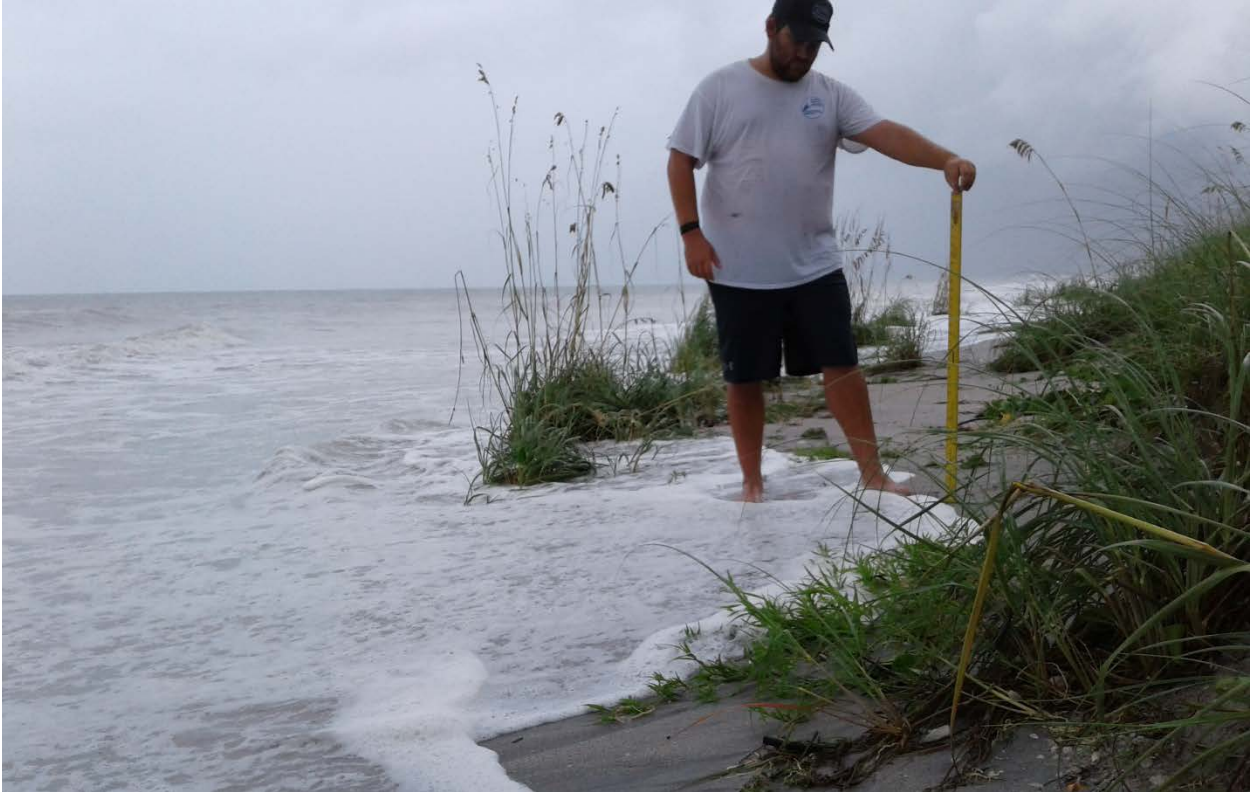
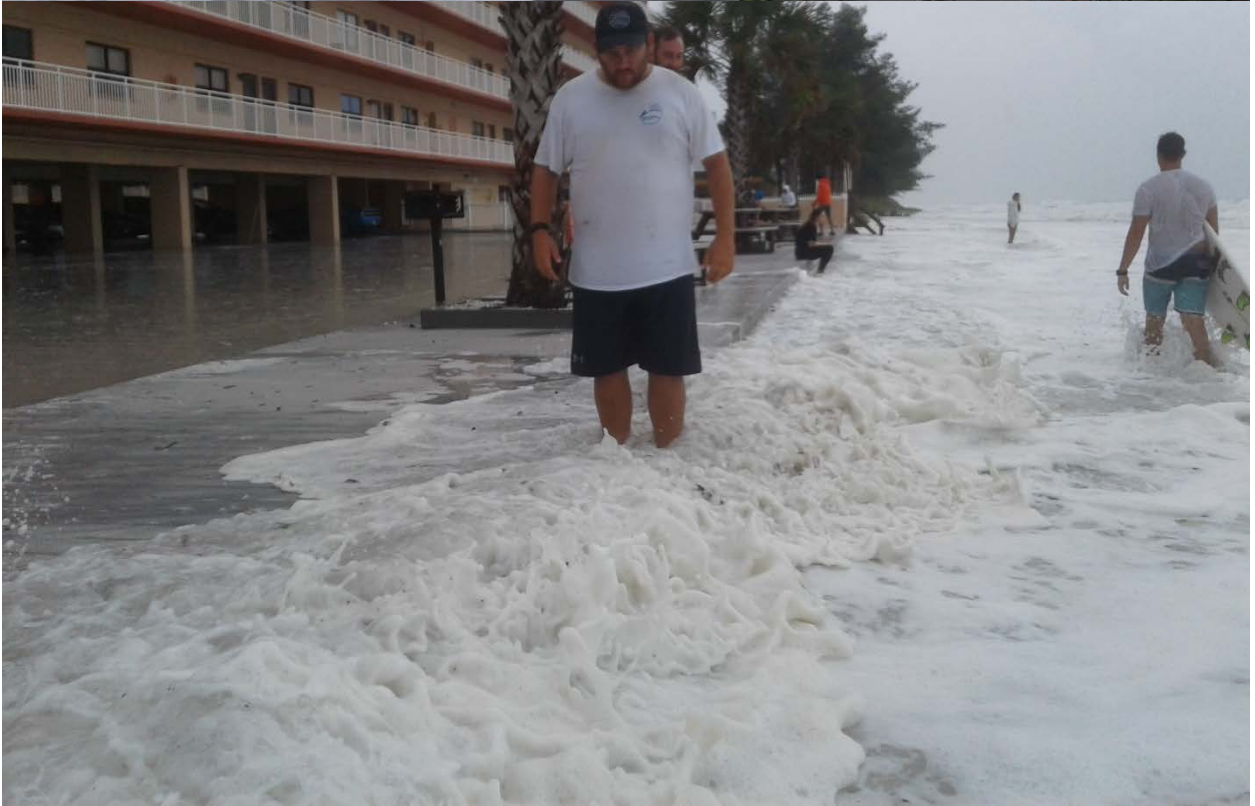
Figure 10. Storm surge plus wave runup reached the dune field (upper panel) and overtopped the seawall (lower panel) during the storm.

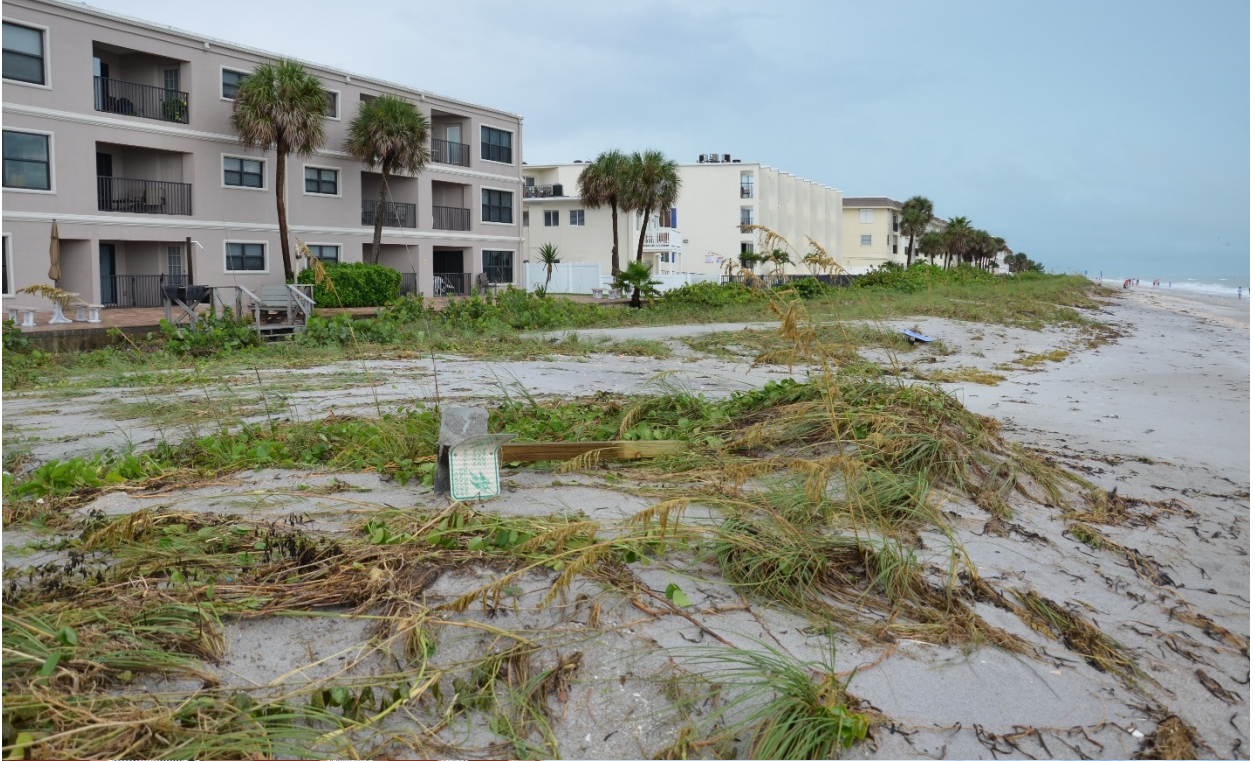
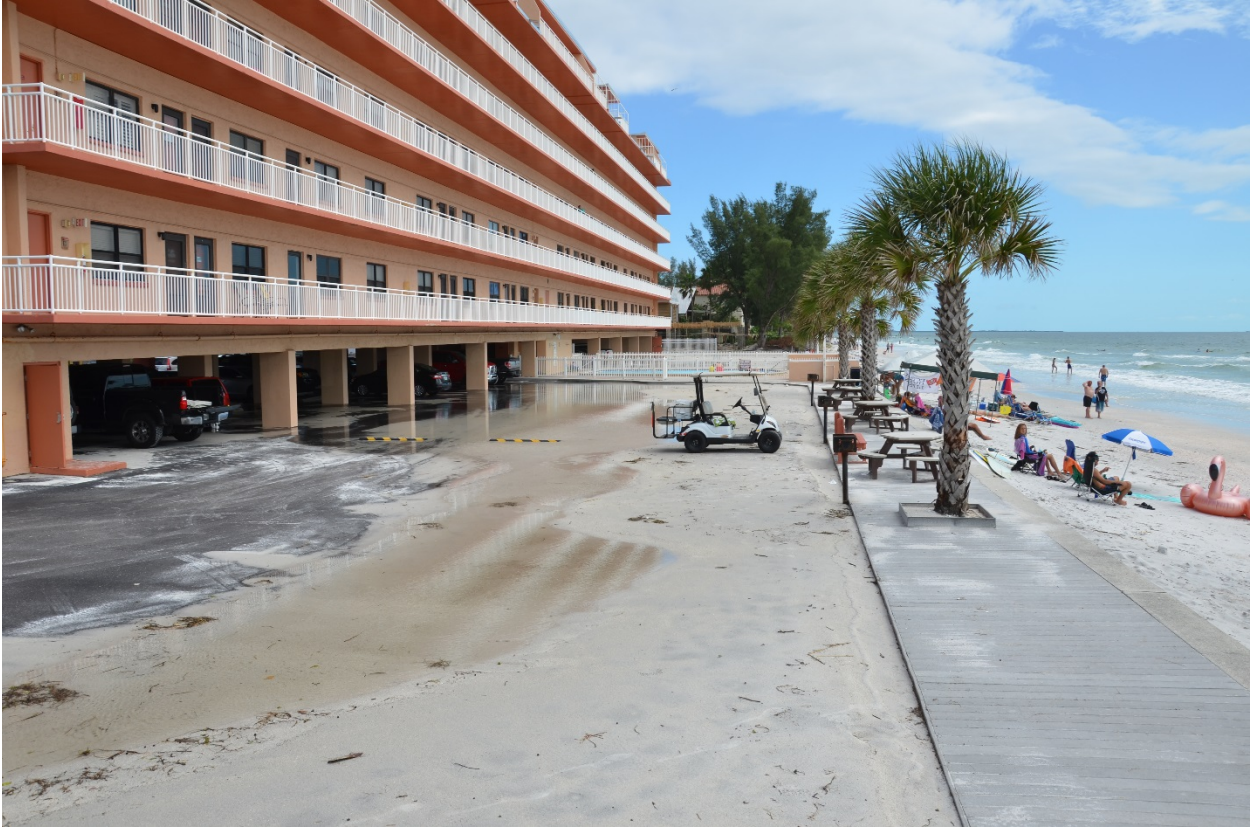
Figure 11. Storm overwash deposits in the dune field (upper panel) and landward of the seawall (lower panel). Photos were taken at similar locations as in Figure 10 during the storm.
