Beckett Bridge Replacement Tarpon Springs, FL

E. Technical Documents

Bridge Investment Program (BIP)
Grant Application

Technical Memorandum

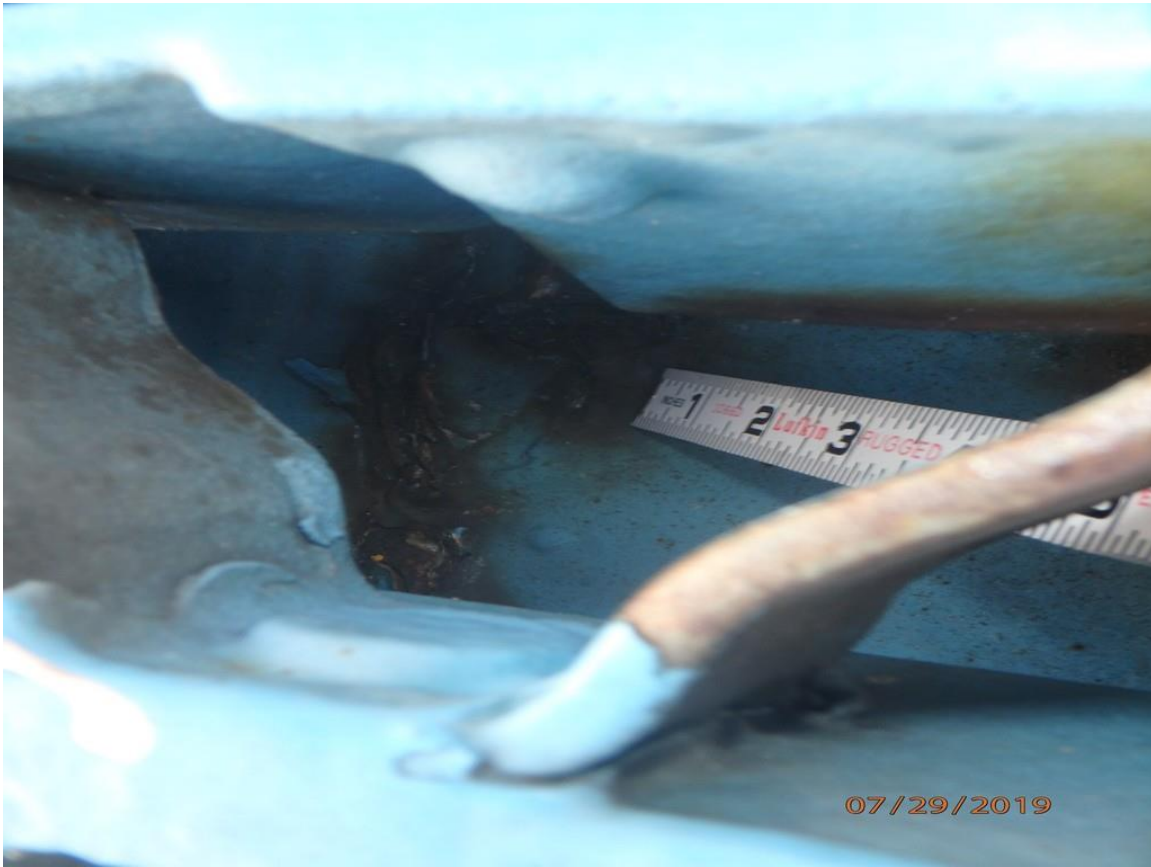
PHOTO 1: 28/4 – Steel Deck-Open Grid

Typical moderate corrosion on the grid deck welds (Stringer 6-7 at Floor Beam 6-2 shown).

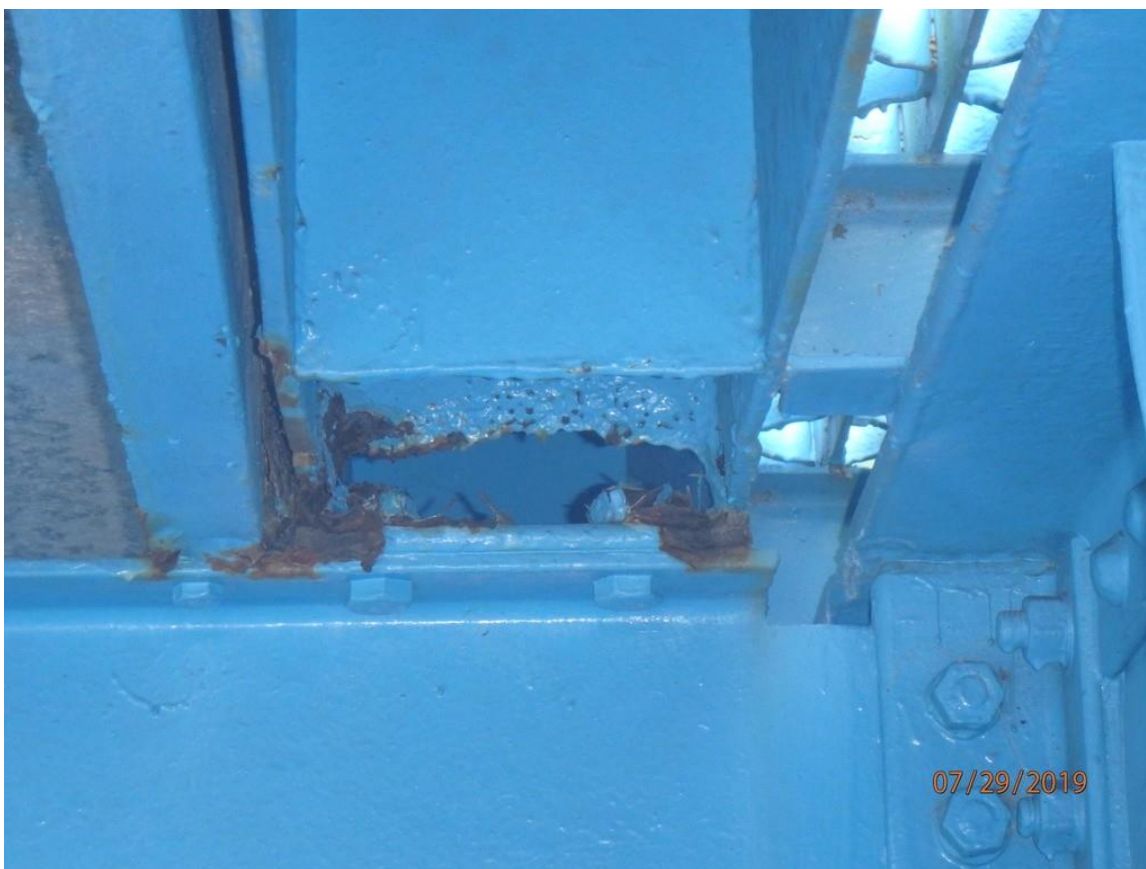
PHOTO 2: 28/4 - Steel Deck-Open Grid

The steel curbs of Span 6 exhibit moderate recurring corrosion in the topside and moderate to heavy corrosion with laminar rust in the underside (left curb underside shown).

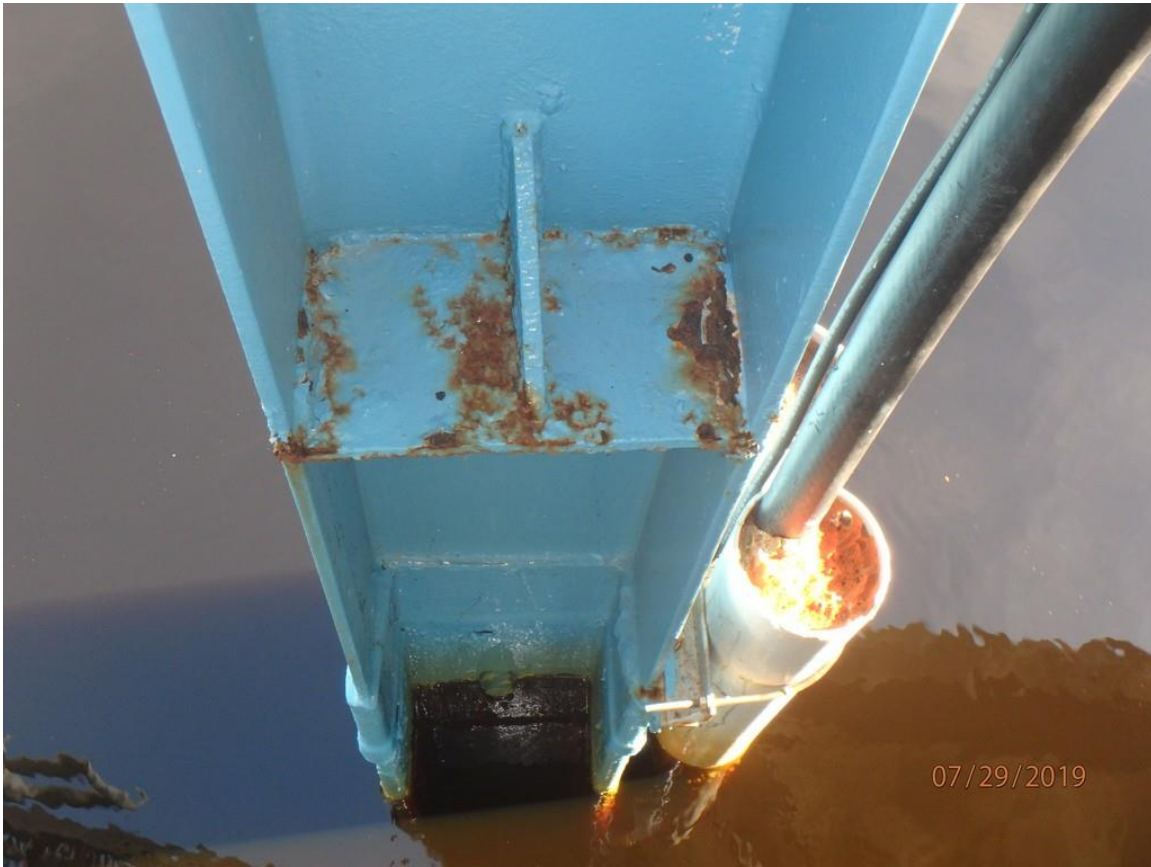
PHOTO 3: 225/4 – Steel Pile

1000, 3440; CS3: The west Tender House pile has isolated areas of heavy corrosion with laminar rust above water. Refer to Photo 3. REPAIR (1000 = 1EA ; 3440 = 22SF)

The west Tender House pile exhibits isolated areas of heavy corrosion with laminar rust.

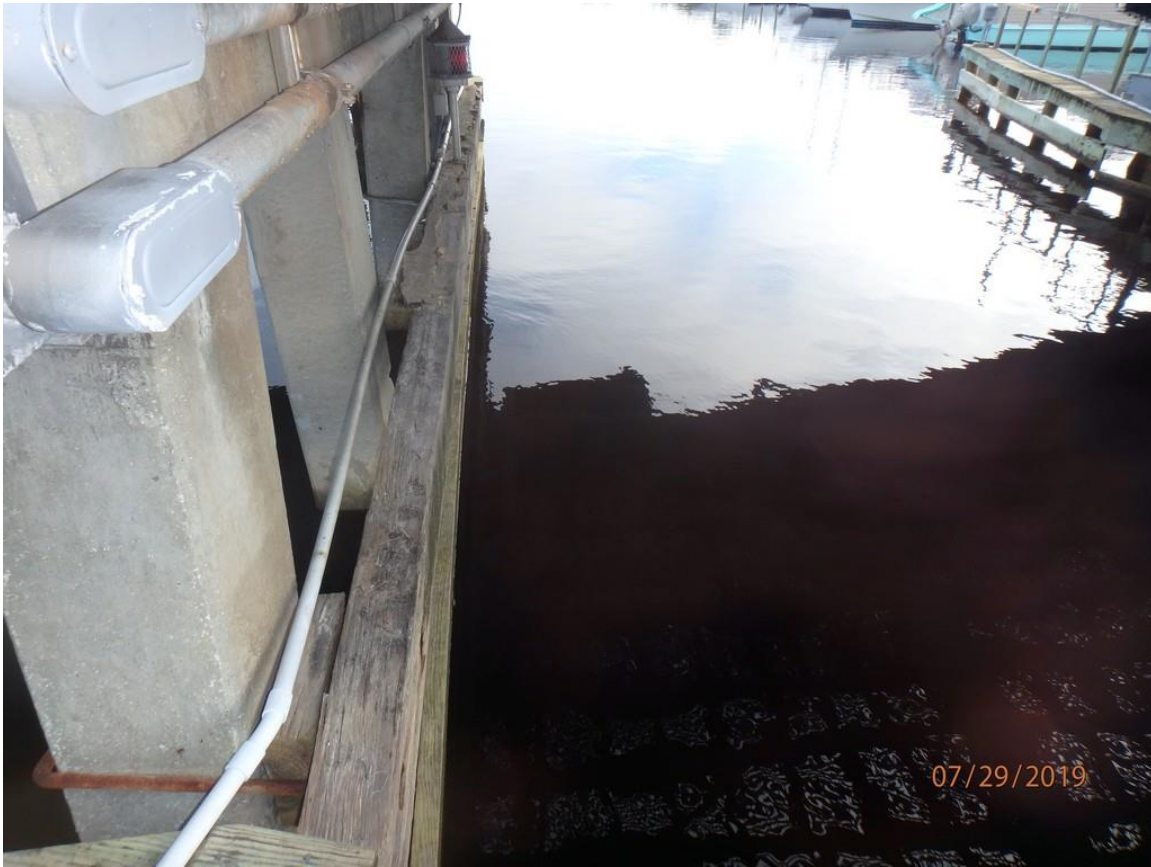
PHOTO 4: 8389/4 - Timber Fender/Dolphin

The top plank for the west fender, (below the main span) is rotten, deteriorated and is missing the south 6ft. Refer to Photo 4. REPAIR

Rotted, deteriorated and missing section of the top plank of the west fender below main span.

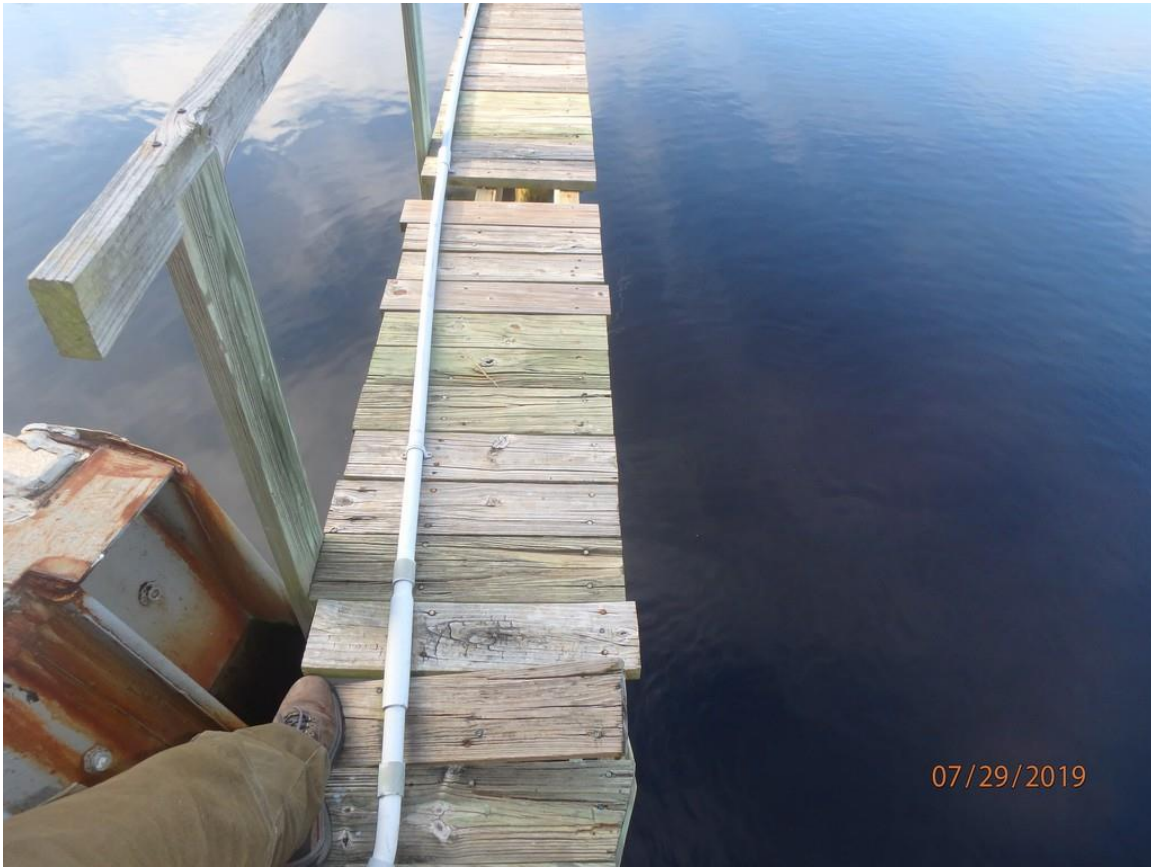
PHOTO 5: 8389/4 - Timber Fender/Dolphin

The southeast fender system has loose catwalk planks intermittently throughout - DECREASE. Refer to Photo 5. REPAIR

Loose transverse cat walk fender catwalk planks on southeast fender system.

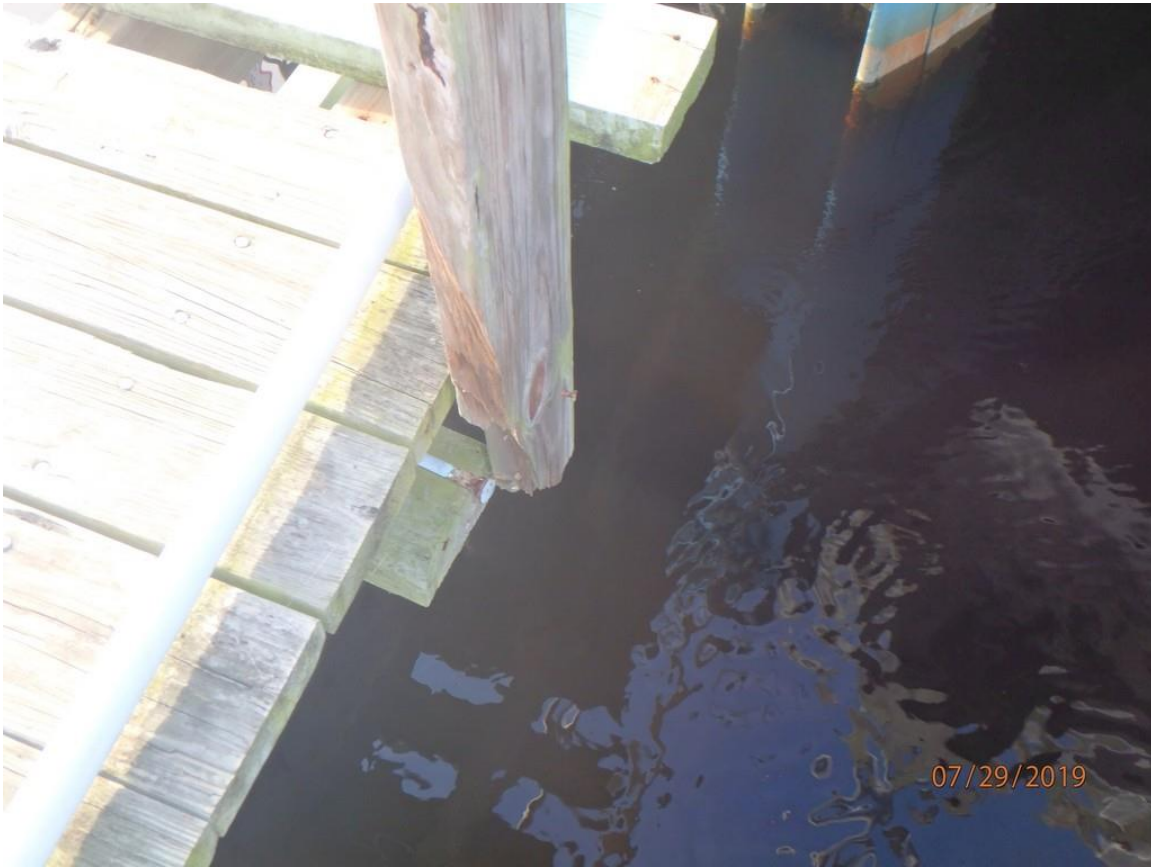
PHOTO 6: 8389/4 - Timber Fender/Dolphin

The west fender north hand railing 4th post from the north is broken at at the base. Refer to Photo 6. REPAIR

Broken west fender handrail post (4th from north end).

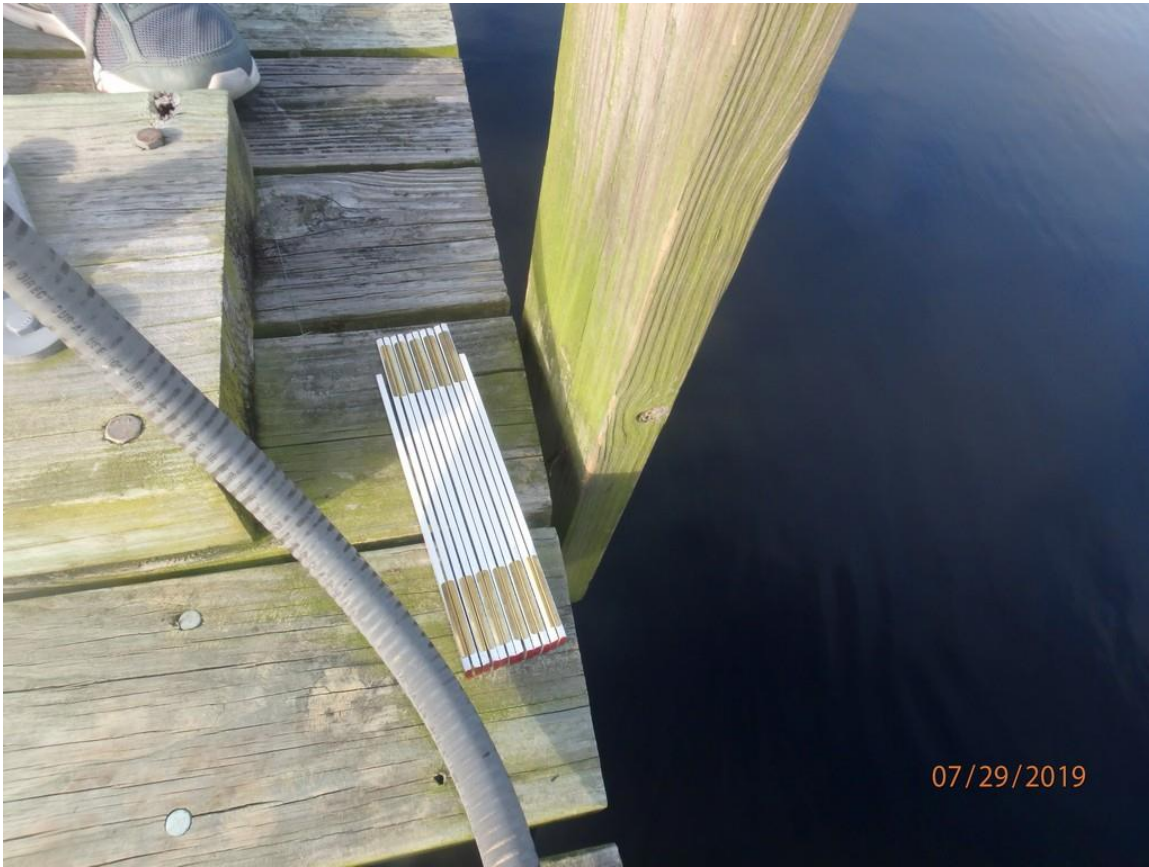
PHOTO 7: 8389/4 - Timber Fender/Dolphin

The southernmost handrail for the west fender is loose - NEW. Refer to Photo 7. REPAIR

Southernmost handrail for west fender loose.

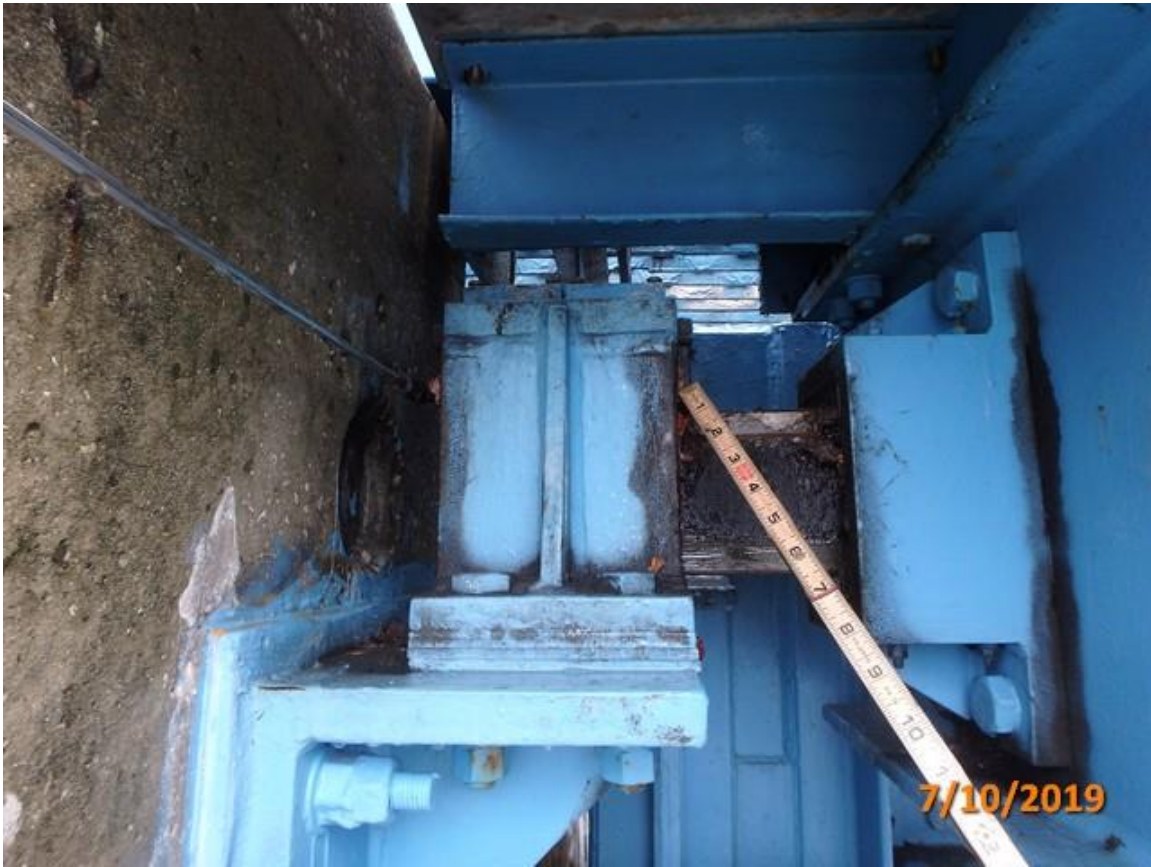
PHOTO 8: 8560/4 - Locks

9030; CS2: The south lock receiver has excessive clearance up to (0.050in.) - DECREASE. Refer to Photo 9. REPAIR (1EA)

Excessive clearance in the south lock receiver (to 0.050in.).

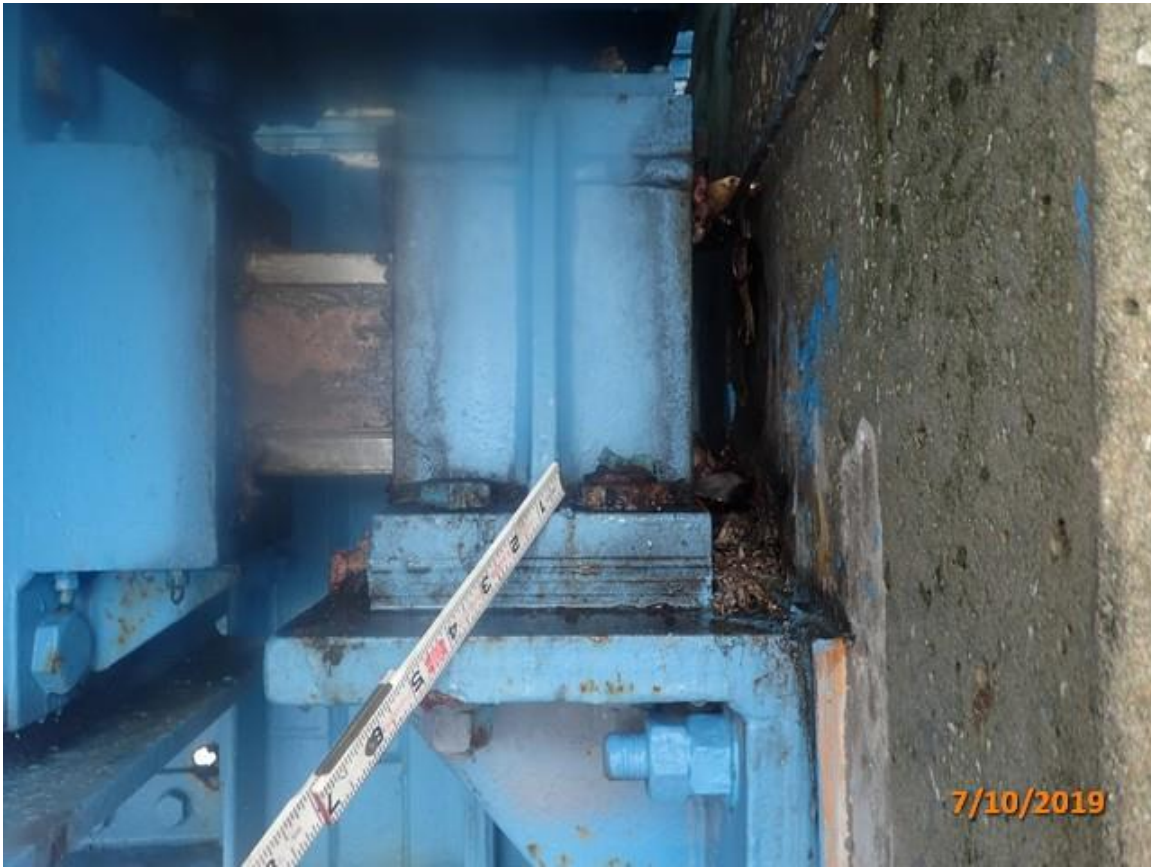
PHOTO 9: 8560/4 - Locks

The north lock receiver has laminar rust in one of four fasteners. Refer to Photo 10. REPAIR ALL (1EA)

North lock receiver with laminar rust.

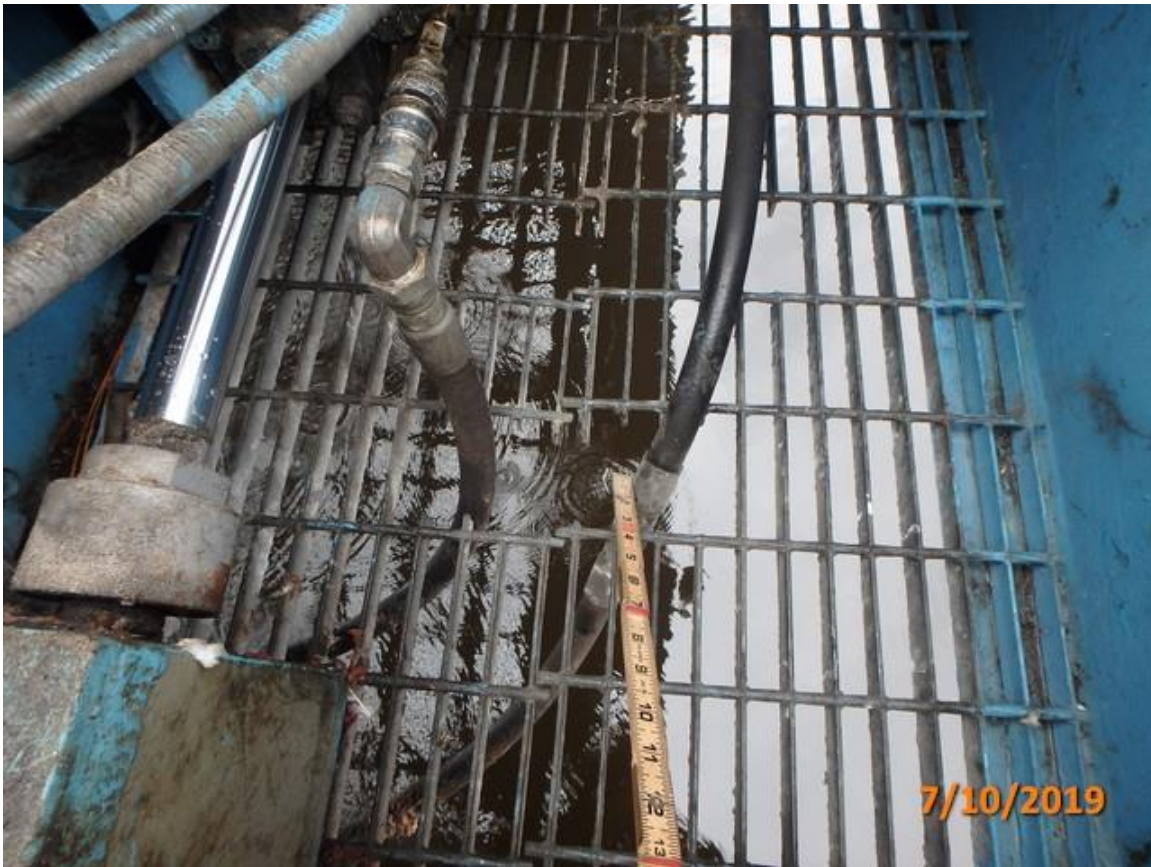
PHOTO 10: 8560/4 - Locks

CS1: The hydraulic piping for the south span lock is missing a clip at the south attachment under the structure - NEW. Refer to Photo 8. REPAIR

South span lock hydraulic piping missing clip at south attachment under structure.

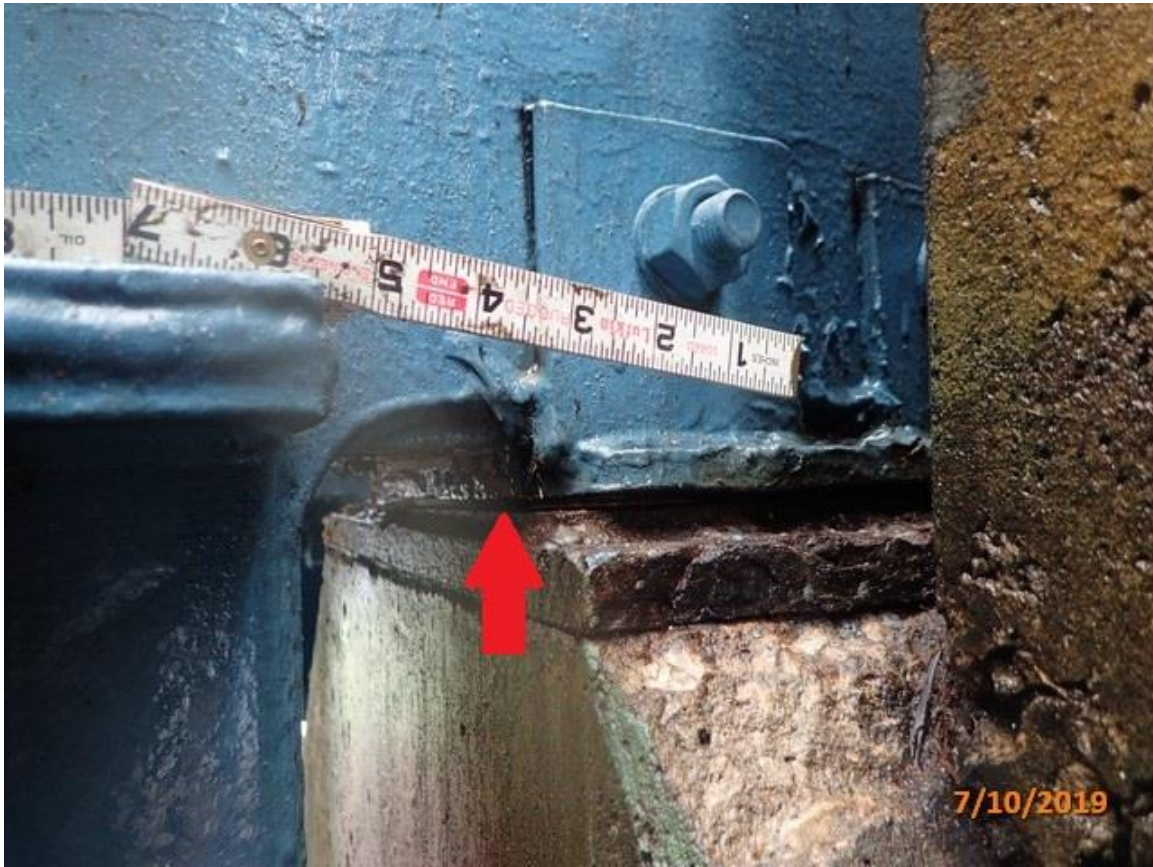
PHOTO 11: 8561/4 - Live Load Shoes

9030; CS2: The south live load shoe has a 3/16in. gap at rest position with slight movement during live loads. Refer to Photo 11. REPAIR (1EA)

South live load shoe 3/16in. gap with movement under live loads. Corrosion on live load shoe. Typical.

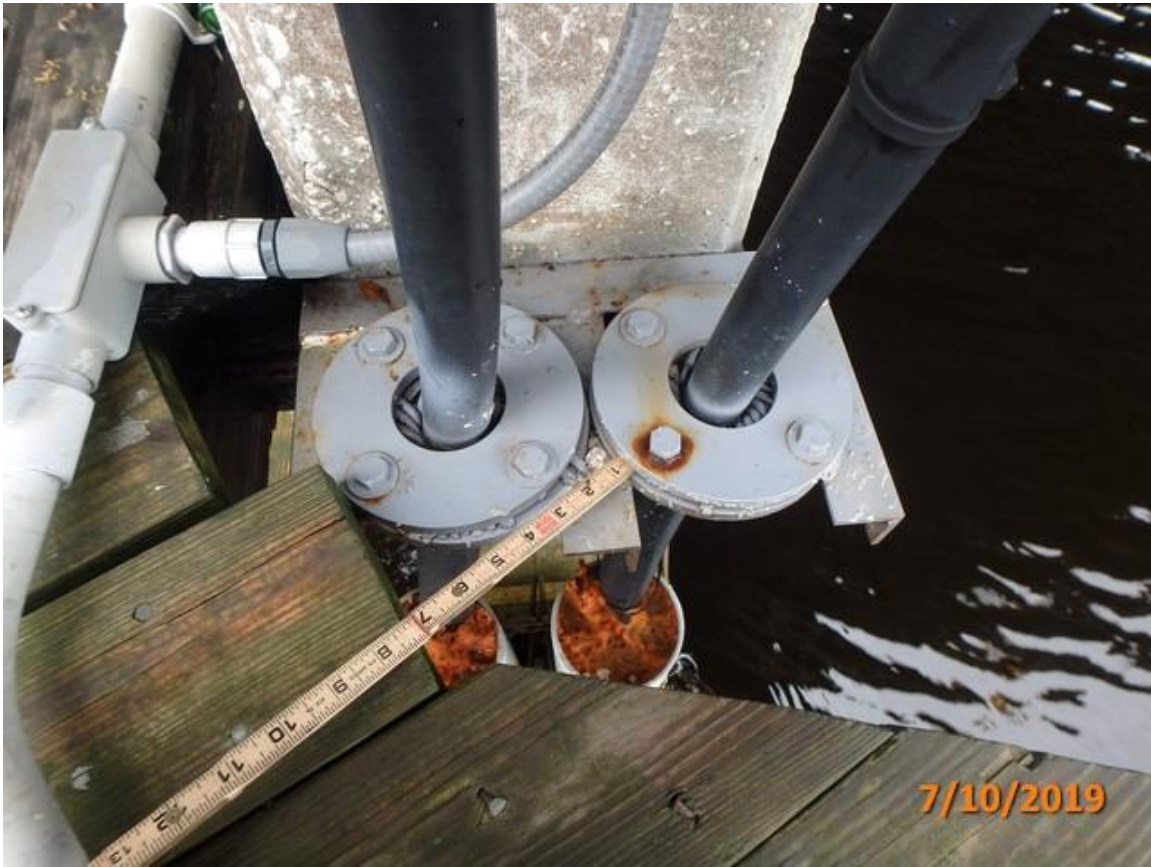
PHOTO 12: 8571/4 - Submarine Cable

NEW. Refer to Photo 12. REPAIR

Corroded fasteners for the submarine cable restraint at Rest Pier 6.

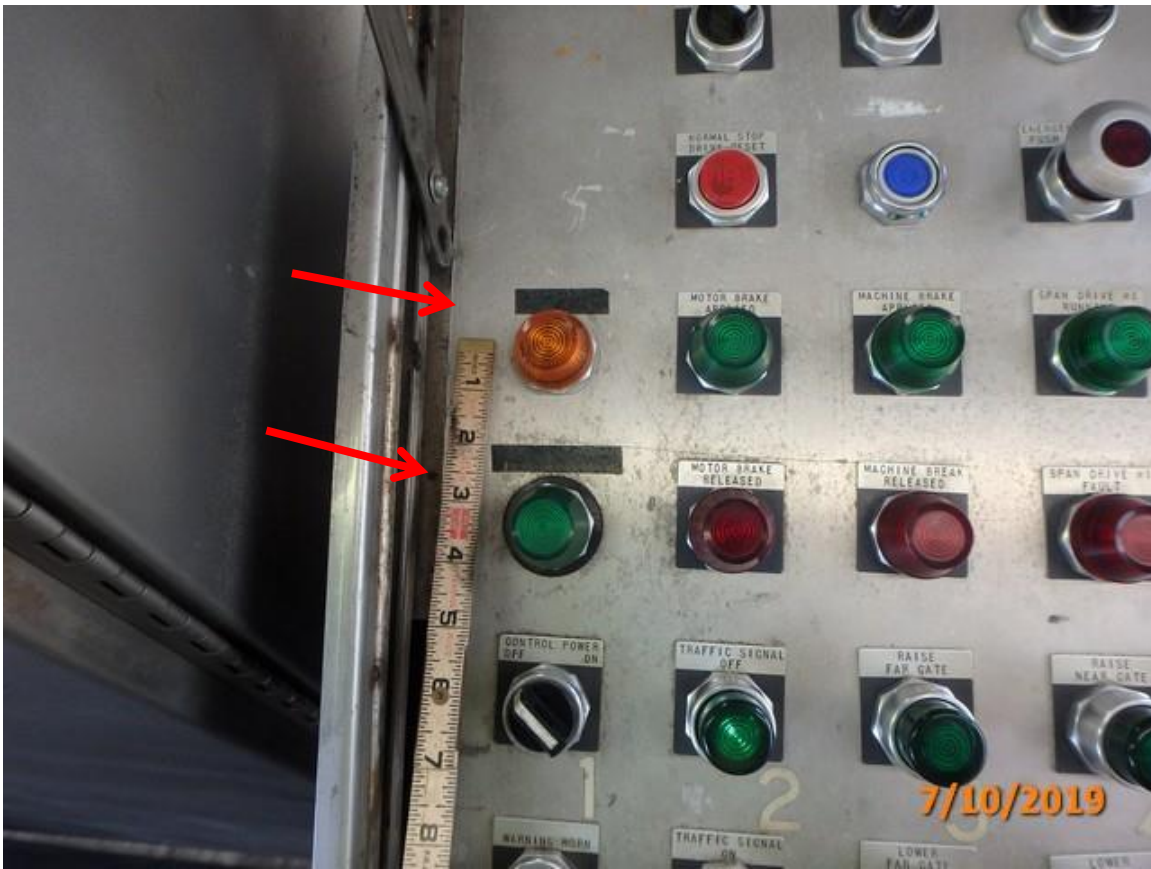
PHOTO 13: 8574/4 – Control Console

CS1: The control console is missing several nameplates for switches and indicator lights. Refer to Photo 13. REPAIR

Missing nameplates for switches and indicator lights on the control console.

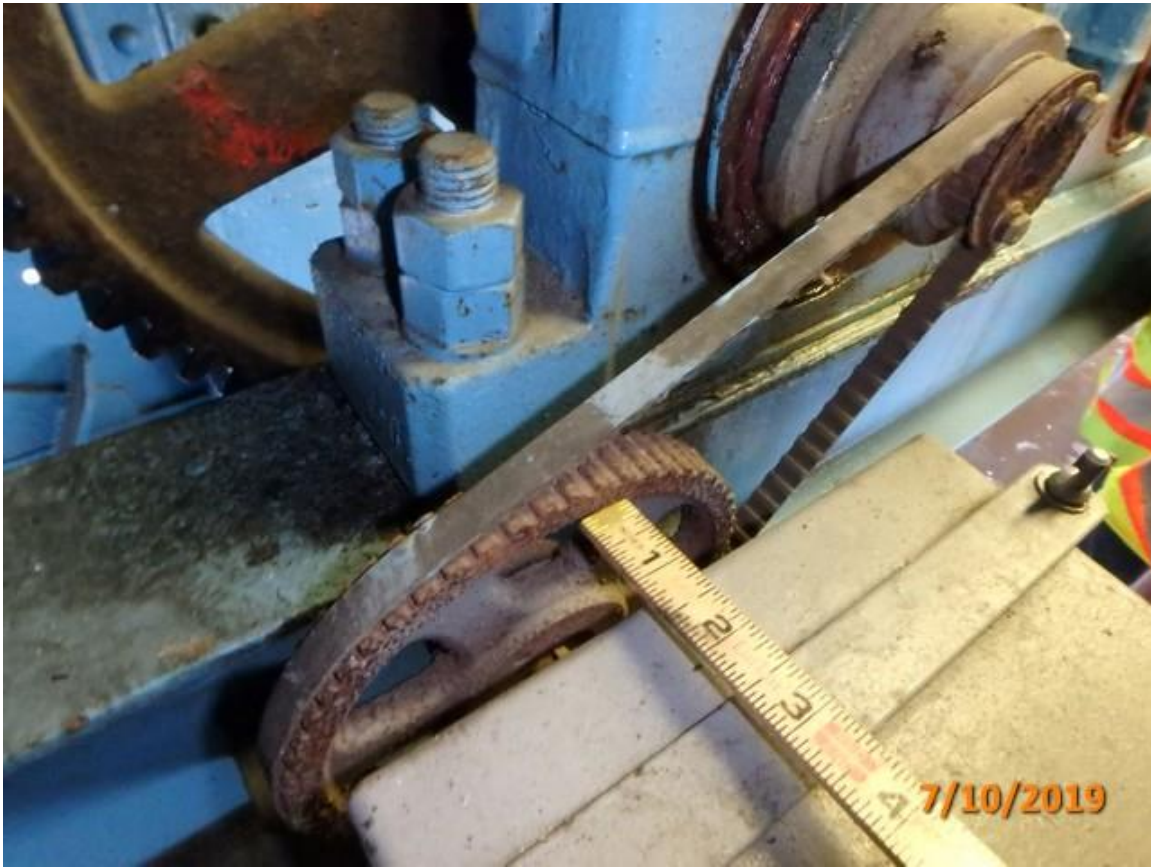
PHOTO 14: 8574/4 – Control Console

The belt sprocket for the span position sensor has heavy surface corrosion. Refer to Photo 14. REPAIR

Heavy surface corrosion on belt sprocket for the position sensor.

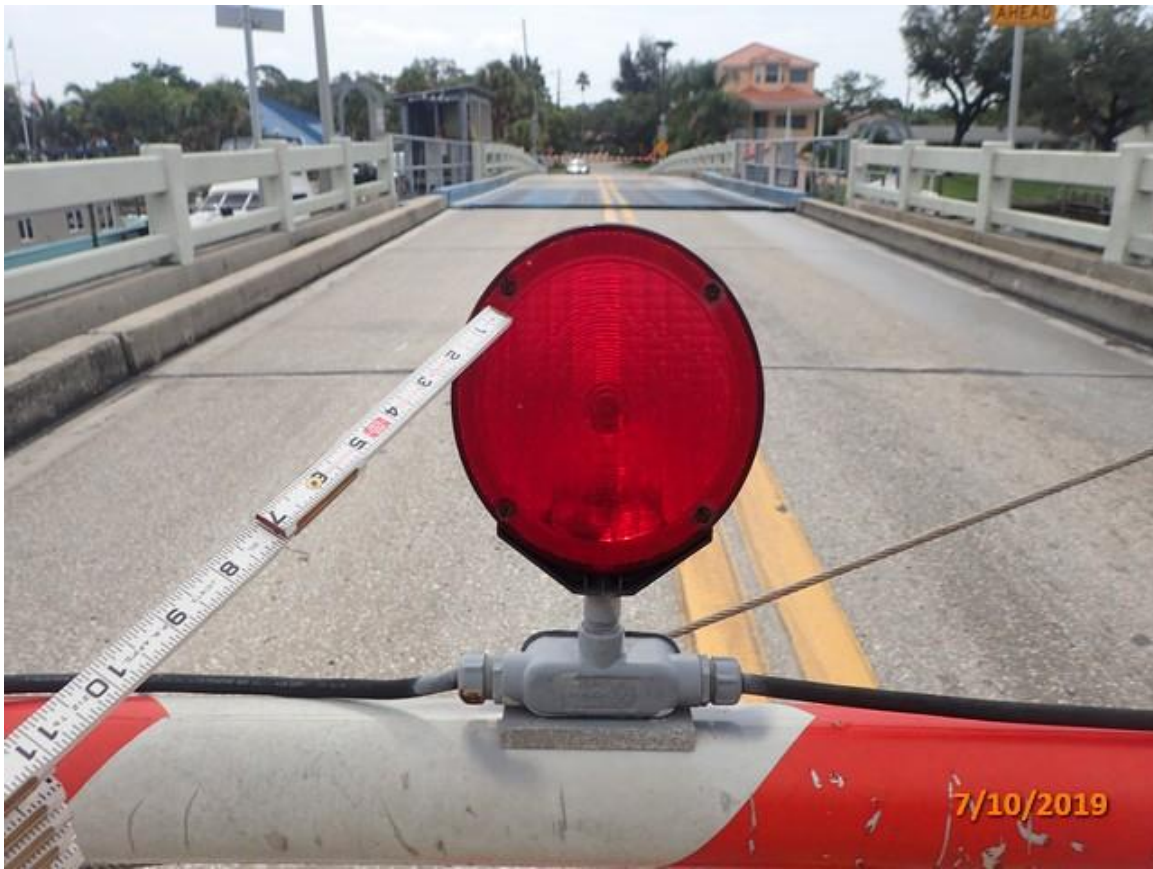
PHOTO 15: 8590/4 - Resistance Barriers

CS1: Several of the barrier gate lens fasteners have moderate surface corrosion. Refer to Photo 15. REPAIR

Barrier gate has corrosion on the lens fasteners.

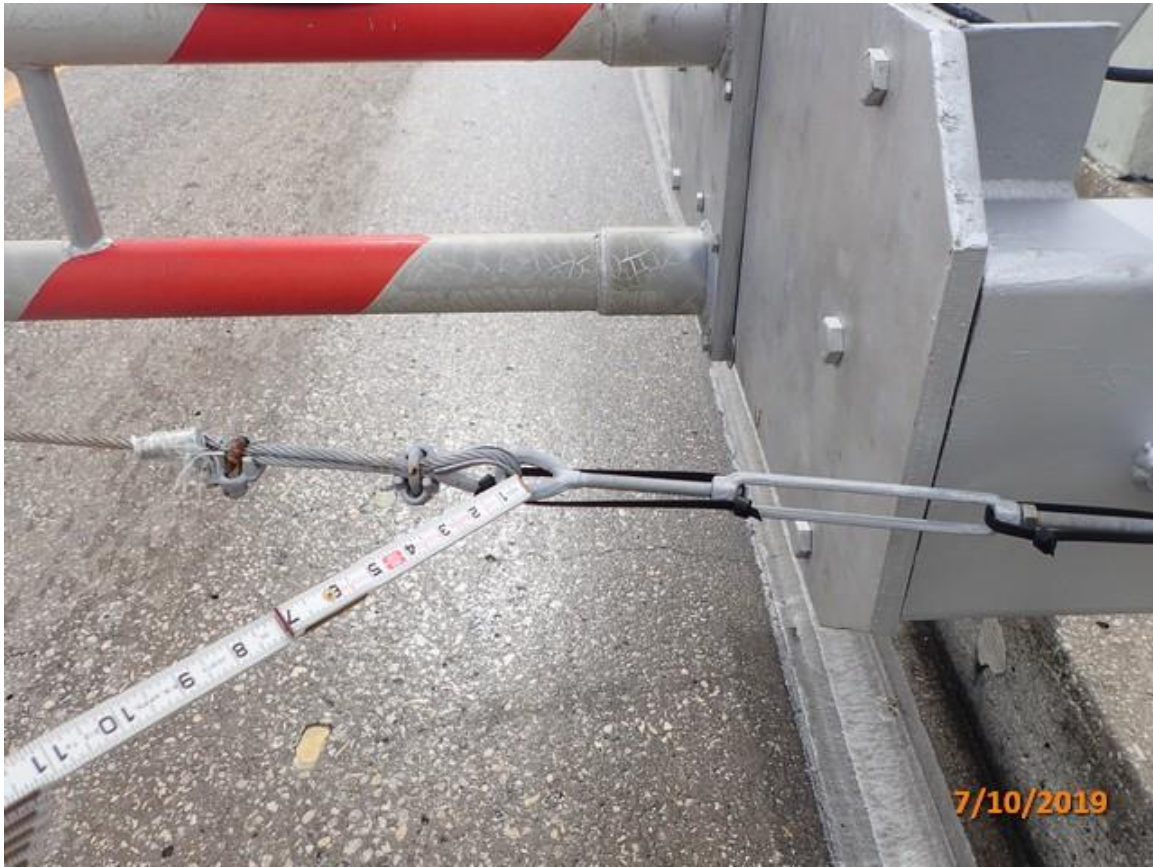
PHOTO 16: 8590/4 - Resistance Barriers

The barrier gate cable stay turnbuckles are too short and have missing jam nuts; threads may be run out too far. Refer to Photo 16. REPAIR

Barrier gate cable stay turnbuckles too short and missing jam nuts. Typical

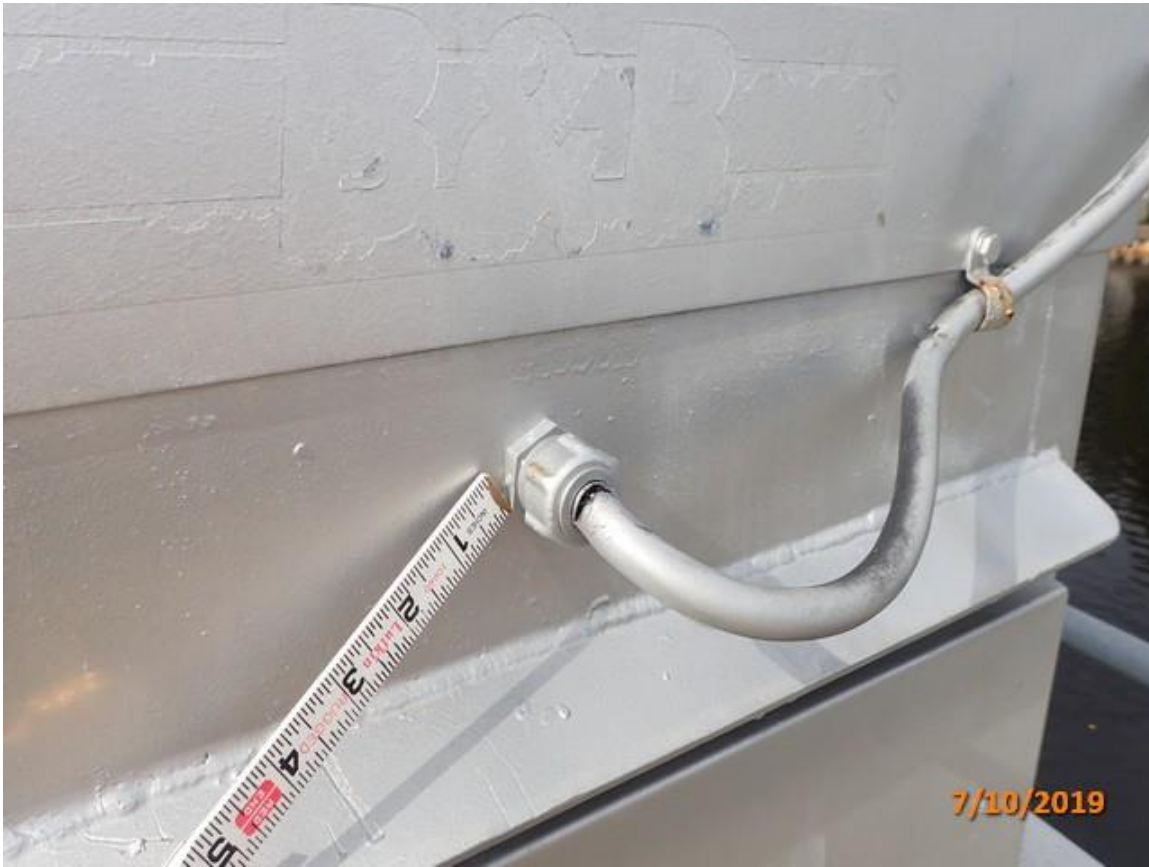
PHOTO 17: 8590/4 - Resistance Barriers

The SO cord at the barrier housing is not properly restrained - NEW. Refer to Photo 17. REPAIR

SO cord not properly restrained at the barrier housing.

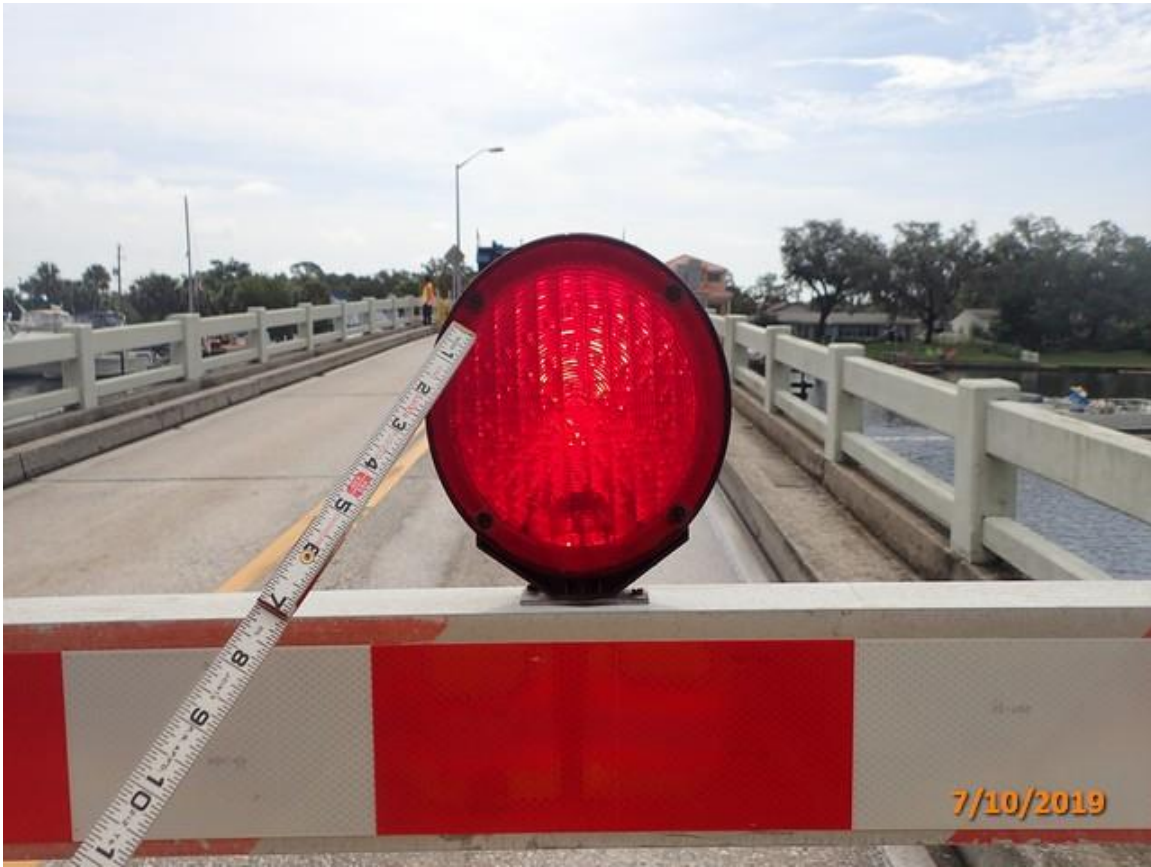
PHOTO 18: 8591/4 - Warning Gates

CS1: Several of the far warning gate lens fasteners have heavy surface corrosion. Refer to Photo 18. REPAIR

Several fasteners of the Far On-Coming warning gate lights exhibit heavy corrosion.

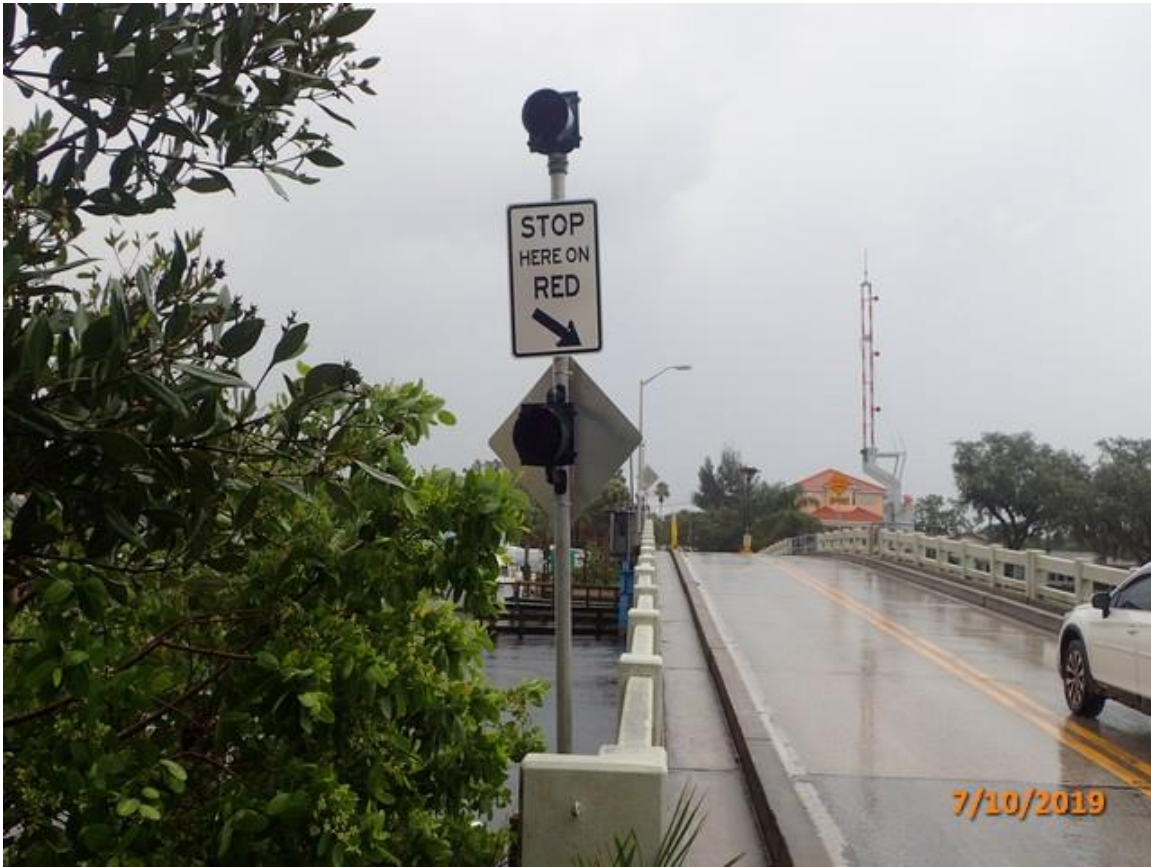
PHOTO 19: 8592/4 – Traffic Signals

9020; CS2 : The far left traffic signals are pointed away from roadway - NEW. Refer to Photo 19. REPAIR (1EA)

Far left traffic signal pointing away from roadway.

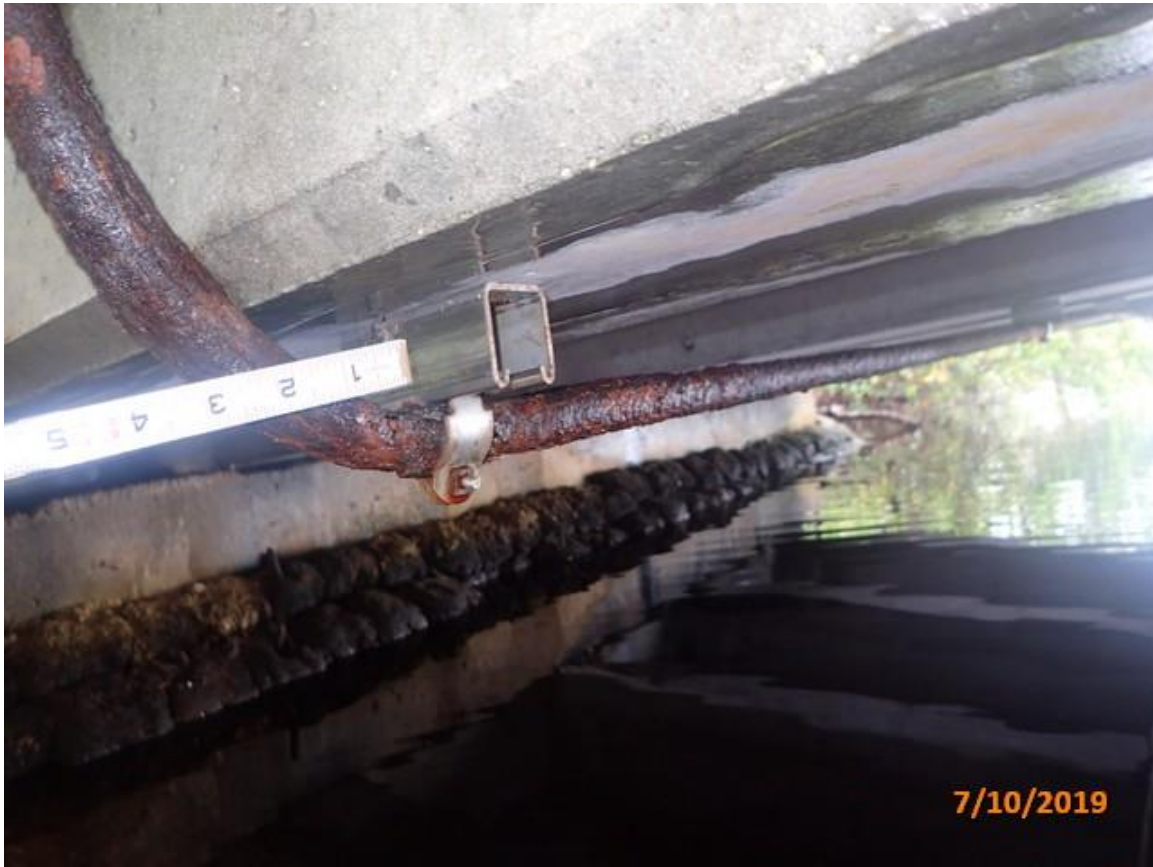
PHOTO 20: 8572/4 - Conduit & Junc. Box

CS1: The traffic signal conduit beneath Span 1 has heavy surface corrosion and laminar rust. Refer to Photo 20. REPAIR

The traffic signal conduit under Span 1 exhibits heavy corrosion with laminar rust.

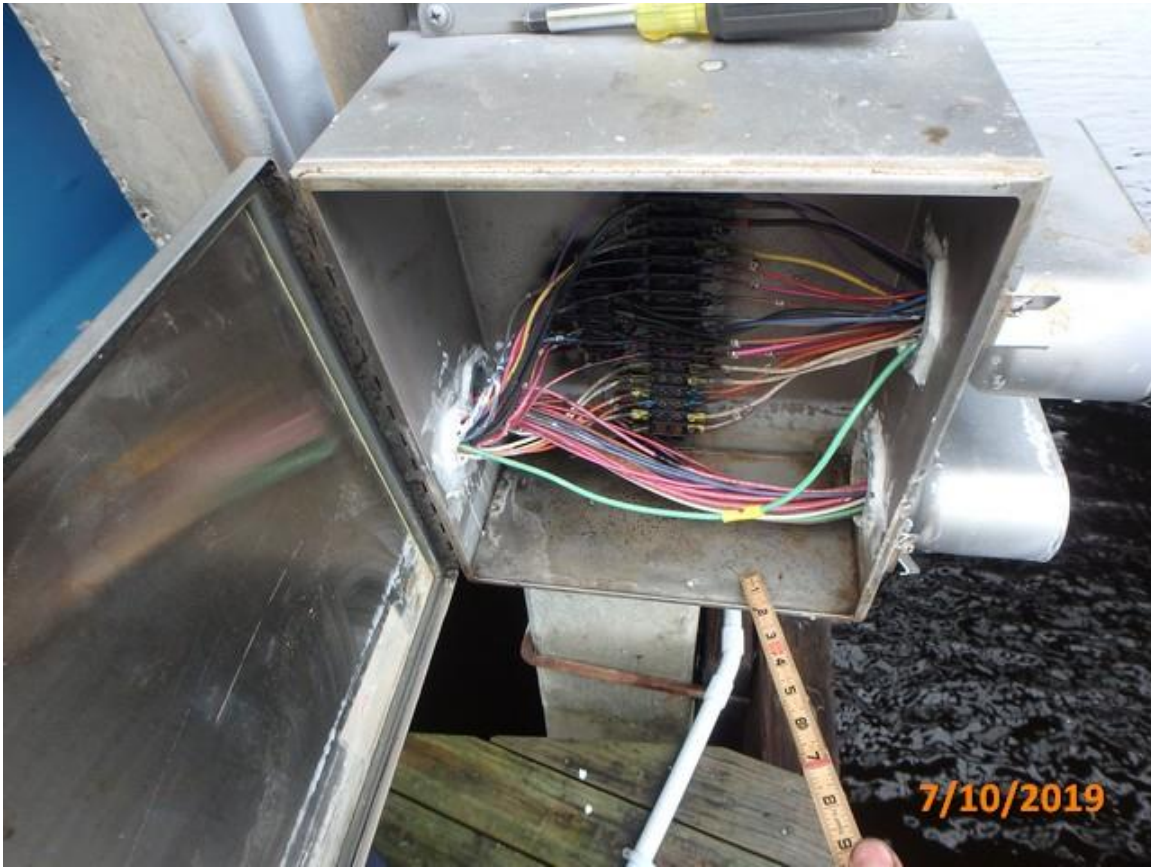
PHOTO 21: 8572/4 - Conduit & Junc. Box

The junction box on the south side of Rest Pier 6 has water ponding in bottom, and there are corroded terminal fasteners - NEW. Refer to Photo 21. REPAIR

Junction box on south side of Rest Pier 6 has ponding water in the bottom.

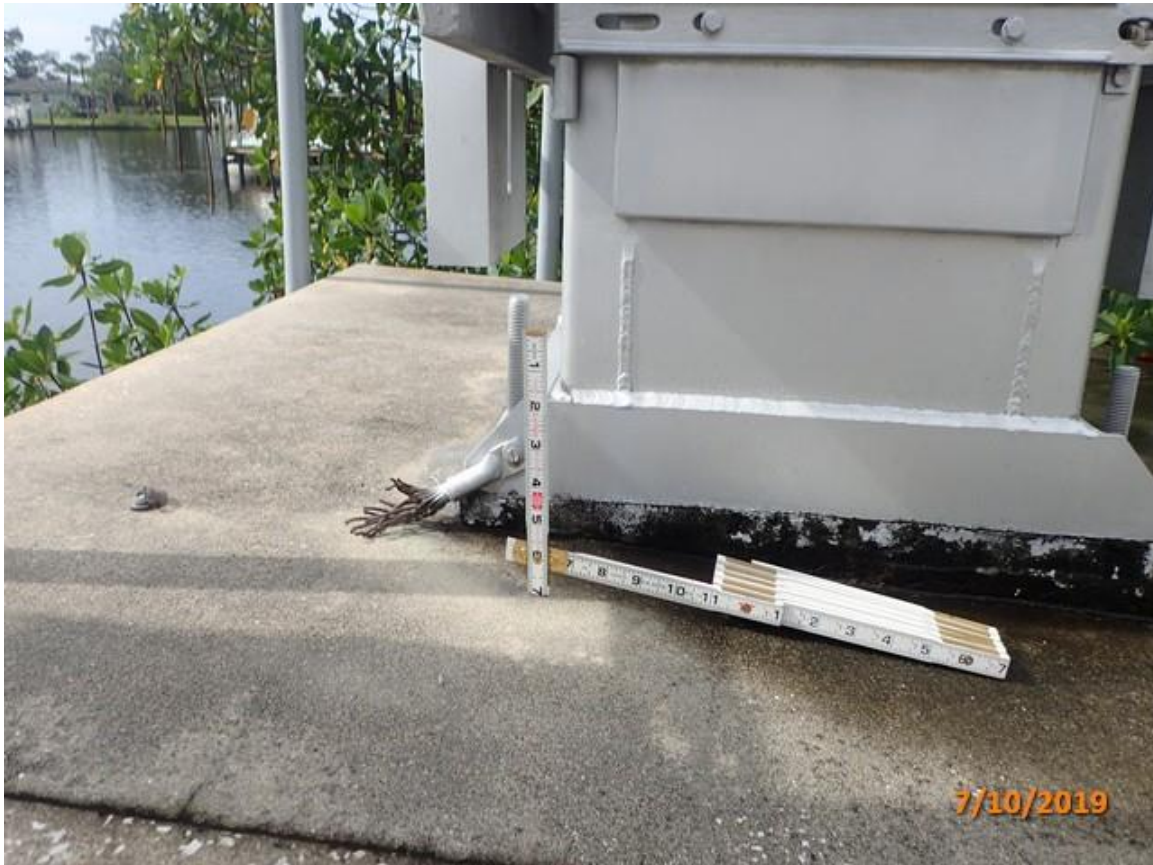
PHOTO 22: 8572/4 - Conduit & Junc. Box

The grounding cables for all warning gates, traffic signals and the resistance barrier are broken or missing. Refer to Photo 22. REPAIR

Typical missing grounding cable (northeast traffic signal shown).
