Beckett Bridge Replacement Tarpon Springs, FL

E. Technical Documents

Bridge Investment Program (BIP)
Grant Application

Technical Memorandum

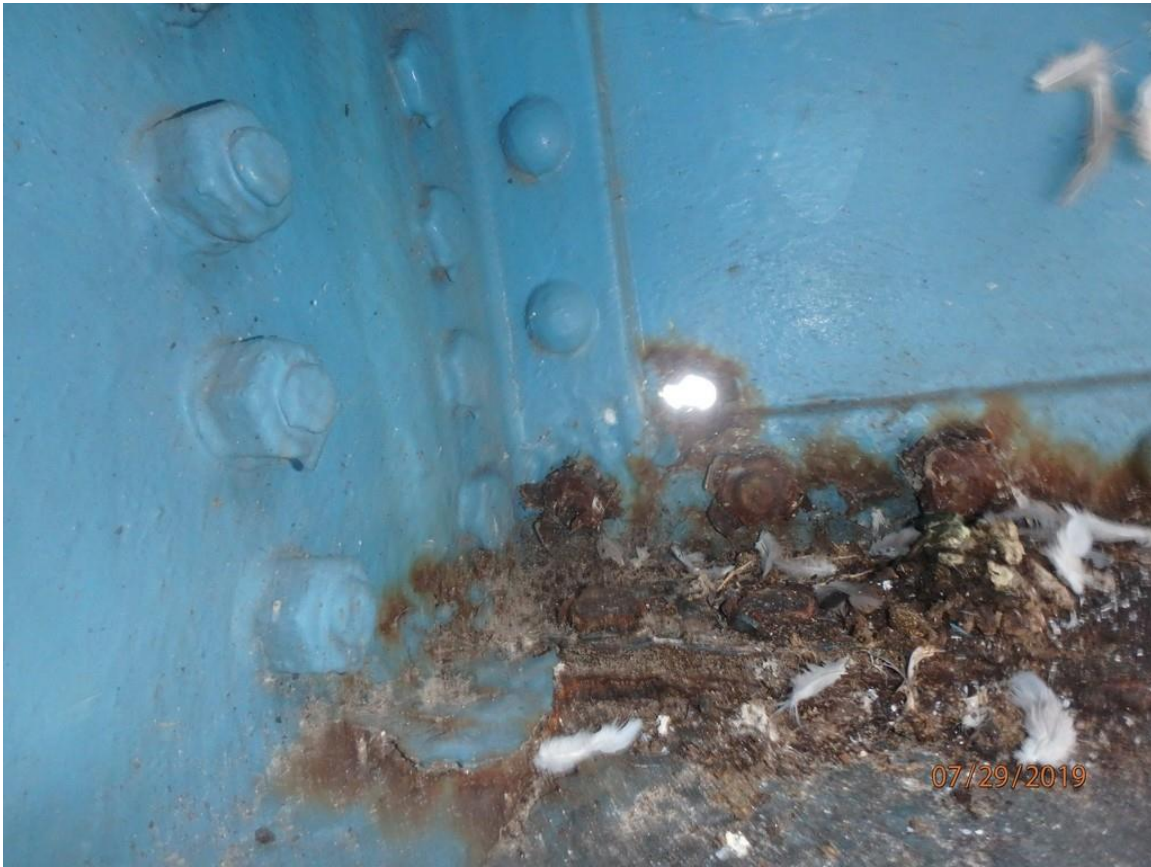
PHOTO 23: 107/4 – Steel Opn Girder/Beam

1000, 3440; CS3: The web of Main Girder 6-1 has a 1in. diameter painted corrosion hole with recurring moderate surface corrosion at Floor Beam 6-1. Refer to Photo 23. (1000 = 1FT ; 3440 = 1SF)

The web of Main Girder 6-1 exhibits a 1in. diameter painted corrosion hole with recurring corrosion at Floor Beam 6-1.

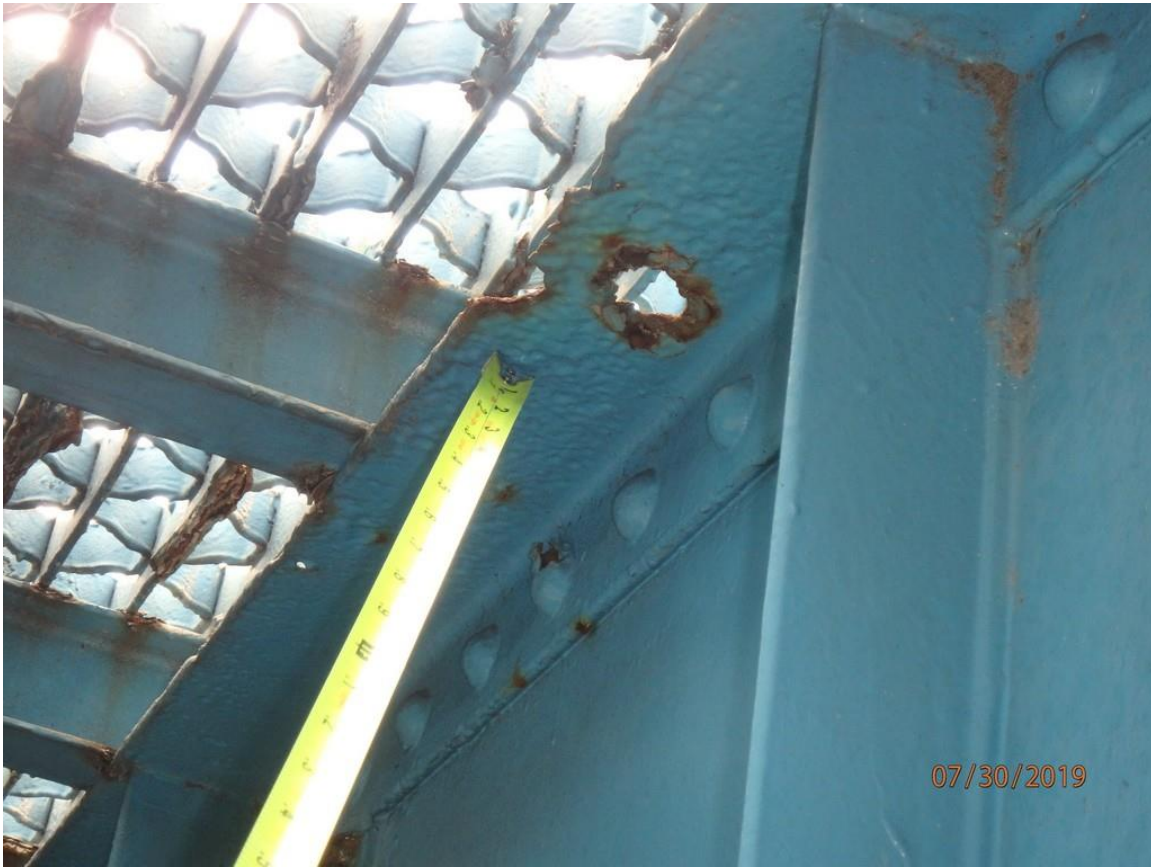
PHOTO 24: 107/4 – Steel Opn Girder/Beam

The north edge of Main Girder 6-2 top flange has painted-over knife edging with recurring minor surface corrosion intermittently throughout. There are several isolated painted corrosion holes up to 1-1/2in. diameter with minor recurring surface corrosion in the north side of the top flange and web on each side of Floor Beam 6-2. Refer to Photo 24. (1000 = 16FT ; 3440 = 32SF)

The top flange and web of Main Girder 6-2, exhibits isolated painted-over corrosion holes up to 1-1/2 in. diameter with recurring corrosion.

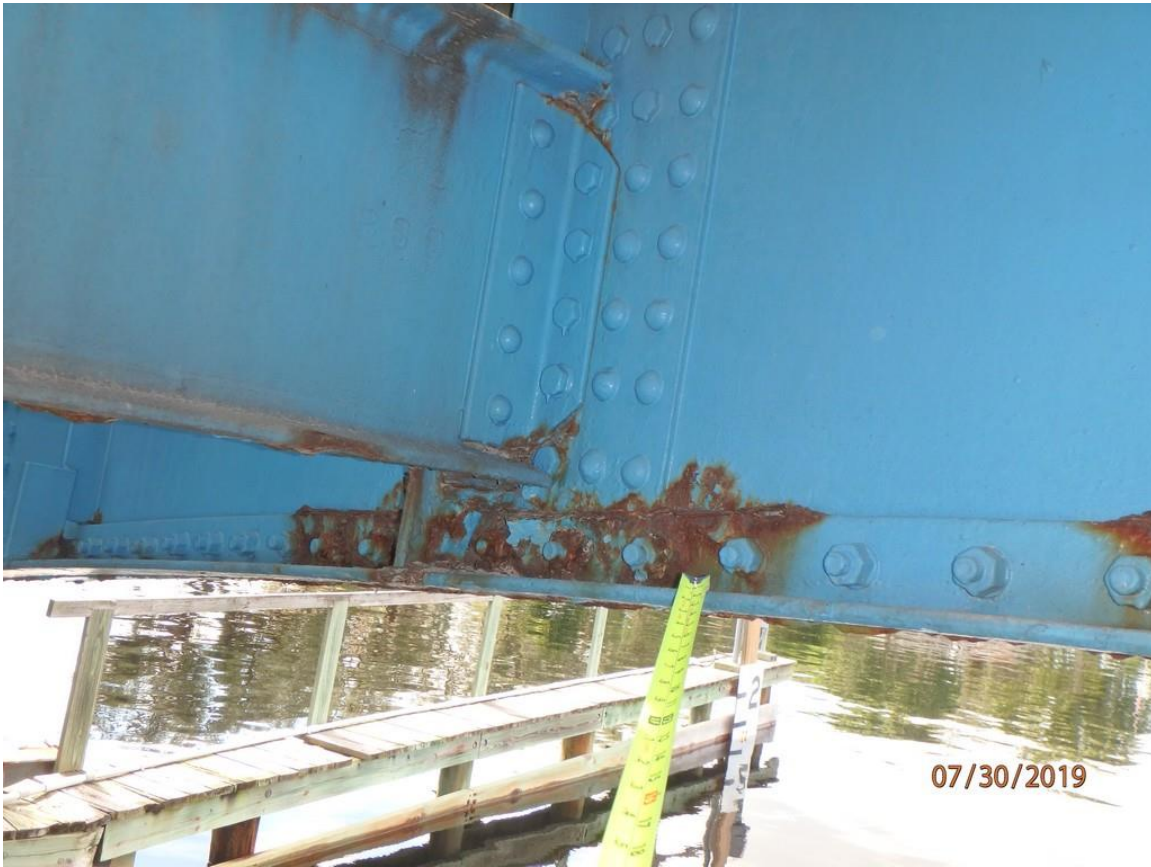
PHOTO 25: 107/4 - Steel Opn Girder/Beam

The built-up bottom flanges and lower portions of the webs of the main girders have areas of recurring heavy active corrosion in the vicinity of Floor Beam 6-2 and 6-3 and at the base of several vertical stiffeners. Refer to Photo 25. (1000 = 14FT ; 3440 = 120SF)

The built-up bottom flanges and lower portions of the webs of the main girders exhibit areas of recurring active corrosion in the vicinity of Floor Beam 6-2 and 6-3 and at the base of several vertical stiffeners (Main Girder 6-2 at Floor Beam 6-2 shown).

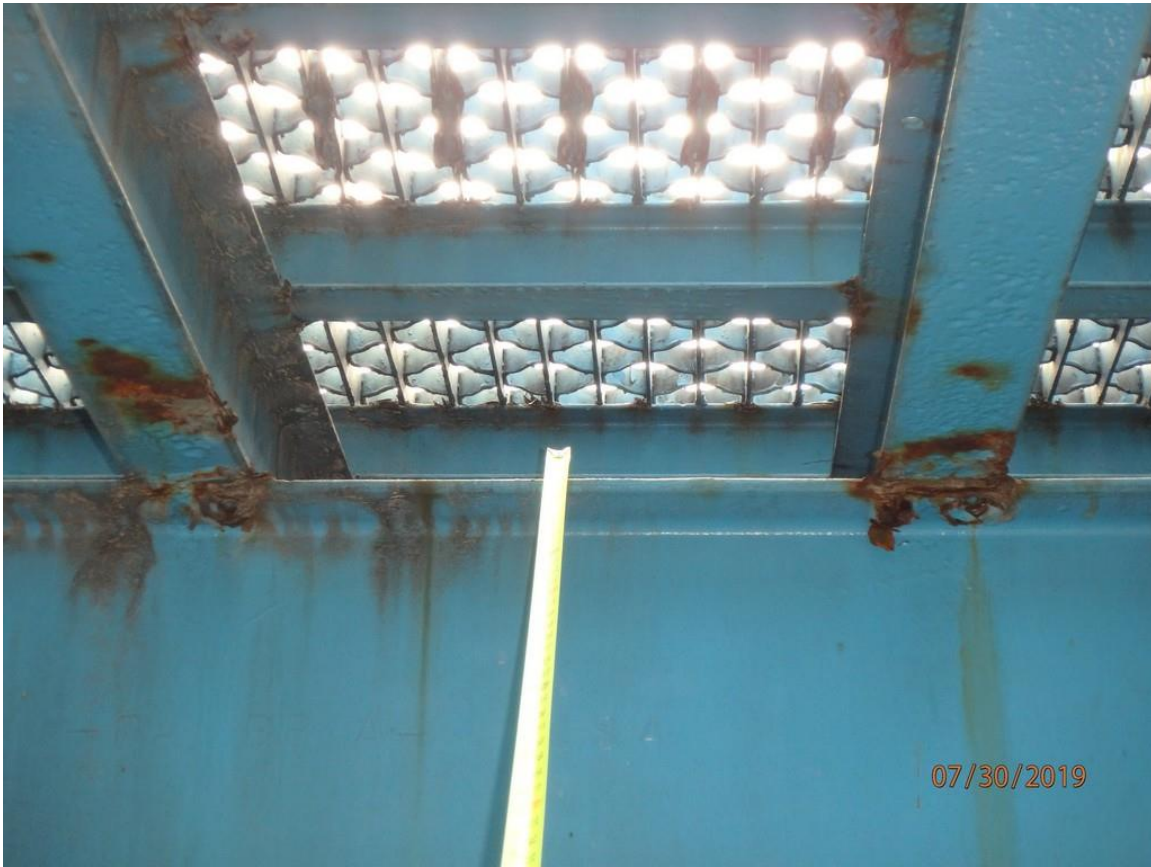
PHOTO 26: 113/4 - Steel Stringer

1000, 3440; CS3: Stringers 6-2 through 6-6 at Floor Beam 6-2 junctions have areas of moderate to heavy recurring surface corrosion. Refer to Photo 26. REPAIR (1000 = 30FT ; 3440 = 95SF)

Stringers 6-2 through 6-6 at Floor Beam 6-2 junction exhibit areas of moderate to heavy recurring corrosion (Stringers 6-5 at Floor Beam 6-2 shown).

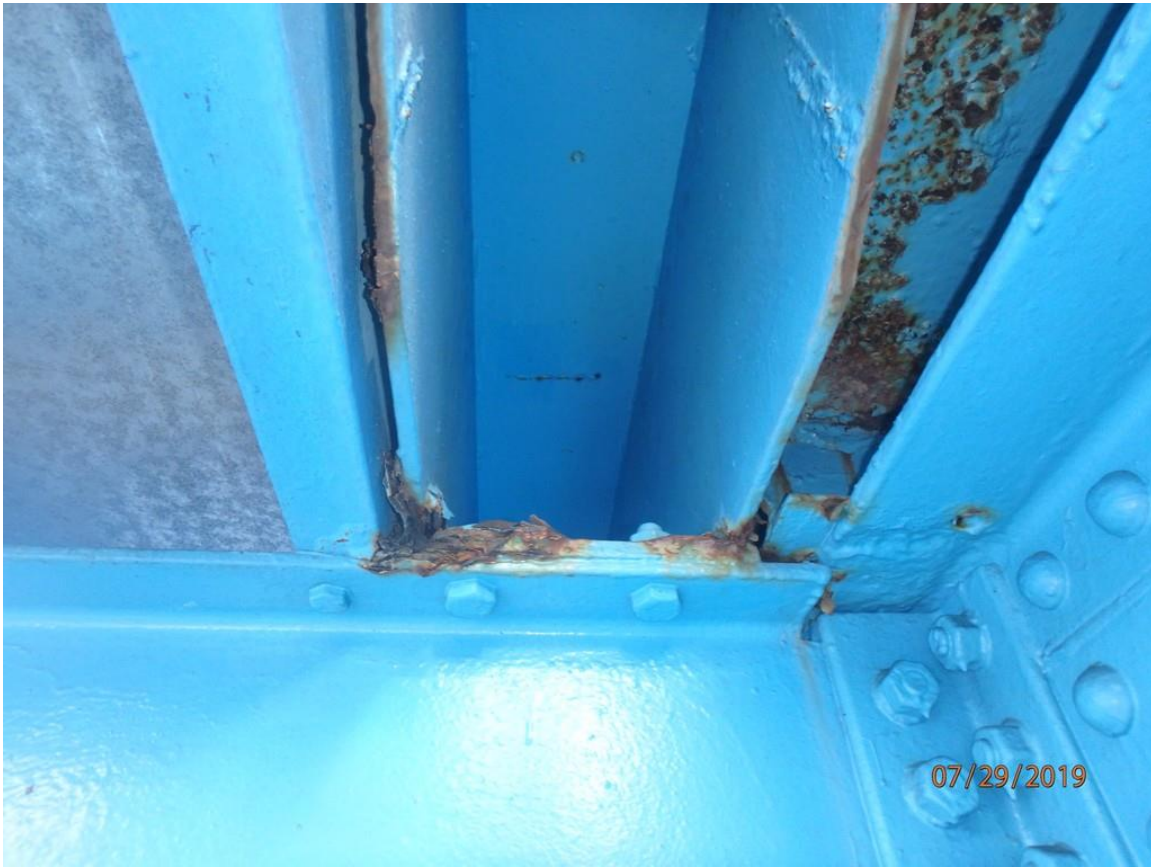
PHOTO 27: 113/4 - Steel Stringer

The sidewalk support channels have isolated areas of moderate to heavy corrosion with laminar rust. Refer to Photo 27. REPAIR

The sidewalk support channels exhibit isolated areas of moderate to heavy corrosion with laminar rust.

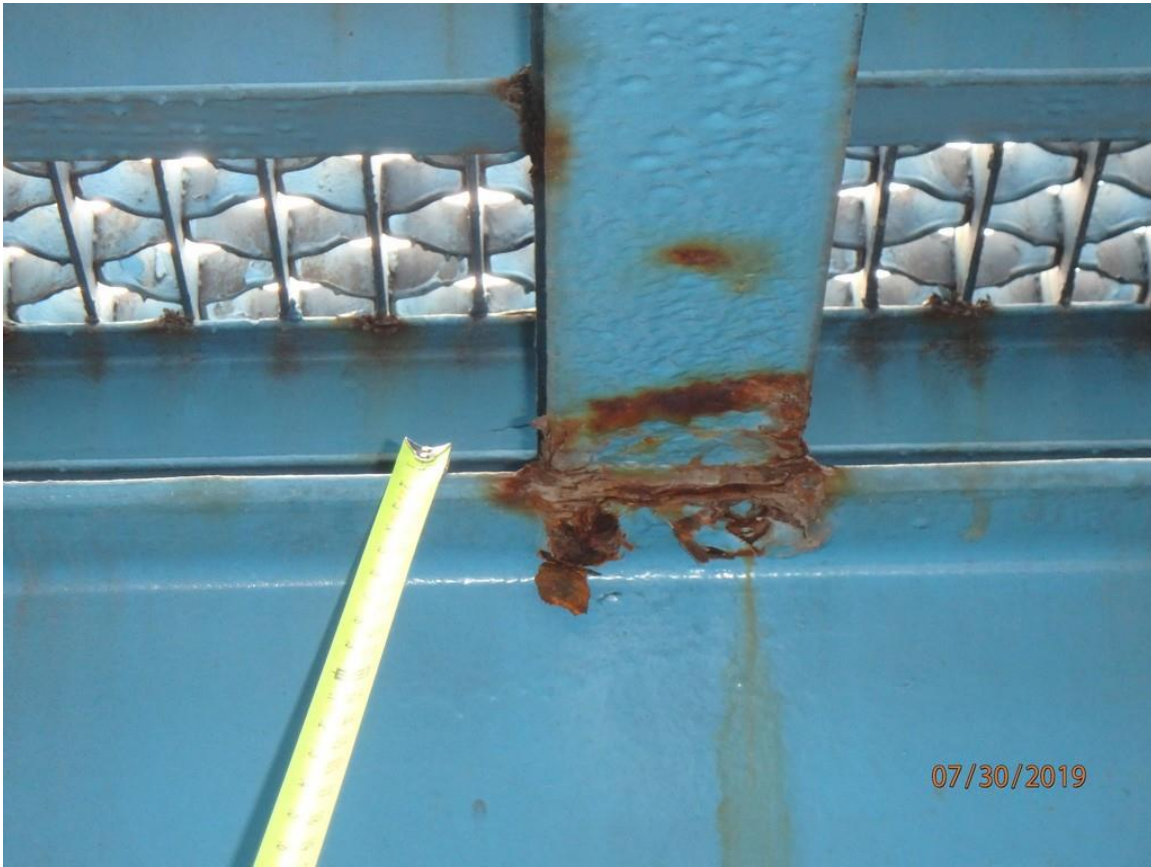
PHOTO 28: 152/4 - Steel Floor Beam

1000, 3440; CS3: Floor Beam 6-2 has areas of heavy corrosion and/or laminar rust at several stringer junctions. Refer to Photo 28. REPAIR (1000 = 5FT ; 3440 = 35SF)

Floor Beam 6-2 exhibits areas of heavy corrosion and/or laminar rust at several stringer junctions (at Stringer 6-6 shown).

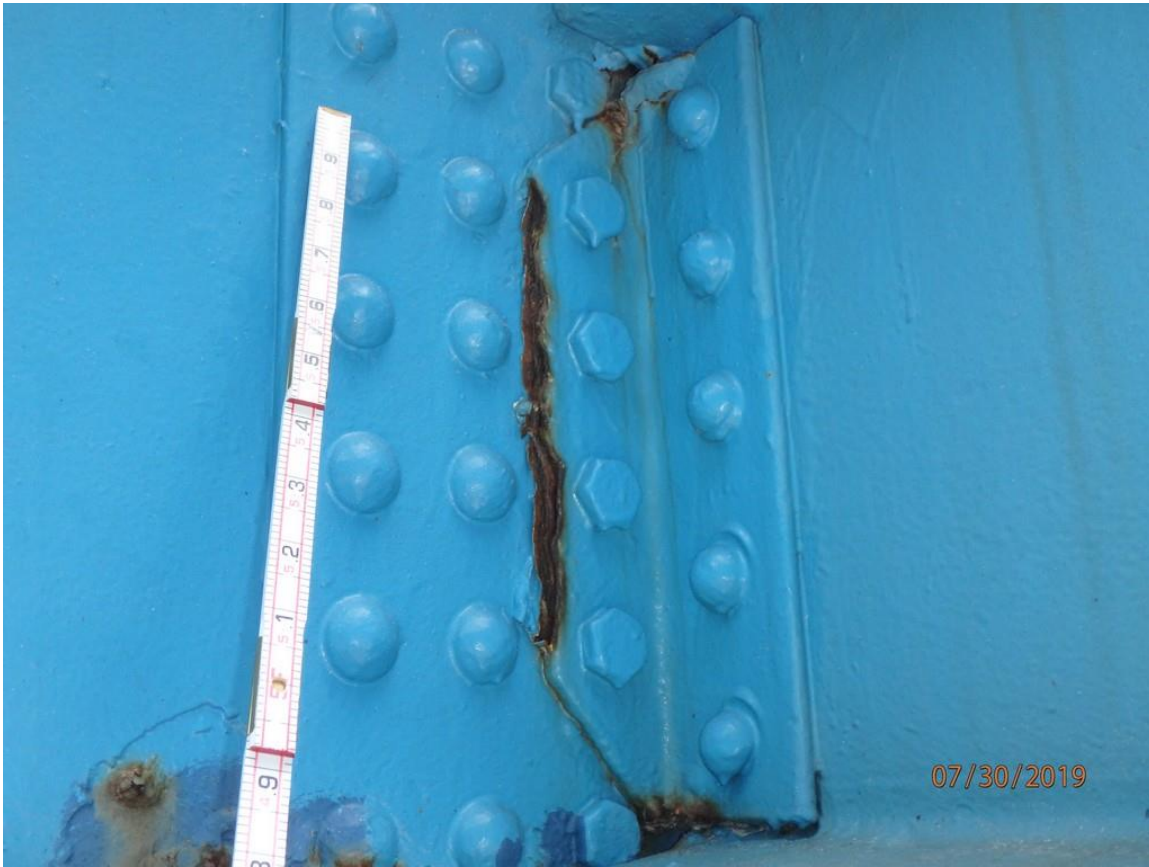
PHOTO 29: 152/4 - Steel Floor Beam

Heavy delaminative corrosion in west end of angle attaching Floor Beam 6-2 to Main Girder 6-1.

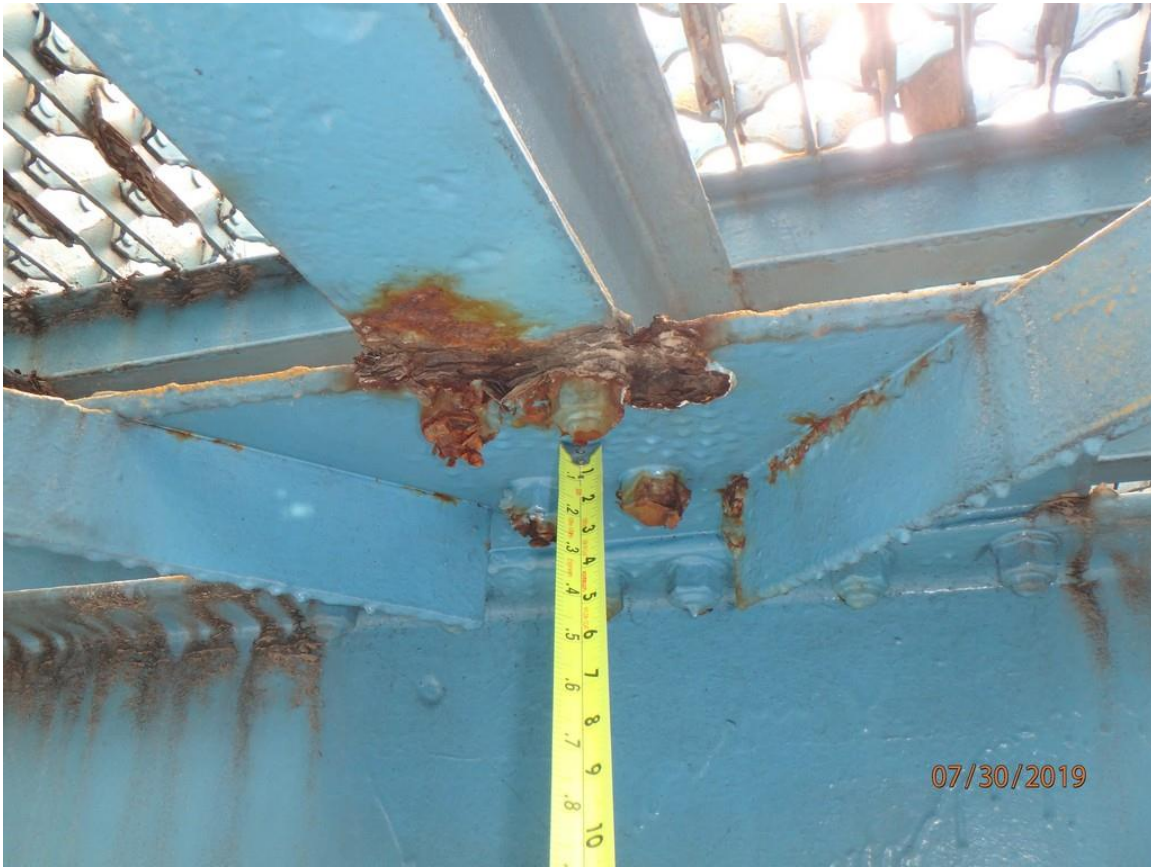
PHOTO 30: 152/4 – Steel Floor Beam

Center lateral bracing gusset plate at Floor Beam 6-2 heavy corrosion with knife edging.

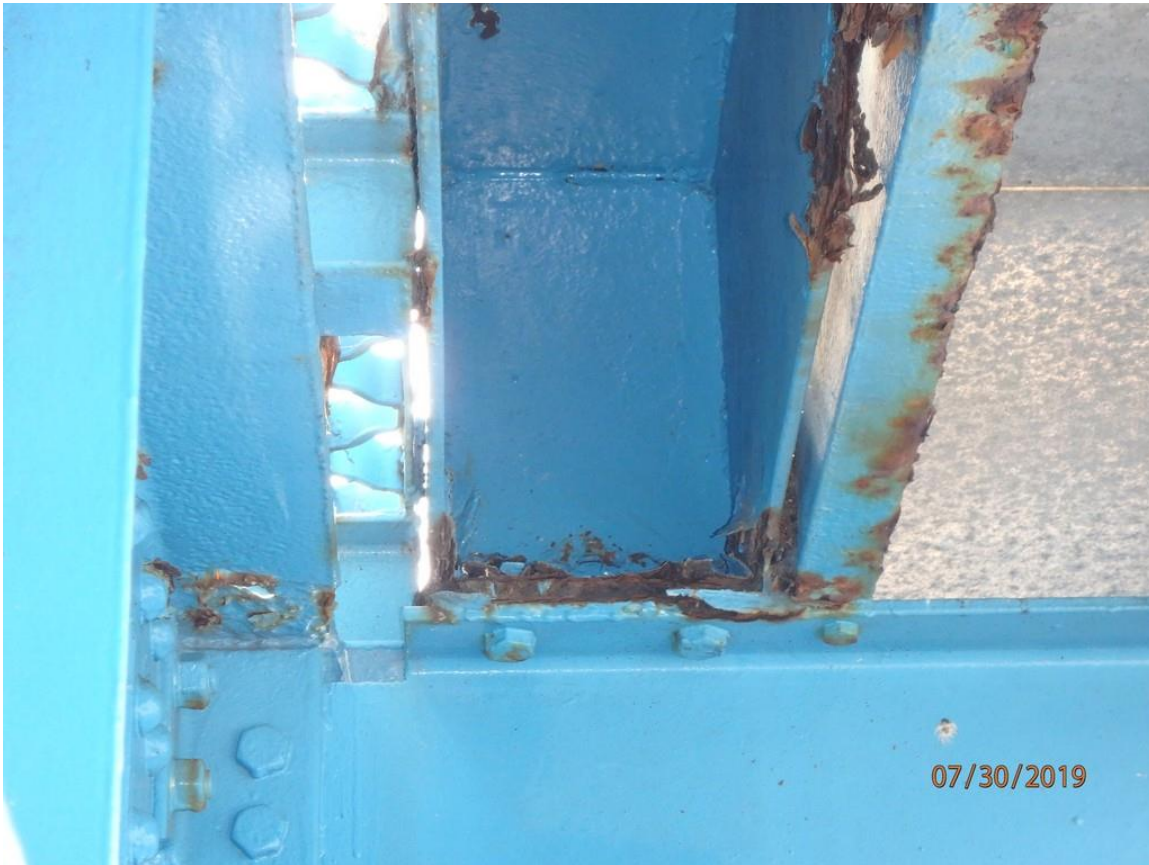
PHOTO 31: 152/4 - Steel Floor Beam

Cantilever sidewalk support junction to curb and sidewalk have corrosion with laminar rust.

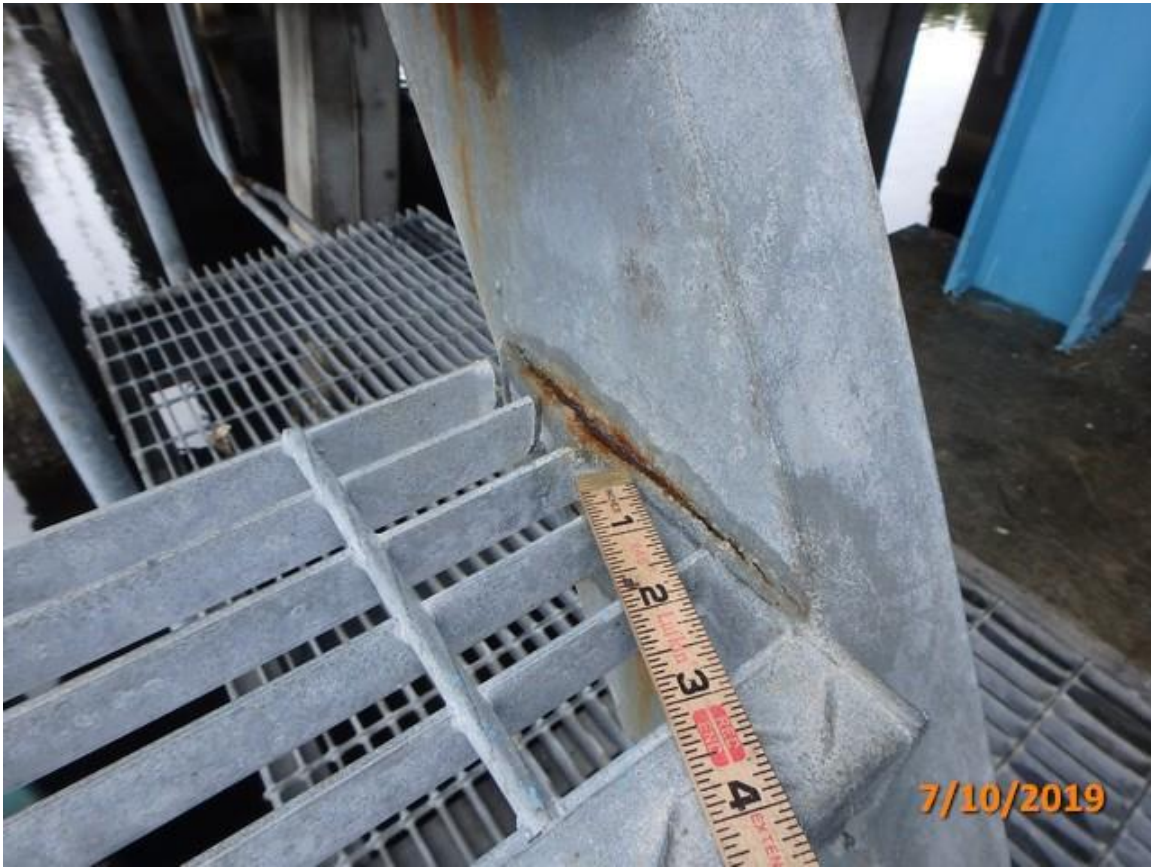
PHOTO 32: 8563/4 - Access Ladder & Platform

The stairs from the Tenders House to the platform exhibit cracked welds and pack rust.

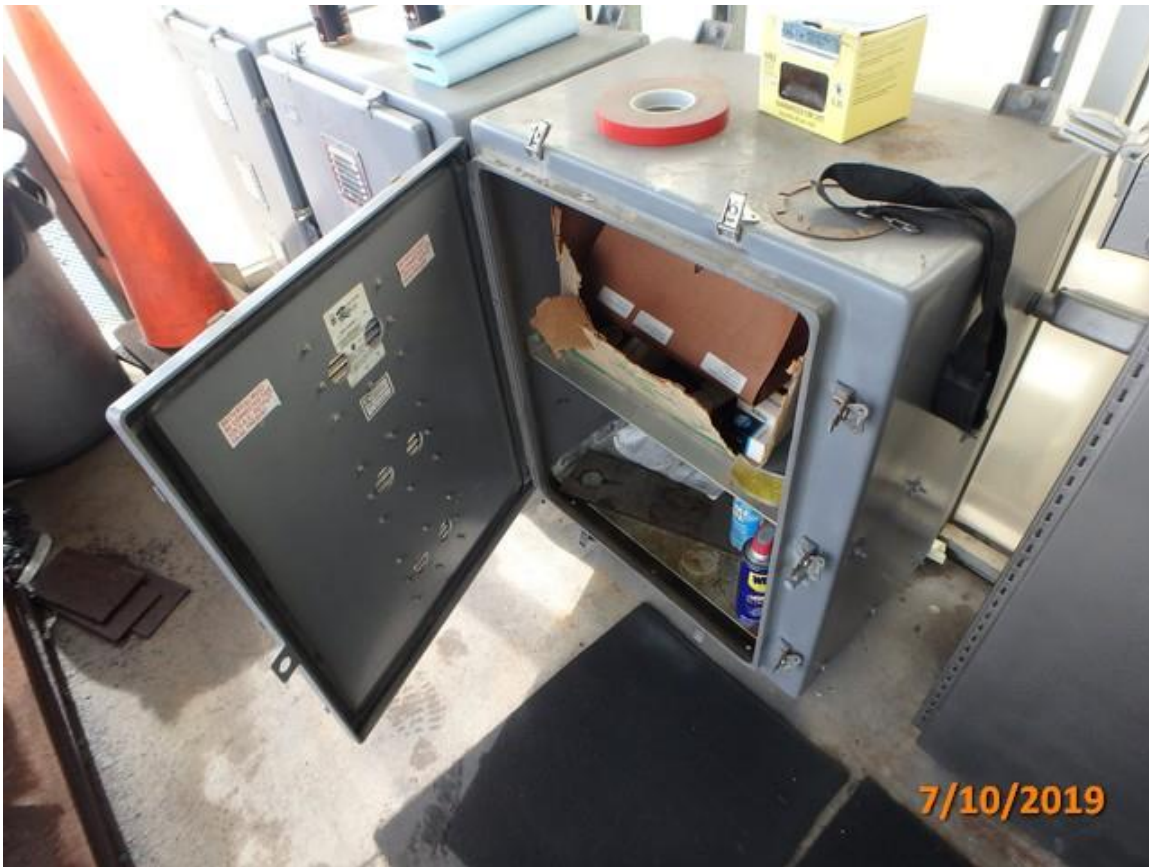
PHOTO 33: 8580/4 - Navigational Lights

The UPS backup battery system for the navigational lights has been removed.

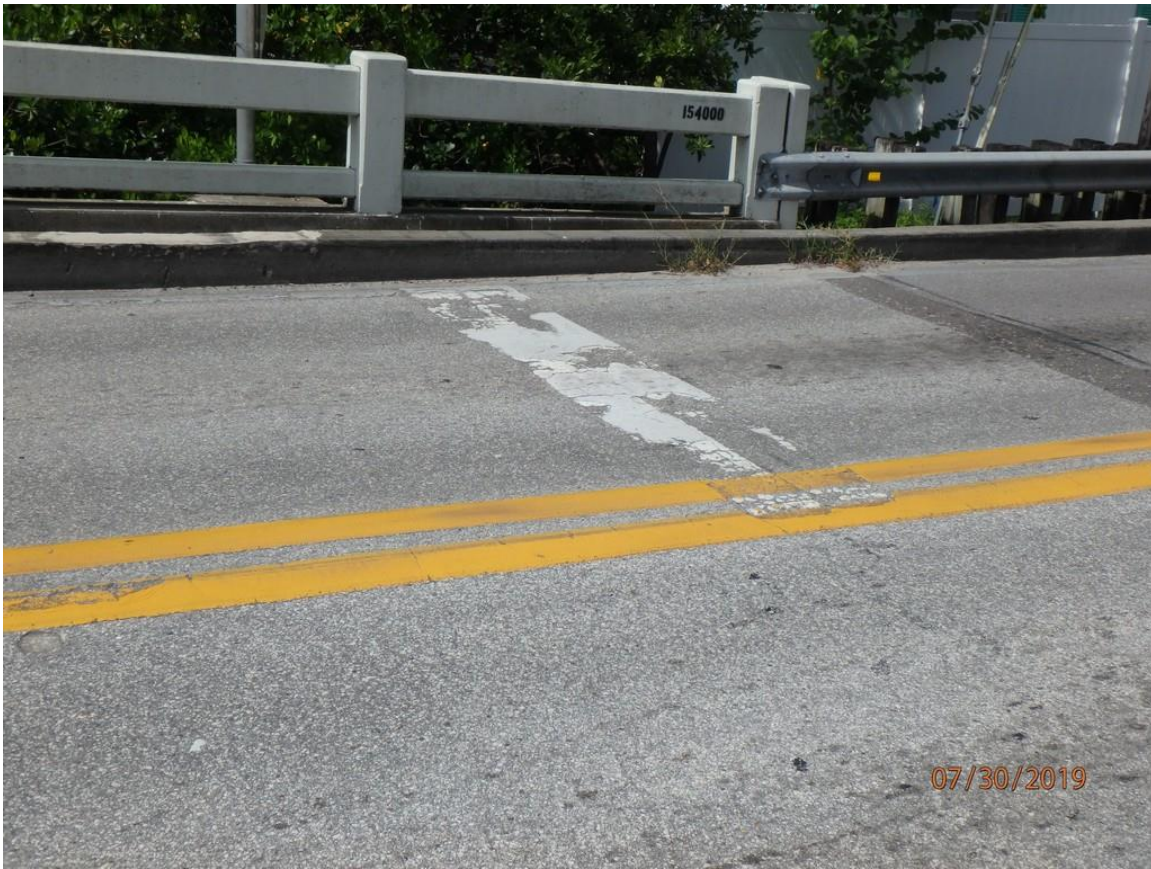
PHOTO 34: Inspection Notes

The traffic stop lines are peeling and faded at both ends of the structure. Refer to Photo 34. REPAIR

West stop line peeling and faded. Typical.

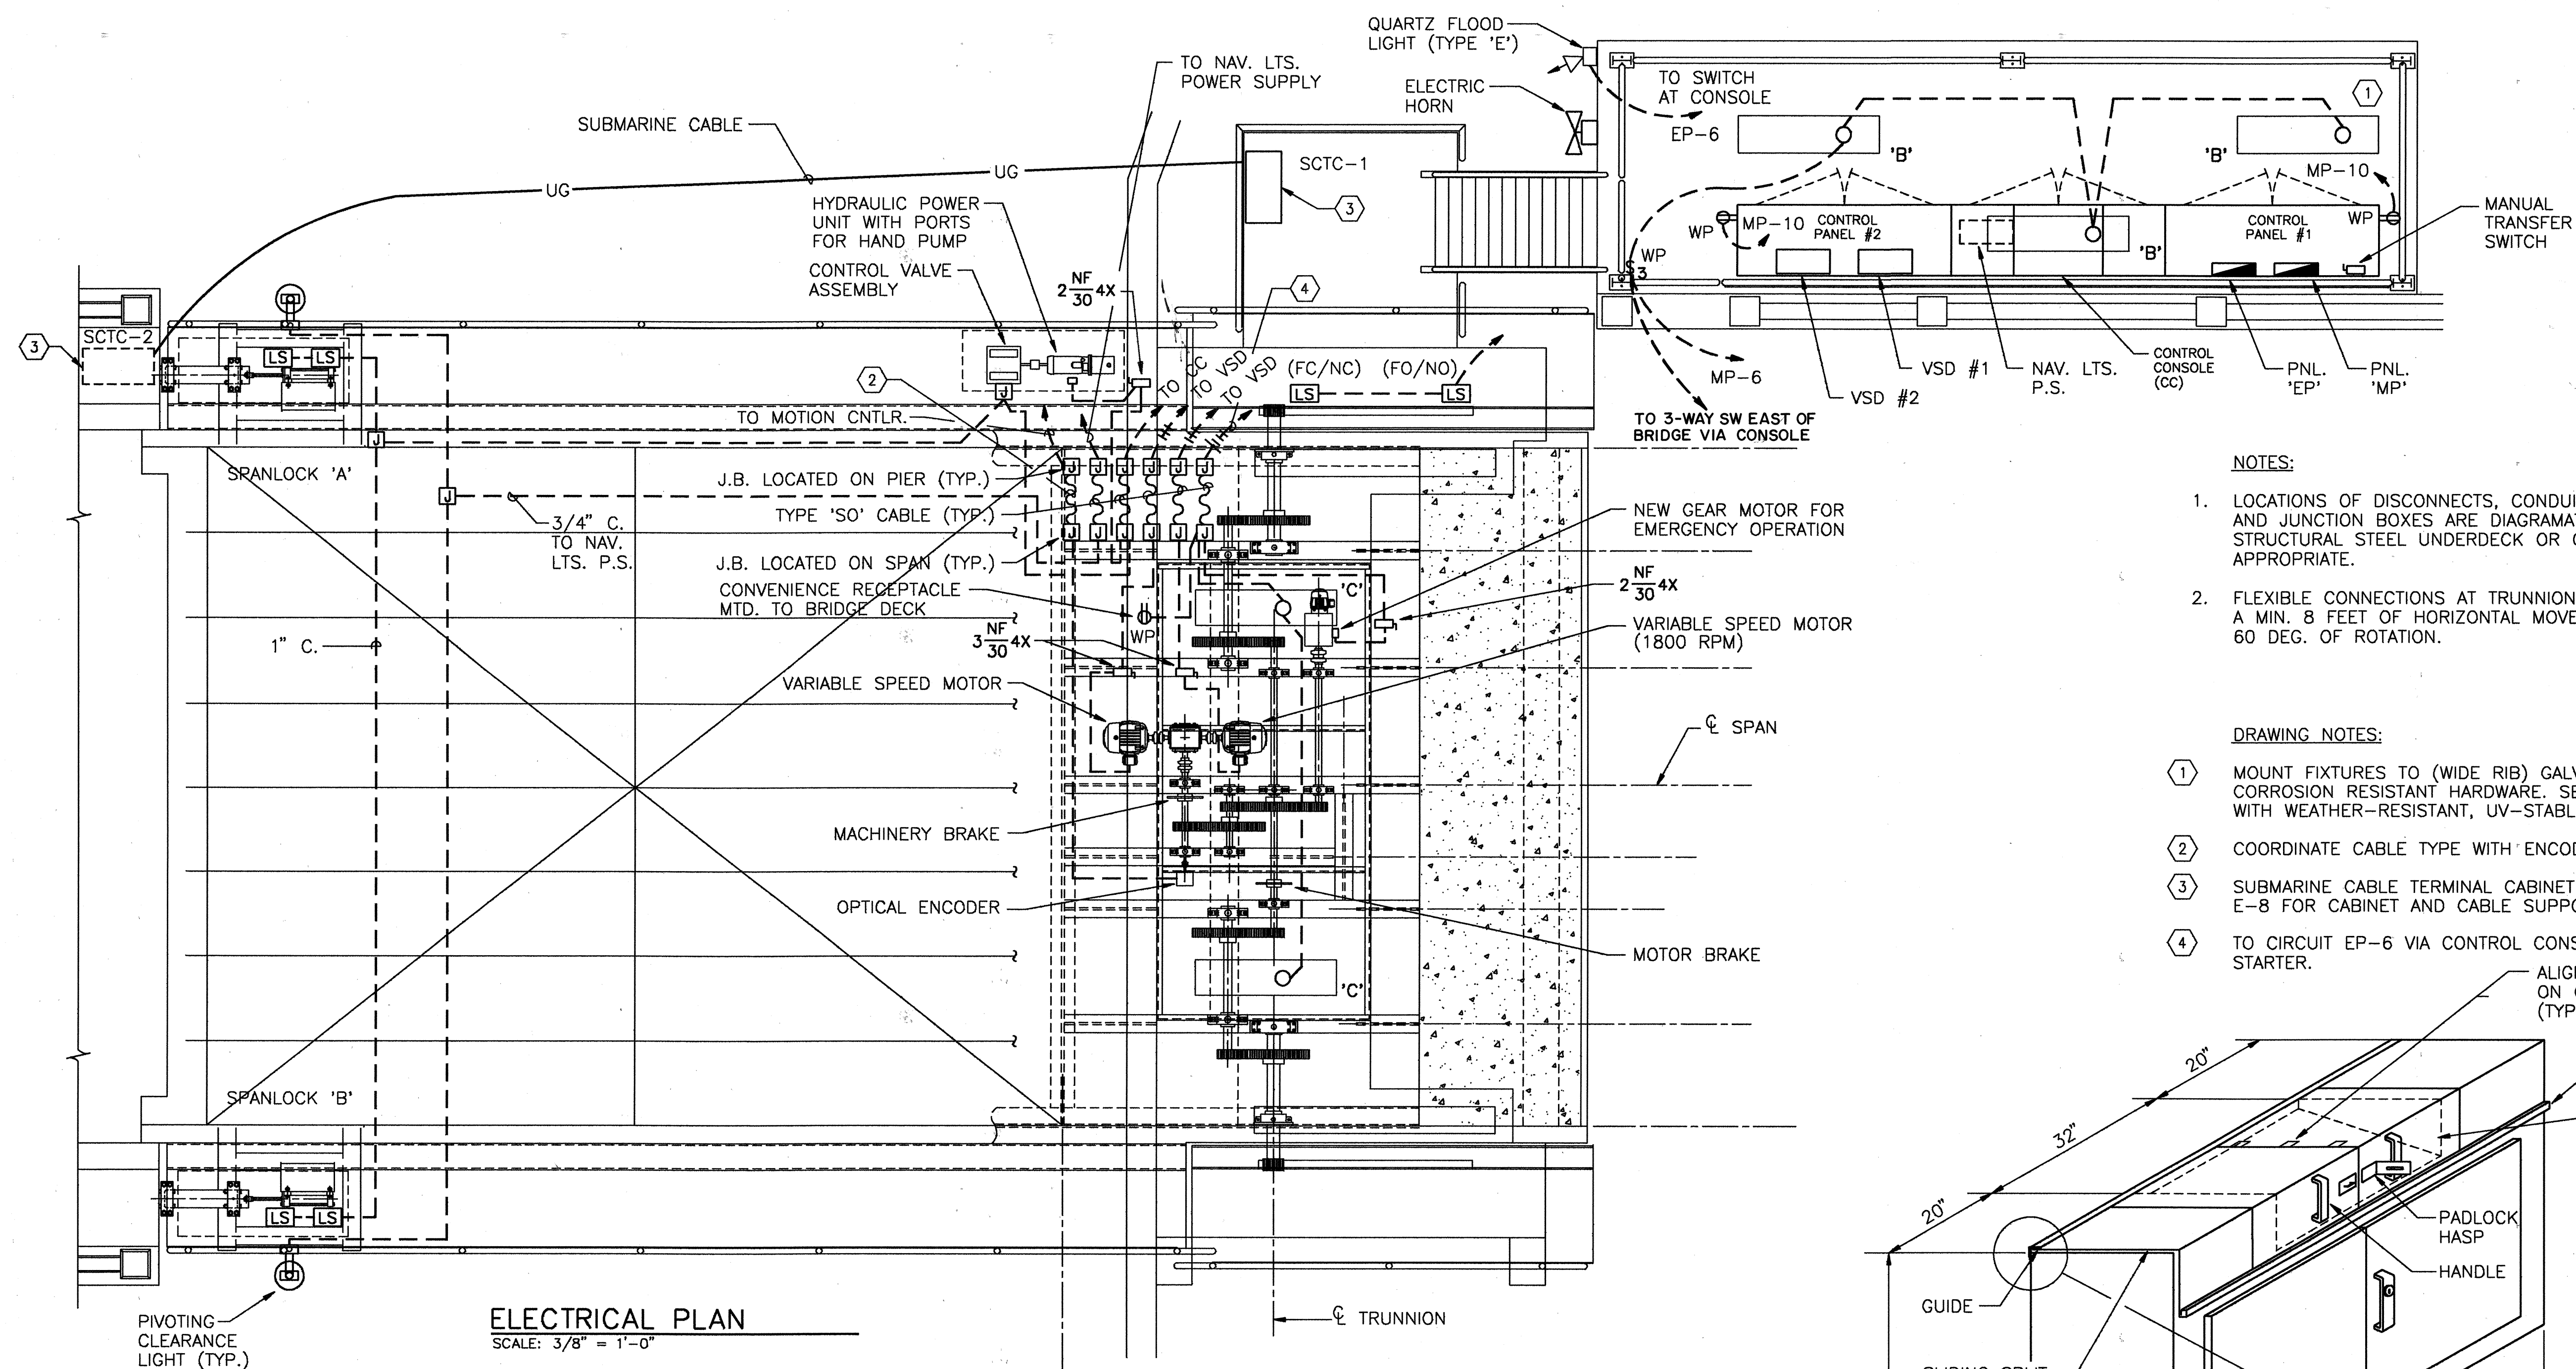
ELECTRICAL PLAN
SCALE: 3/8" = 1'-0"

- 1 MOUNT FIXTURES TO (WIDE RIB) GALVANIZED ROOF WITH CORROSION RESISTANT HARDWARE. SEAL ALL PENETRATIONS WITH WEATHER-RESISTANT, UV-STABLE SEALANT.
- 2 COORDINATE CABLE TYPE WITH ENCODER SUPPLIER.
- 3 SUBMARINE CABLE TERMINAL CABINET. REFER TO SHEET E-8 FOR CABINET AND CABLE SUPPORT.
- 4 TO CIRCUIT EP-6 VIA CONTROL CONSOLE AND EP-10 VIA STARTER.

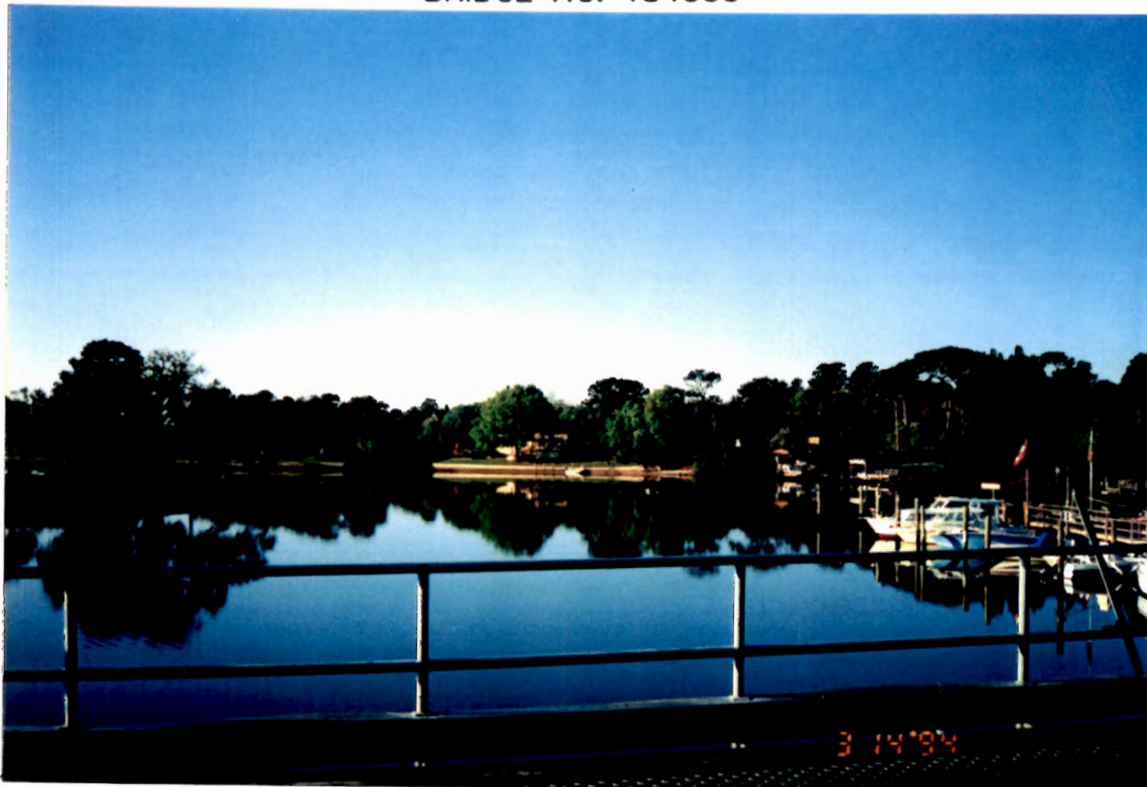
UPSTREAM CHANNEL

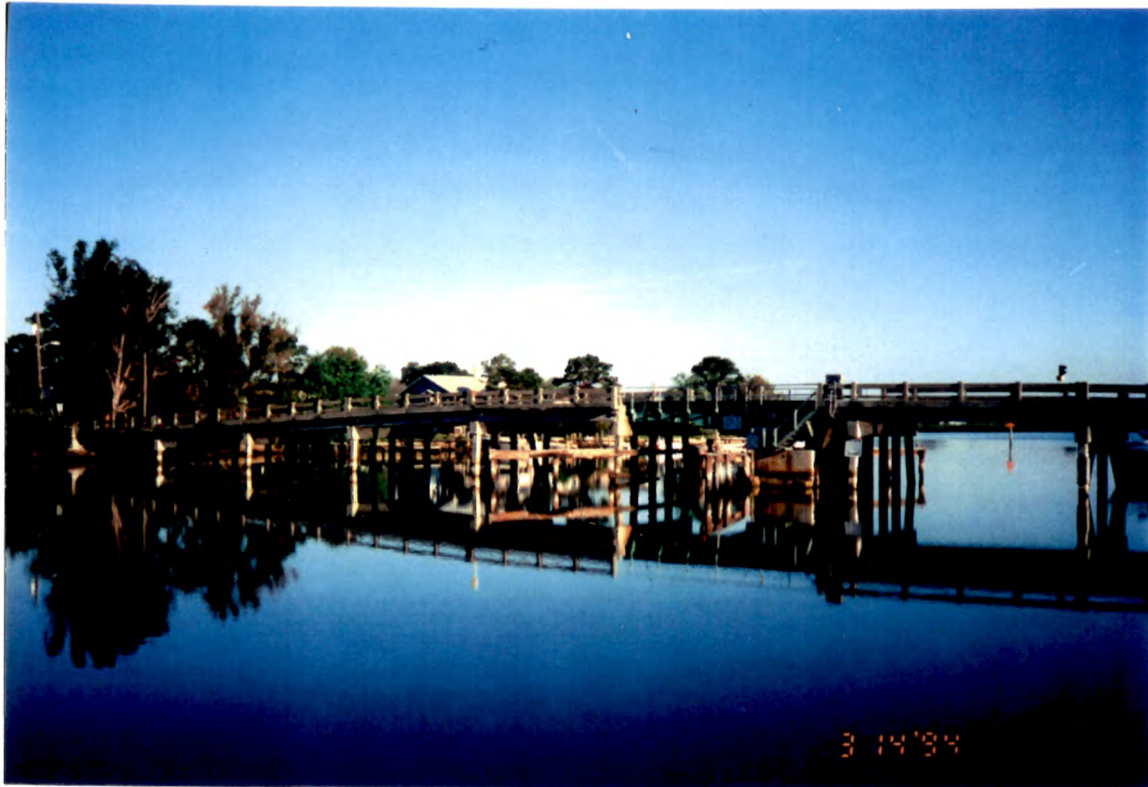
UPSTREAM FACE

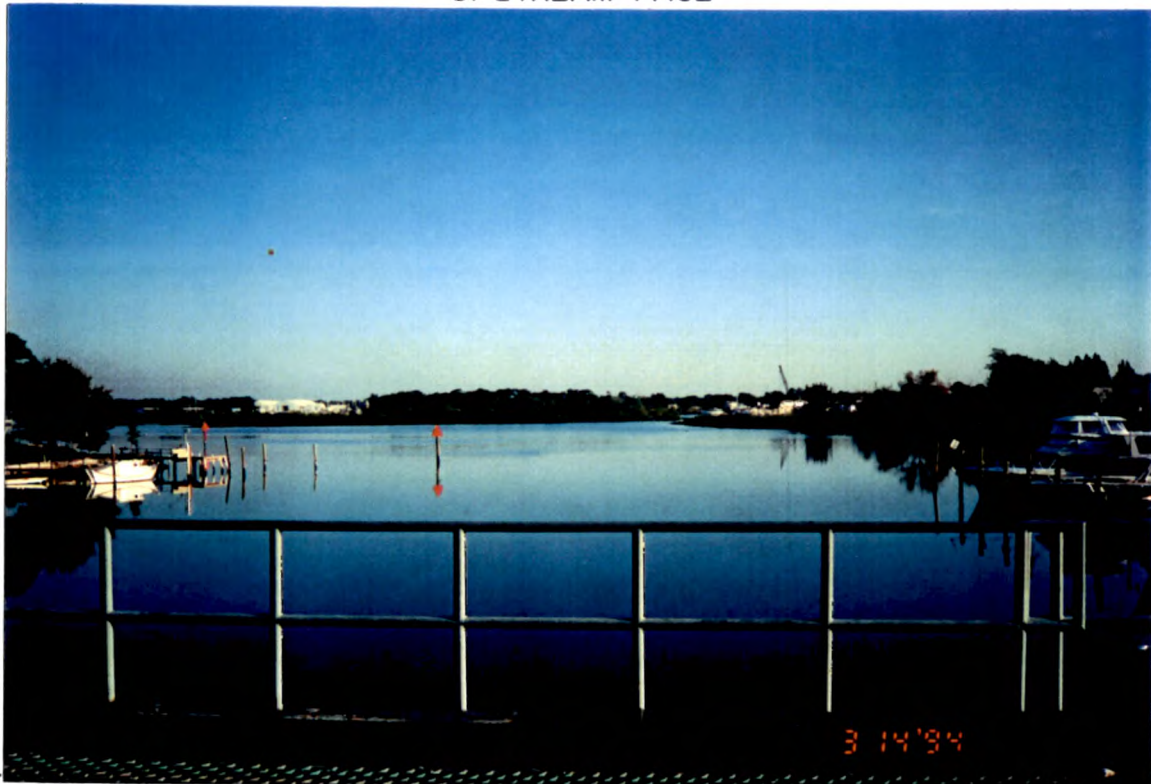
DOWNSTREAM CHANNEL

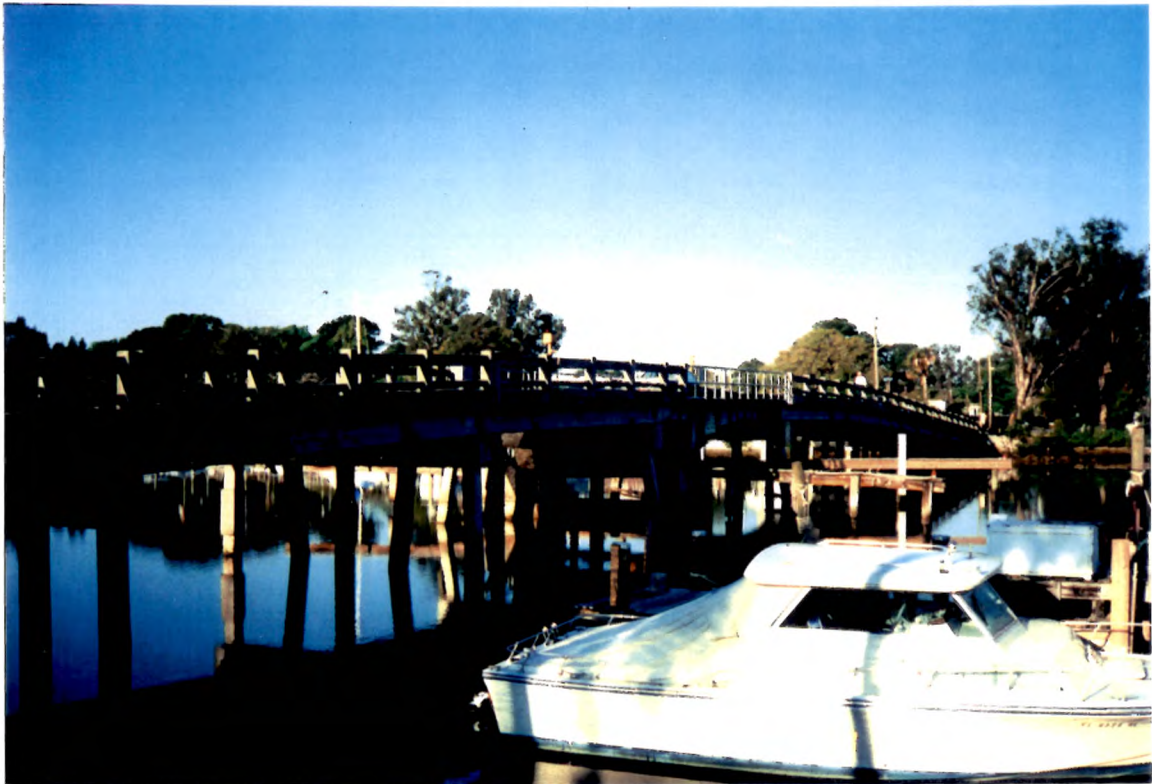
DOWNSTREAM FACE

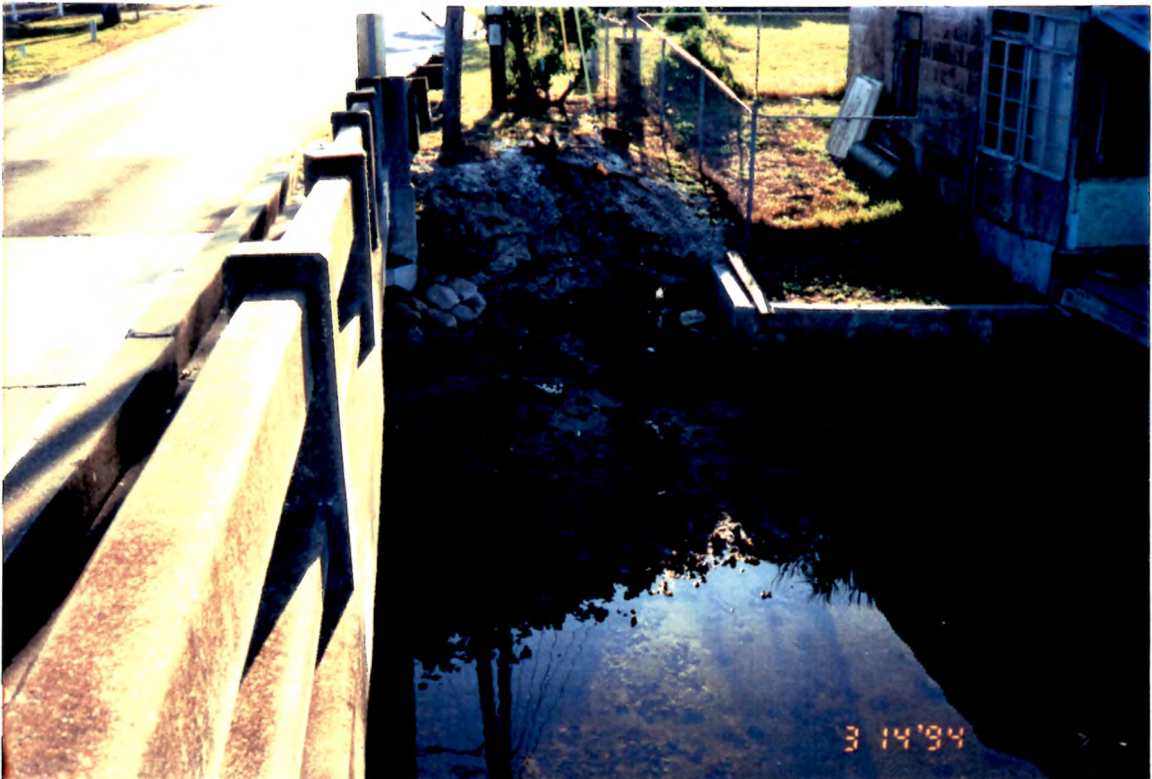
UPSTREAM RIGHT ABUTMENT

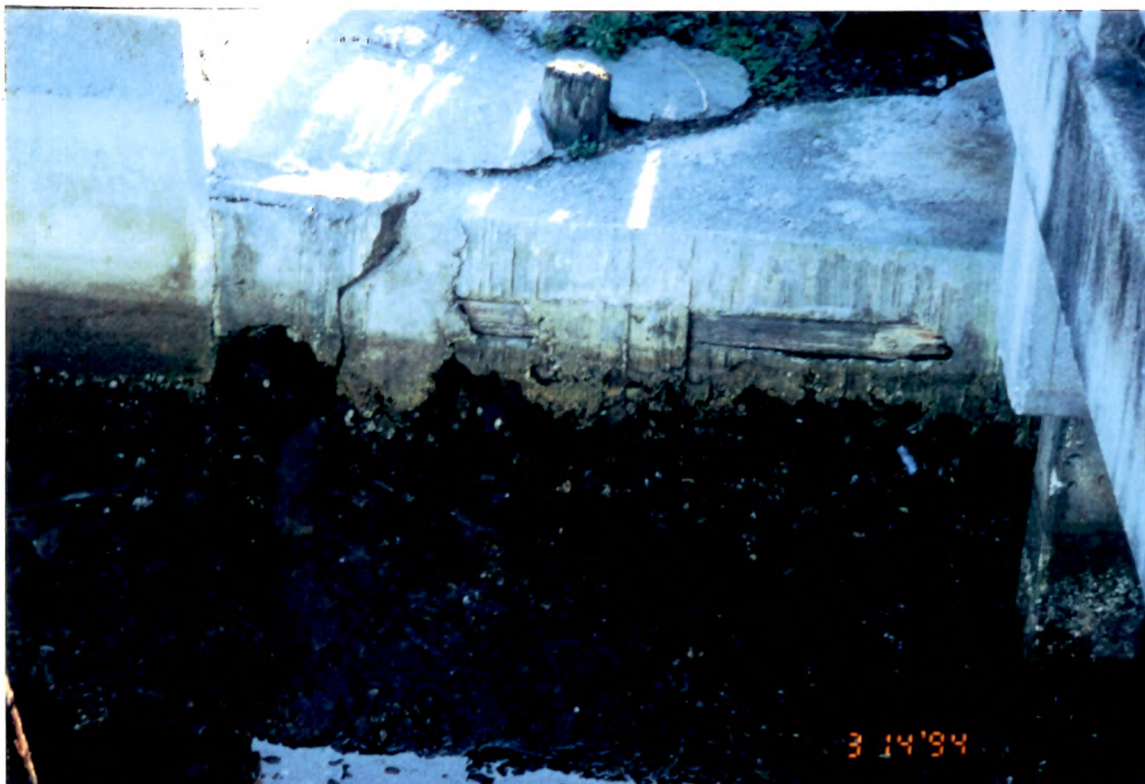
DOWNSTREAM RIGHT ABUTMENT

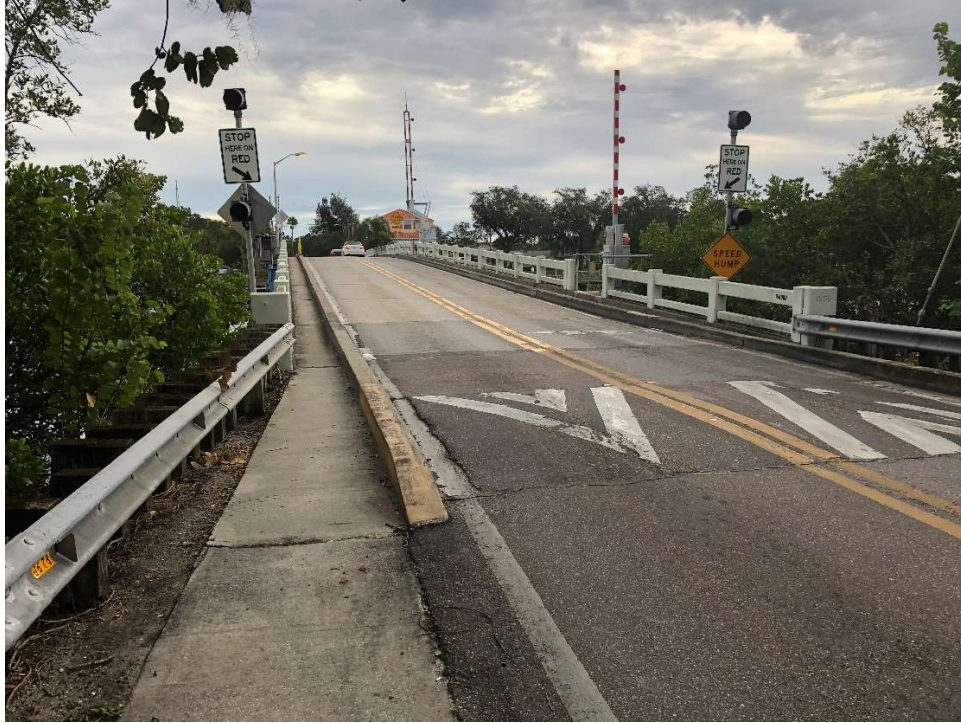
Photo 1 - West Approach Looking East
