Beckett Bridge Replacement Tarpon Springs, FL

E. Technical Documents

Bridge Investment Program (BIP)
Grant Application

Technical Memorandum

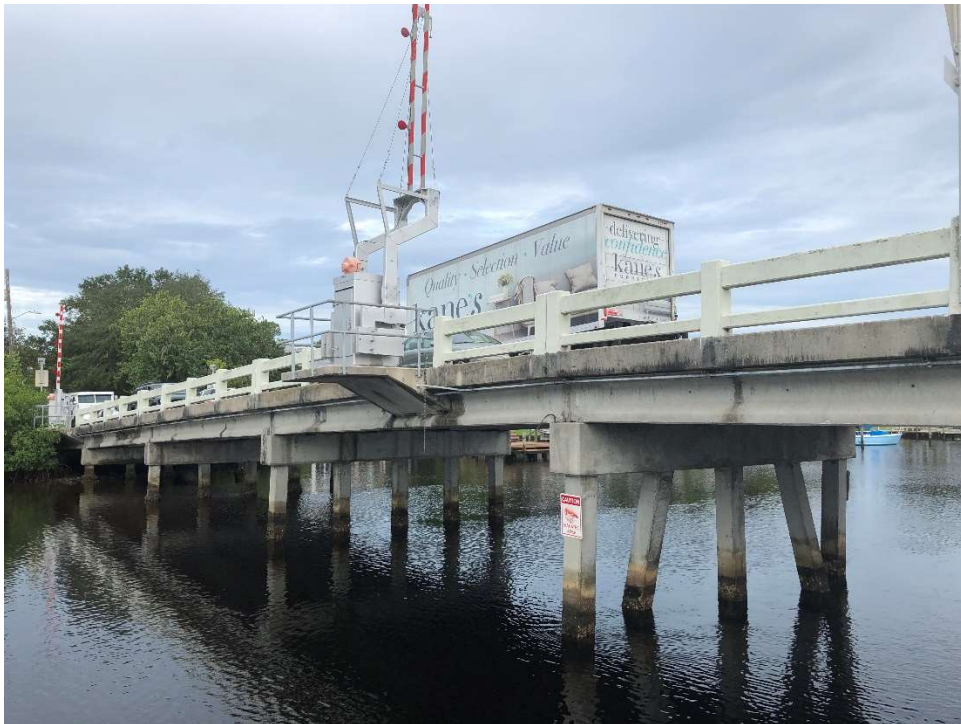
Photo 2 - West Approach Spans

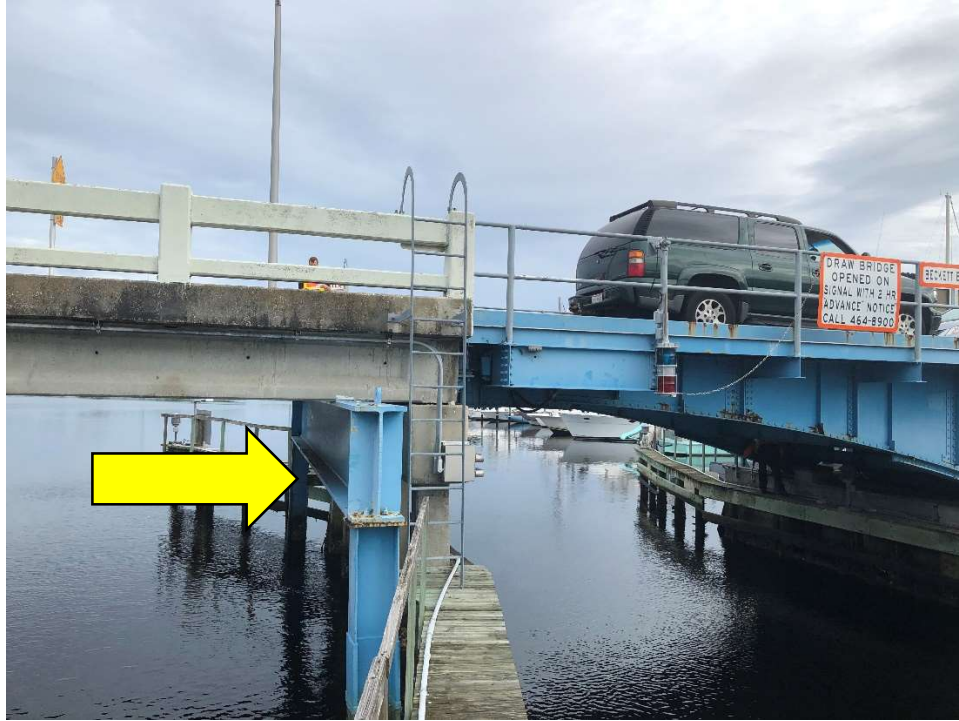
Photo 3 - Crutch Bent at Rest Pier/Bent 6

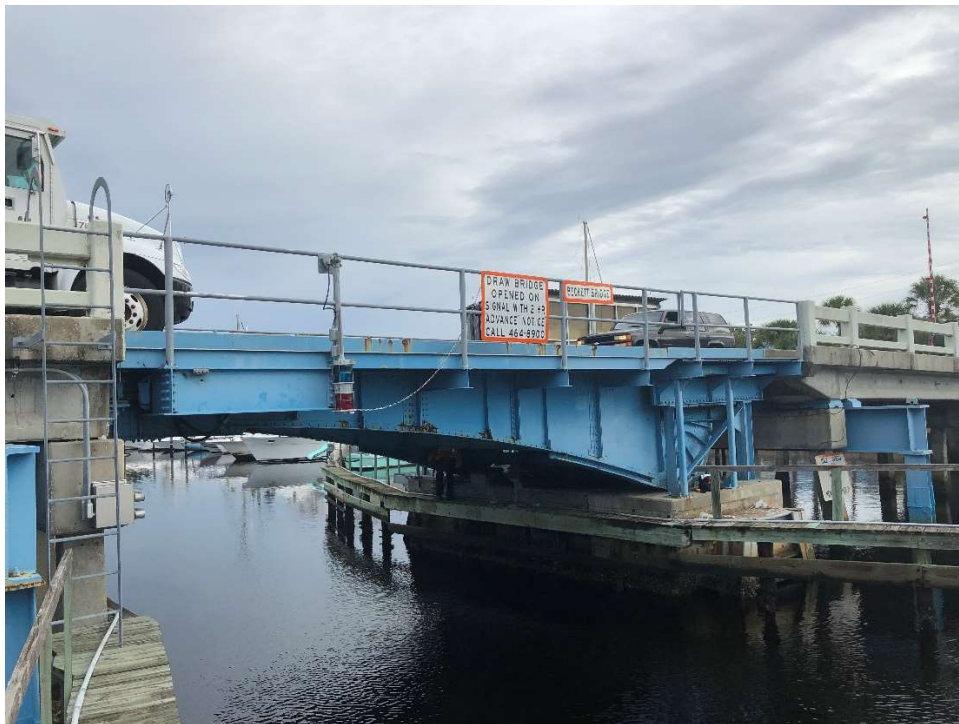
Photo 4 - Bascule Span

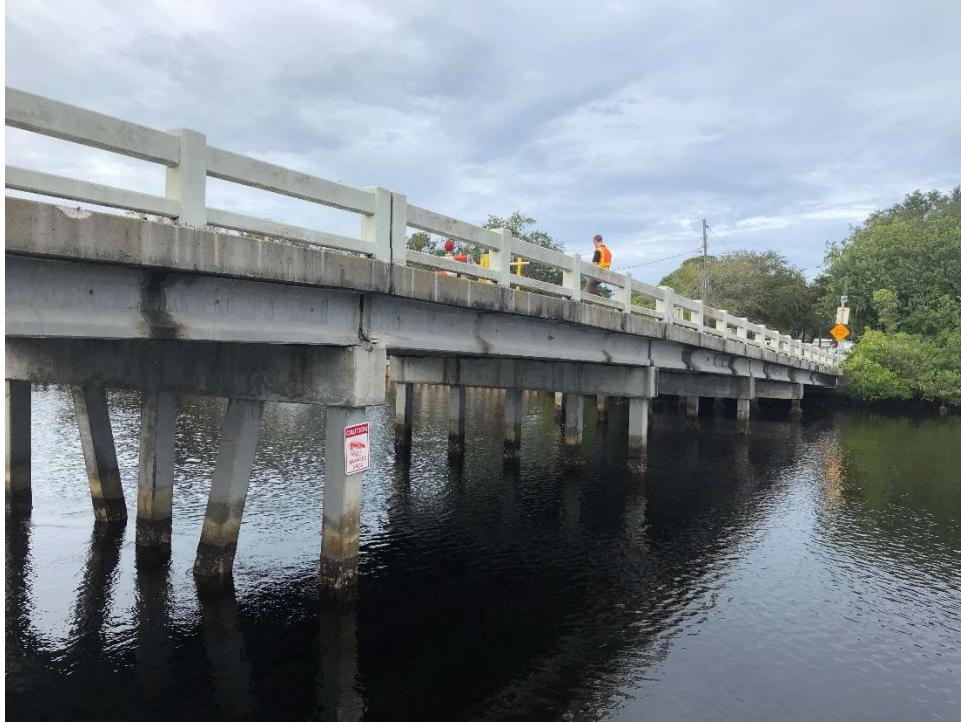
Photo 5 - East Approach Spans

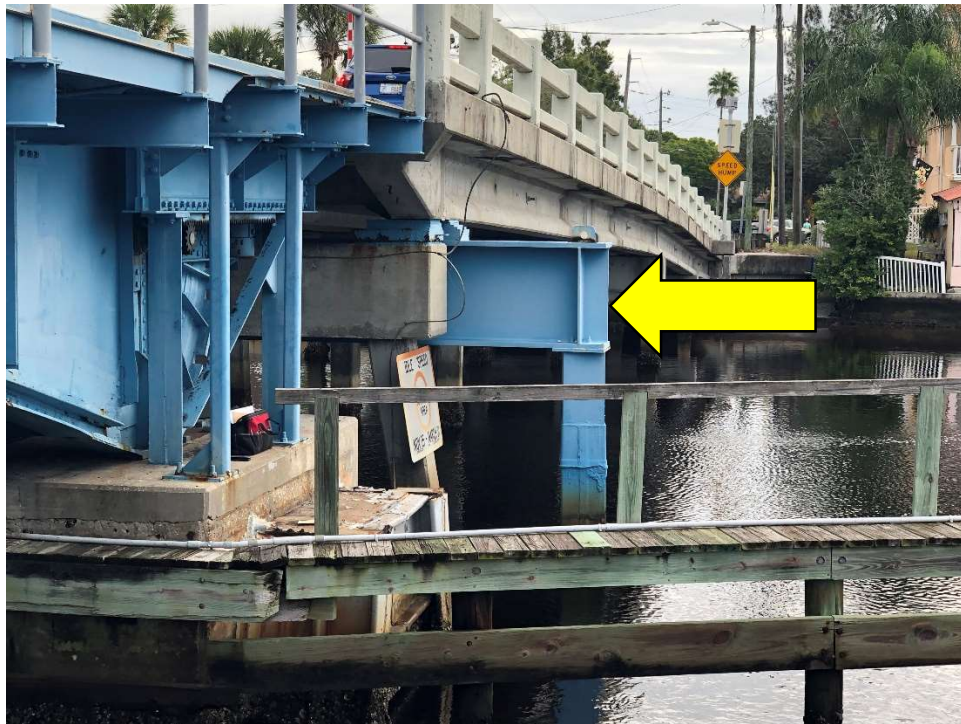
Photo 6 - Crutch Bent at Bent 7

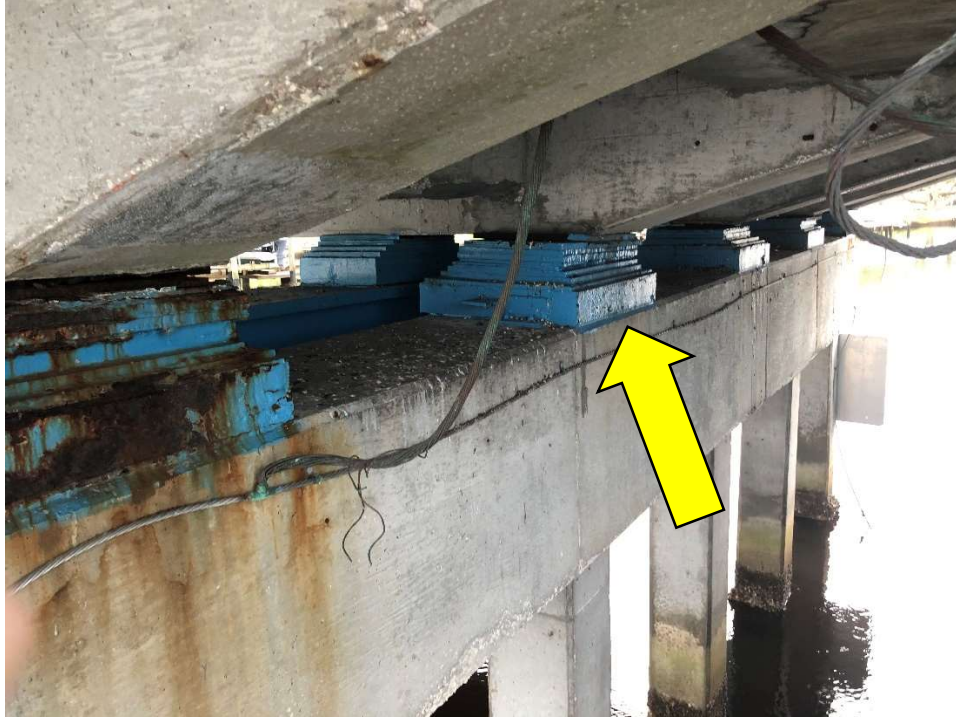
Photo 7 - Shims/Blocking at Bent 7 to Address Prior Settlement

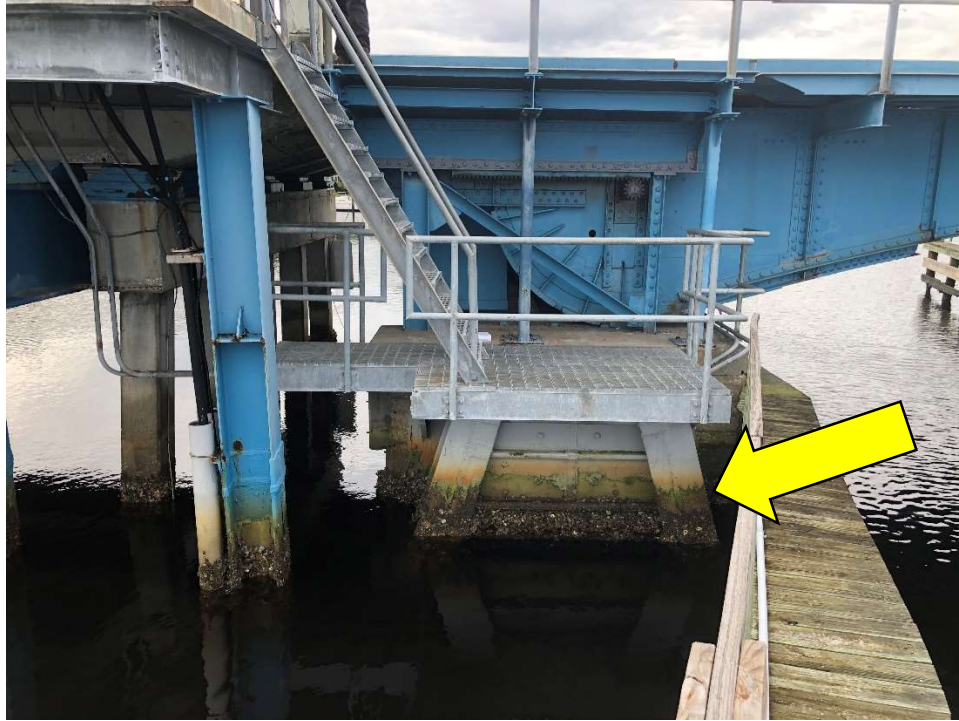
Photo 8 - Bascule Pier Helper Piles at North Side

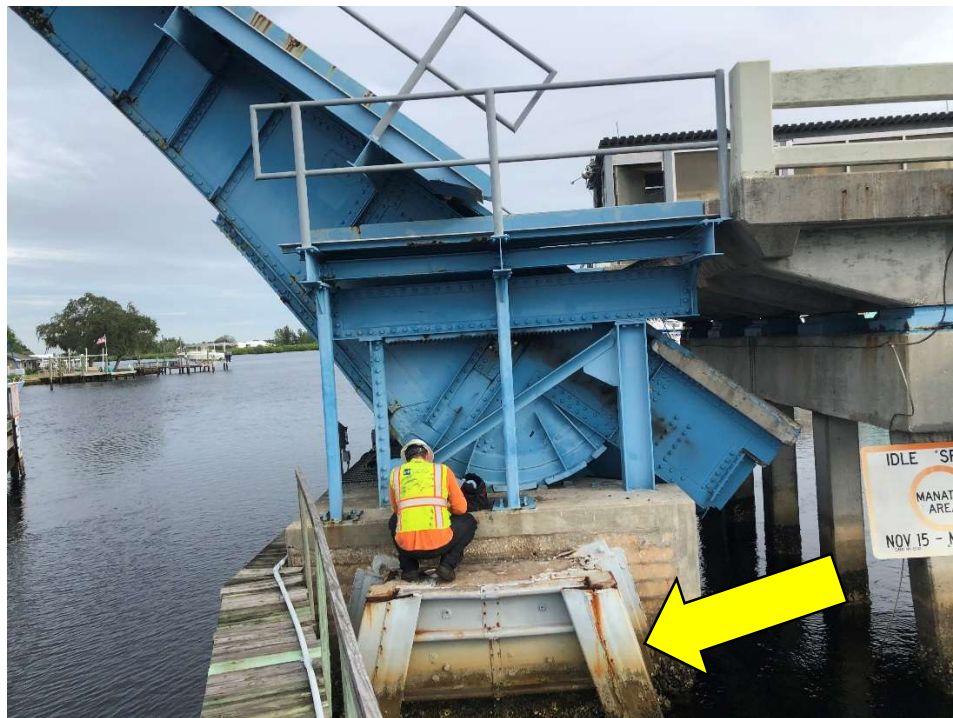
Photo 9 - Bascule Pier Helper Piles at South Side

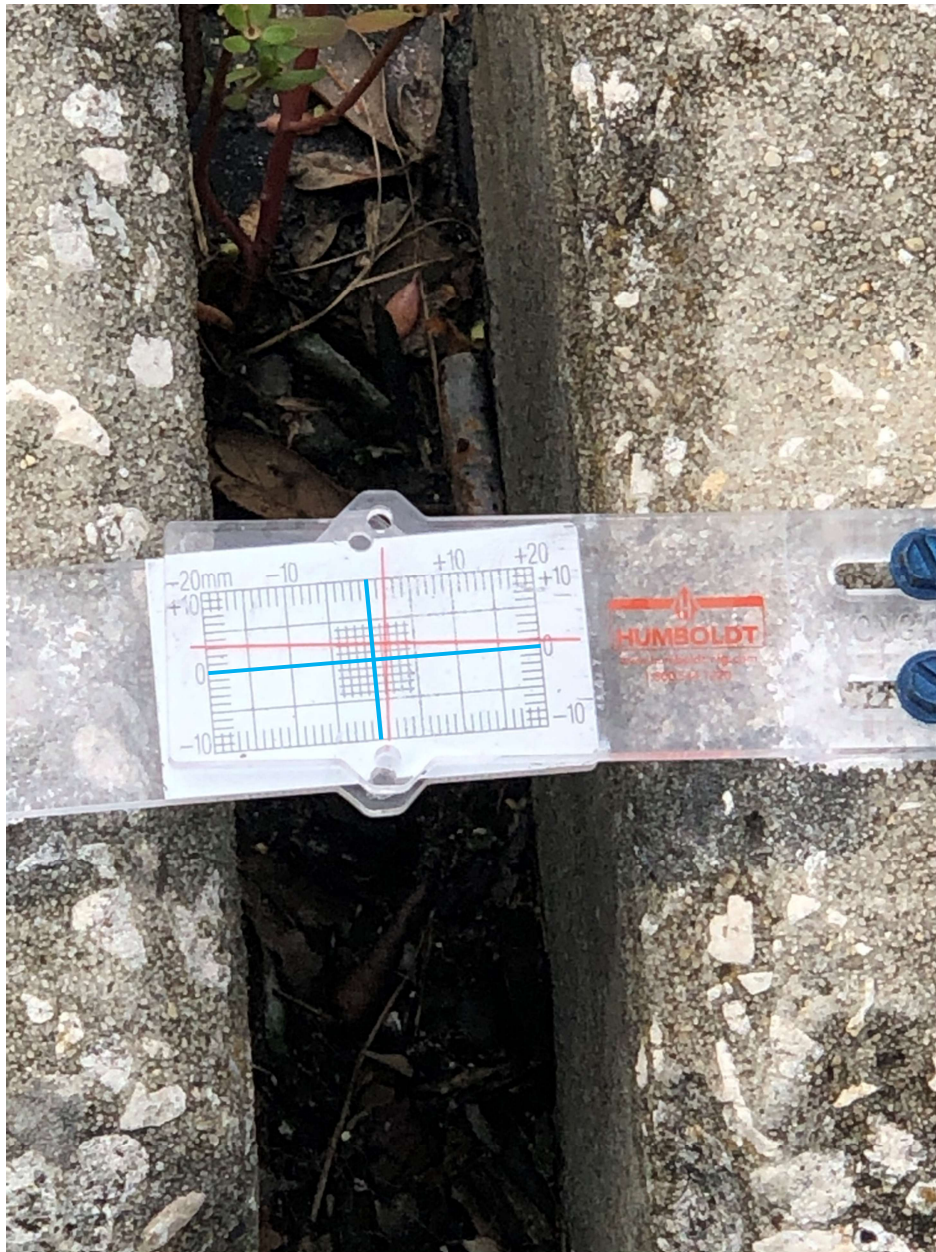
Photo 10 - Monitoring Devices on Top of Curb with Evidence of Lateral Movement/Rotation

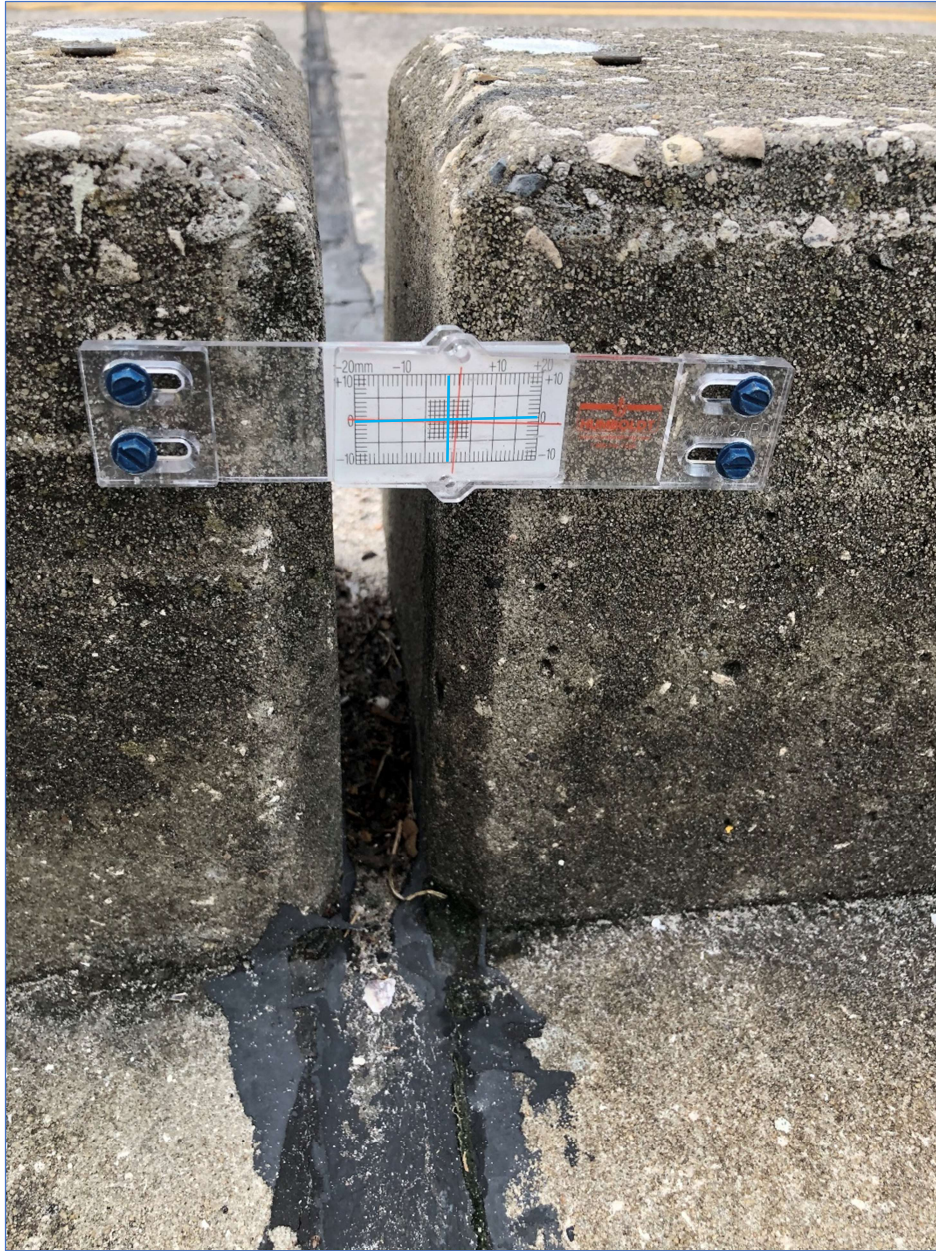
Photo 11 - Monitoring Devices at Face of Curb with Evidence of Settlement/Rotation

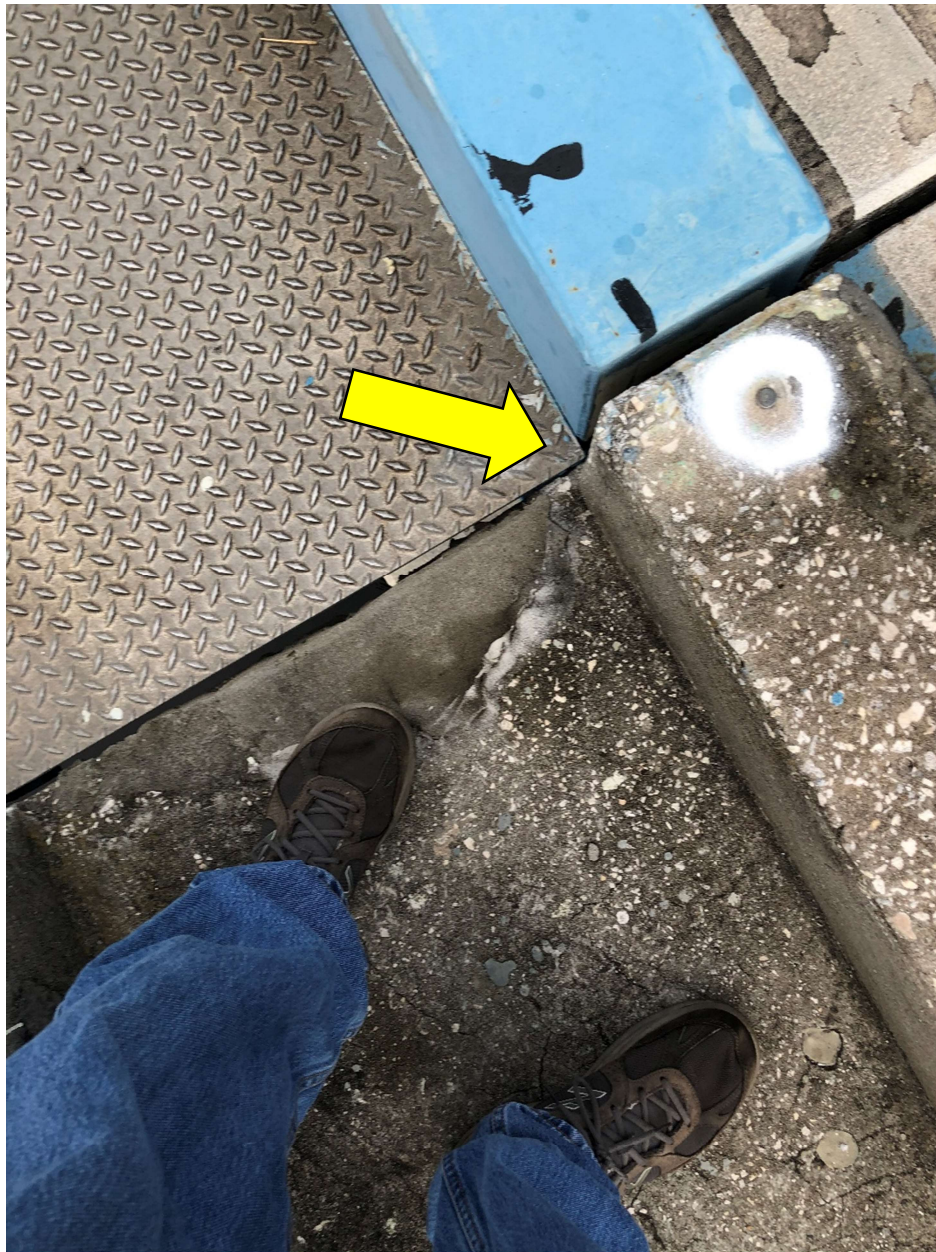
Photo 14 Sidewalk Joint at Bascule Span with Evidence of Horizontal & Longitudinal Movement/Rotation

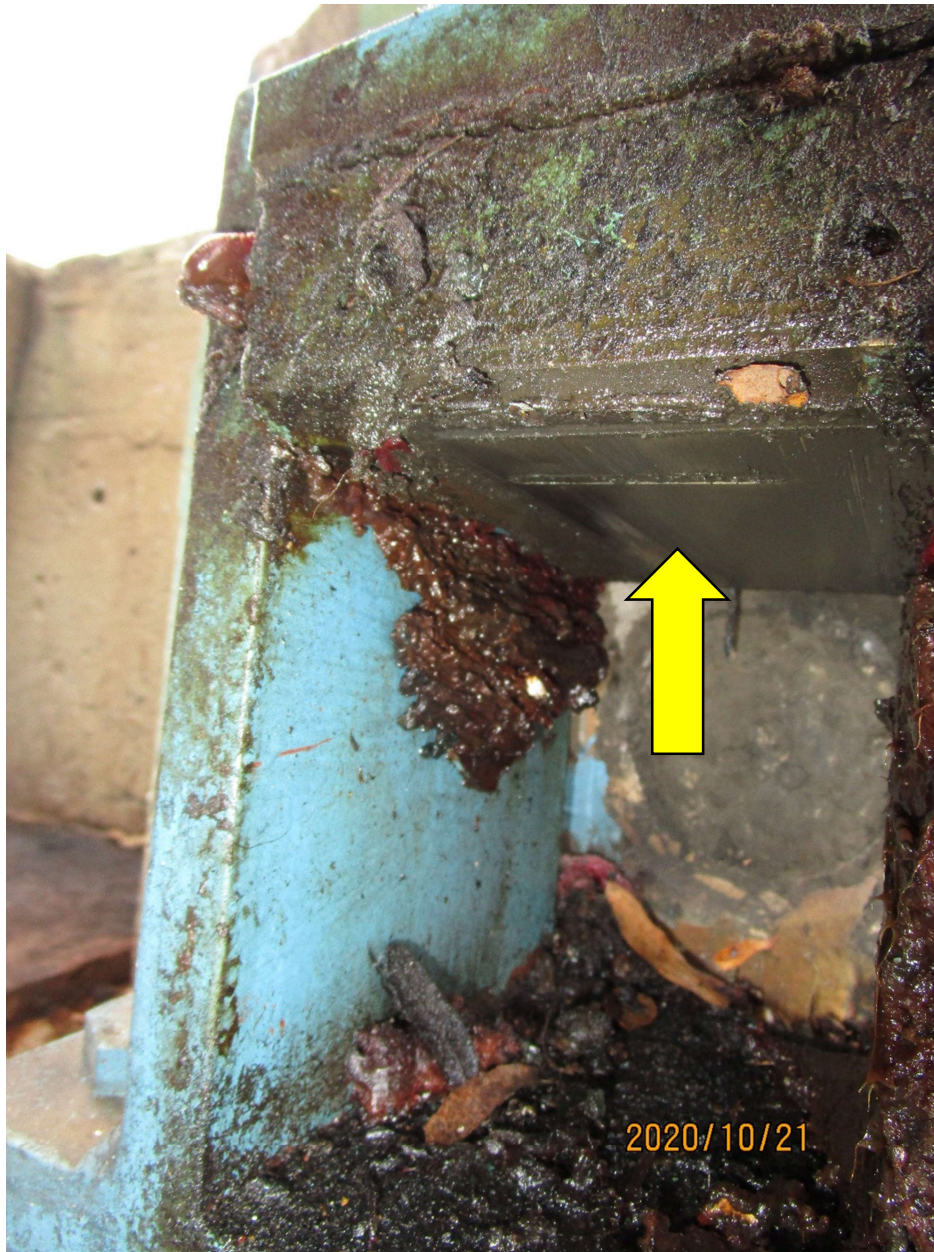
Photo 16 - Span Lock Receiver with Evidence of Tight Contact with Lock Bar from Rest Pier Settlement

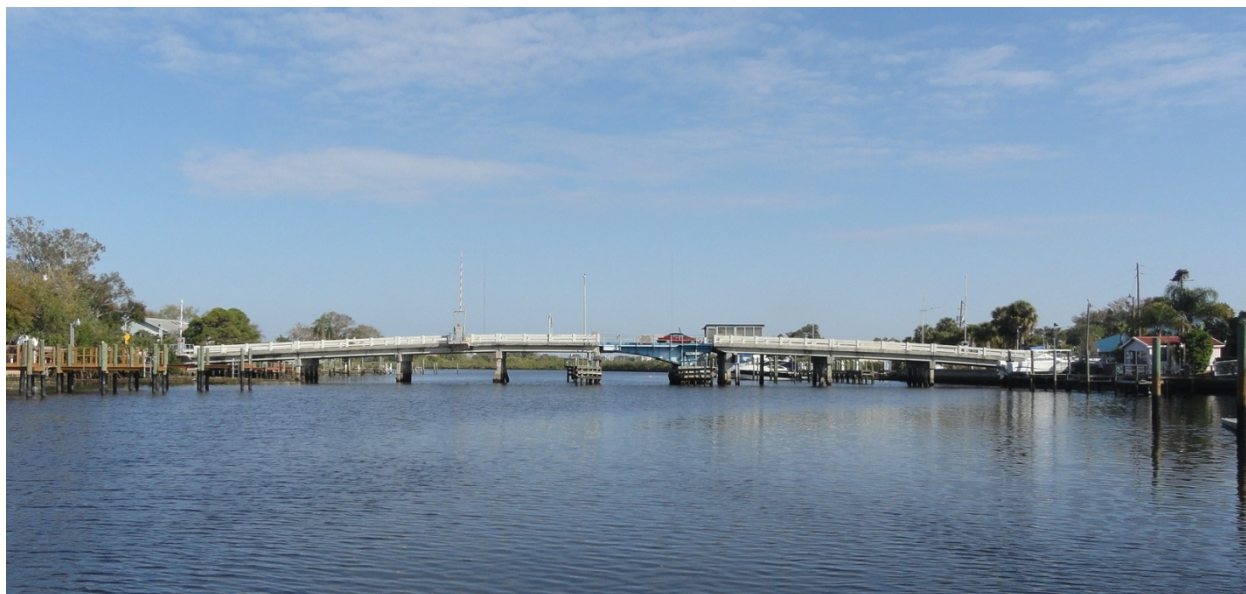
Beckett Bridge – Elevation View

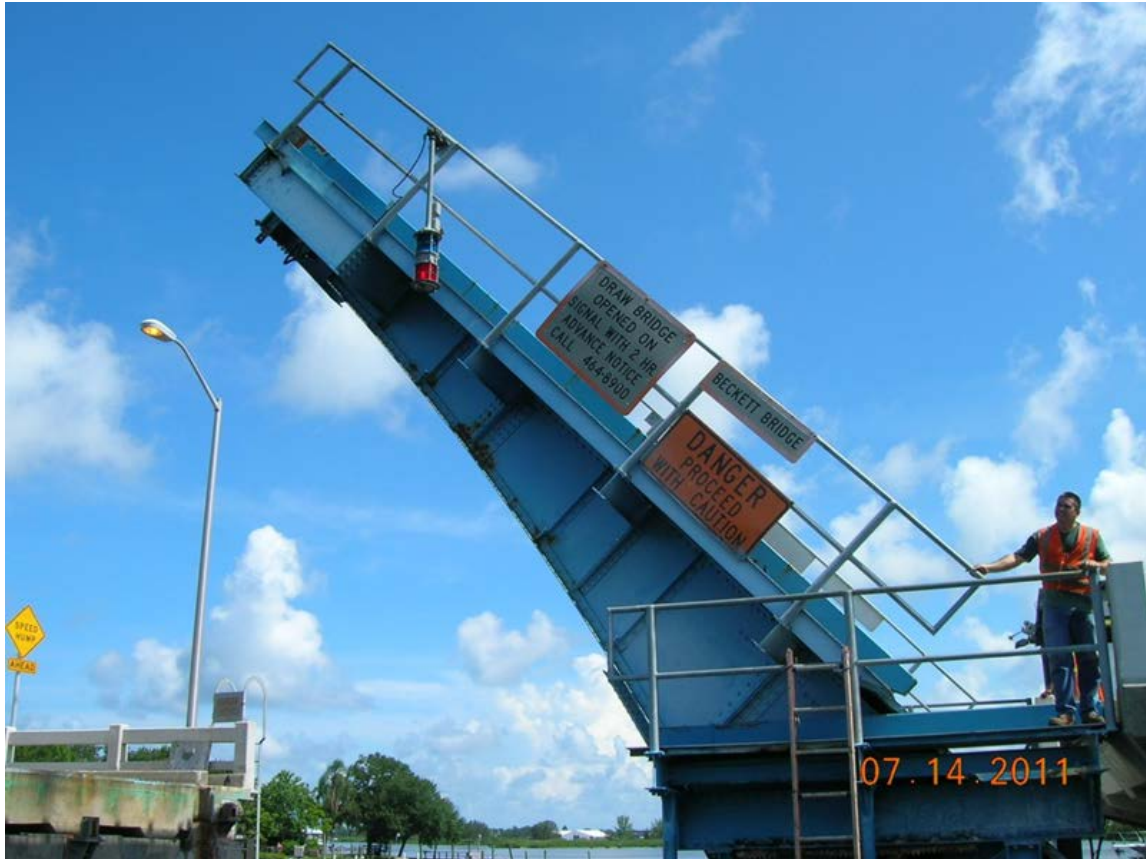
Bascule Leaf in Full Open Position

There are no official USCG navigational clearance guidelines for this waterway at this location. The existing vertical clearance at the fenders is six feet. The tip of the bascule leaf overhangs the fender with the leaf fully raised, limiting the clearance for a portion of the channel between the fenders. It is likely that unlimited vertical clearance was provided for the entire width of the channel when the bridge was originally constructed. The existing horizontal clearance between the fenders is 25 feet.

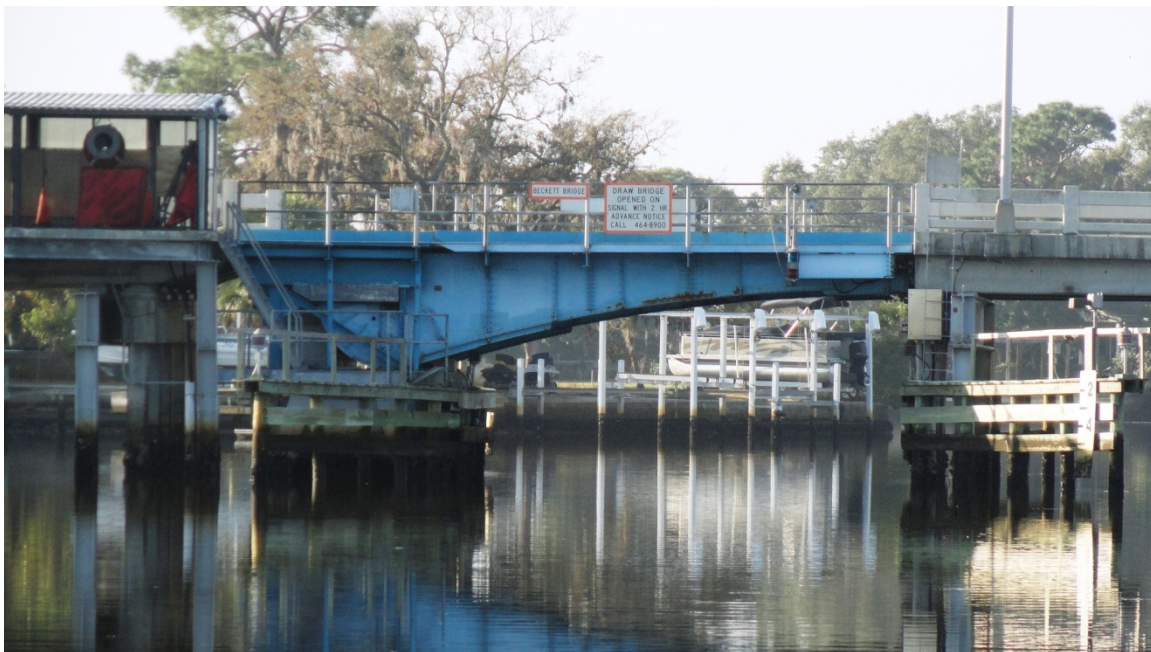
Bascule Leaf in Closed Position

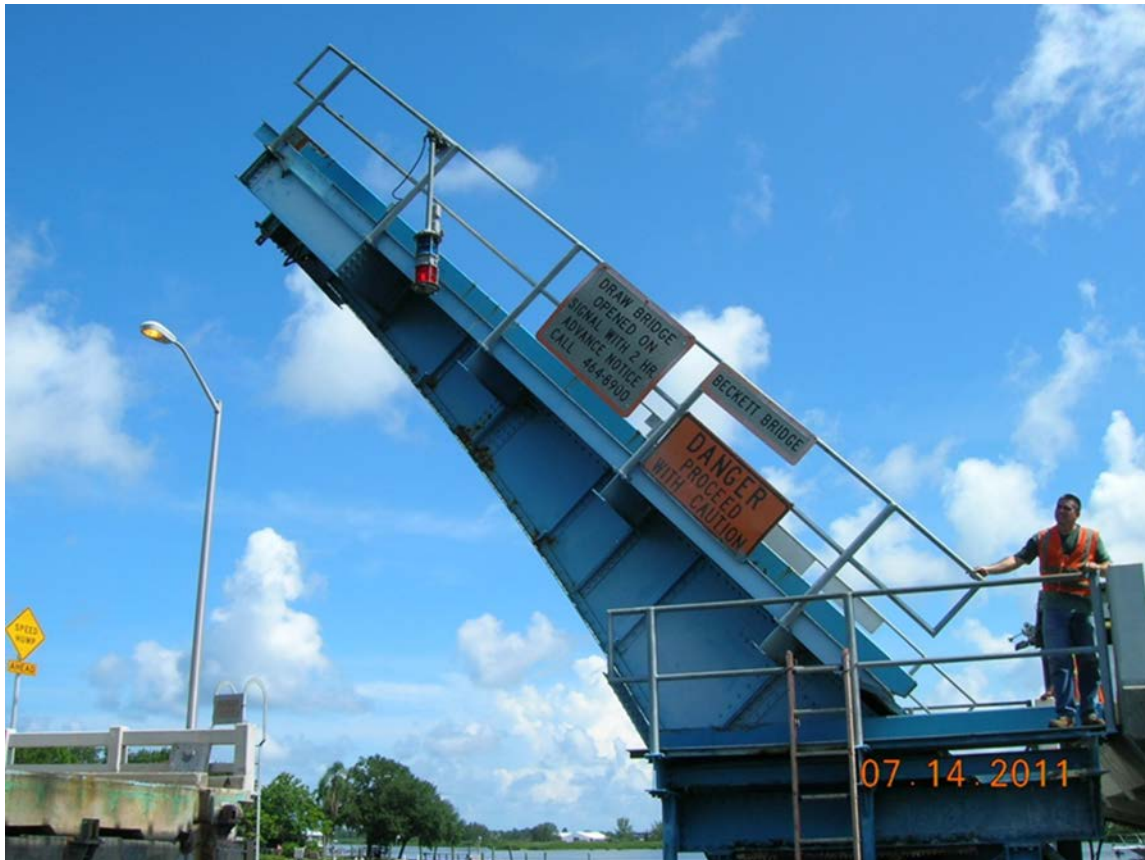
The existing bascule bridge crosses Whitcomb Bayou approximately perpendicular to the channel. Waterborne vessels are guided between the bascule piers by a fender system consisting of timber rub rails attached to driven timber piles. Navigation lights mounted to the fender system and the bascule leaf provides a warning indication. The channel has a minimum horizontal width of 25 feet between faces of fenders. When the bascule leaf is in the closed position there is approximately six feet of vertical clearance at the face of the east fender for the entire width of the channel. When the bridge opens, the leaf rolls away from the channel and rotates to a 49 degree angle. In this open position the bridge provides unlimited vertical only between the west fender and the tip of the span of approximately 14 feet. The remaining 11 feet of the channel is obstructed by the raised bascule span.

Bascule Leaf in Full Open Position – Unlimited Clearance Restricted

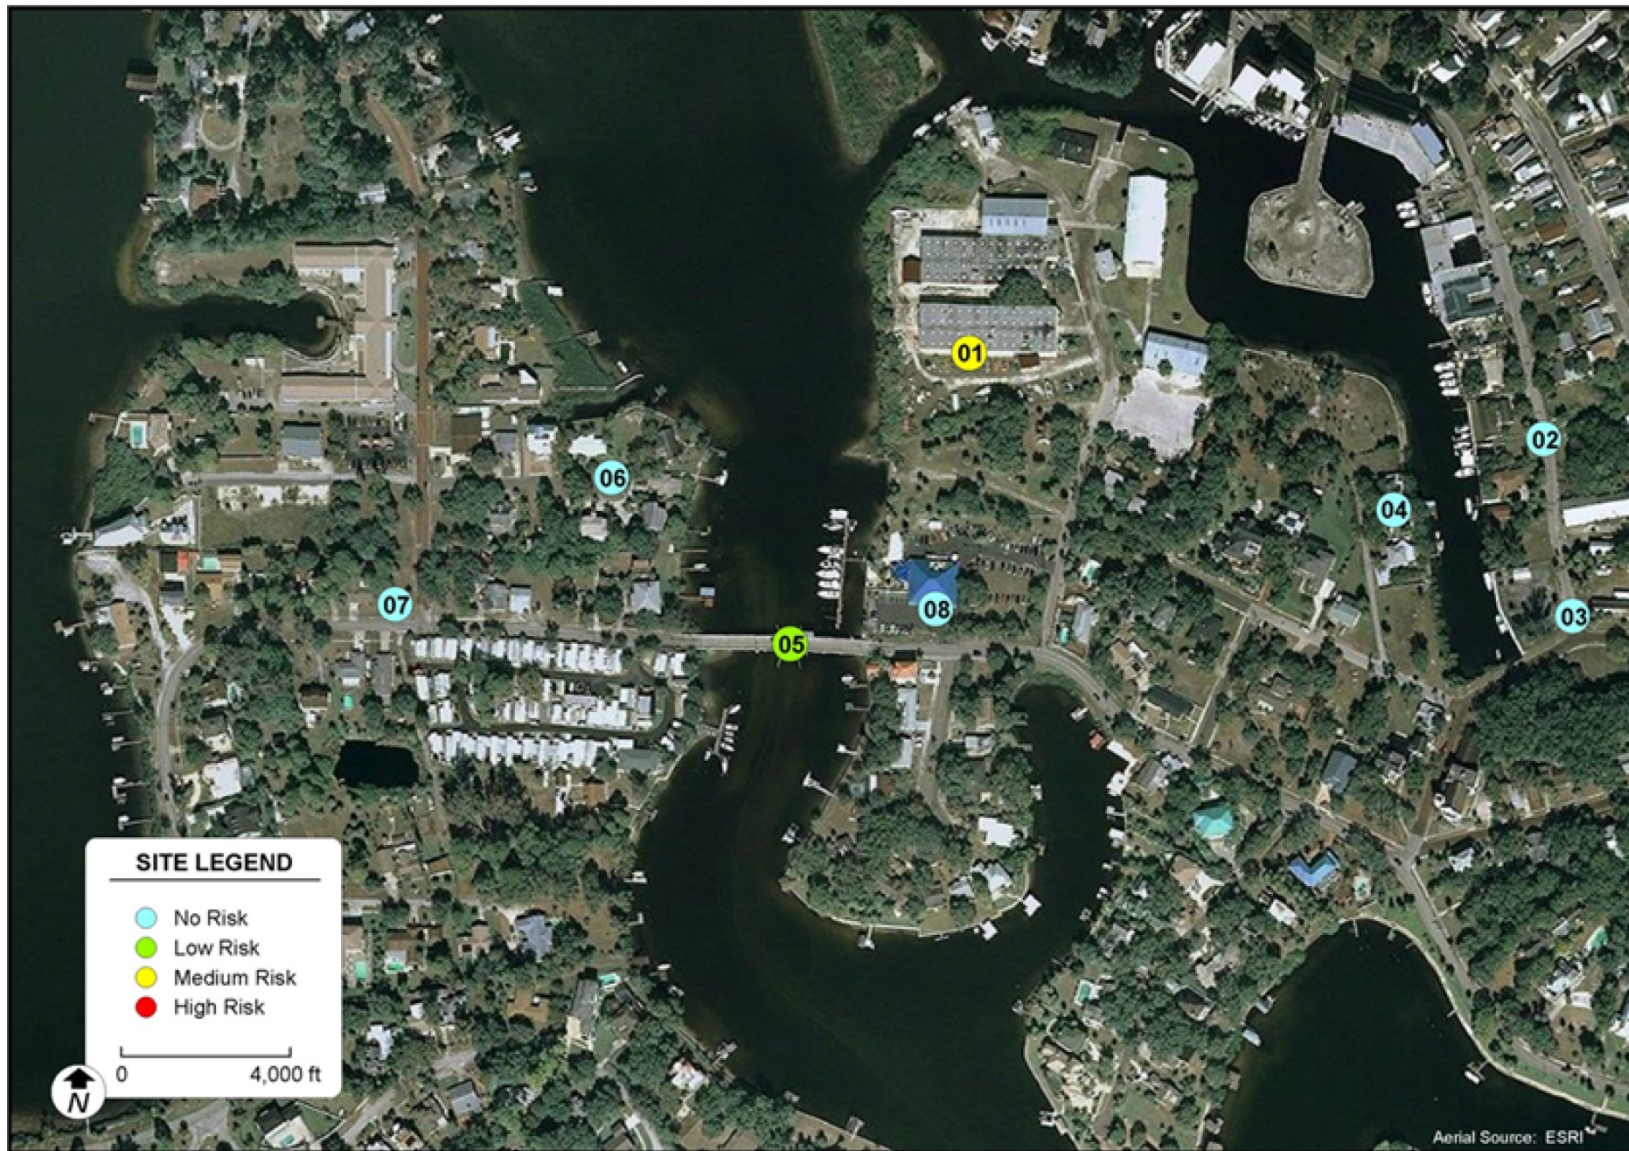
Figure 3-8 – Potentially Contaminated Sites

Consistent with the guidance provided by FDOT and FHWA, and based on environmental records searches, land use surveys, field surveys and other screening methodologies cited within the PD&E manual, eight potential contamination sites were identified within the vicinity of the project corridor. The location of these sites is shown on **Figure 3-8** and described in **Table 3-6**. Of the eight sites, six were identified as "No" contamination risk, one was identified as "Low" contamination risk, and one was identified as "Medium" contamination risk. Accordingly, no further evaluation of these sites is recommended during the design phase of the project unless changes are made to the project design that could potentially change the location or alignment of the bridge.

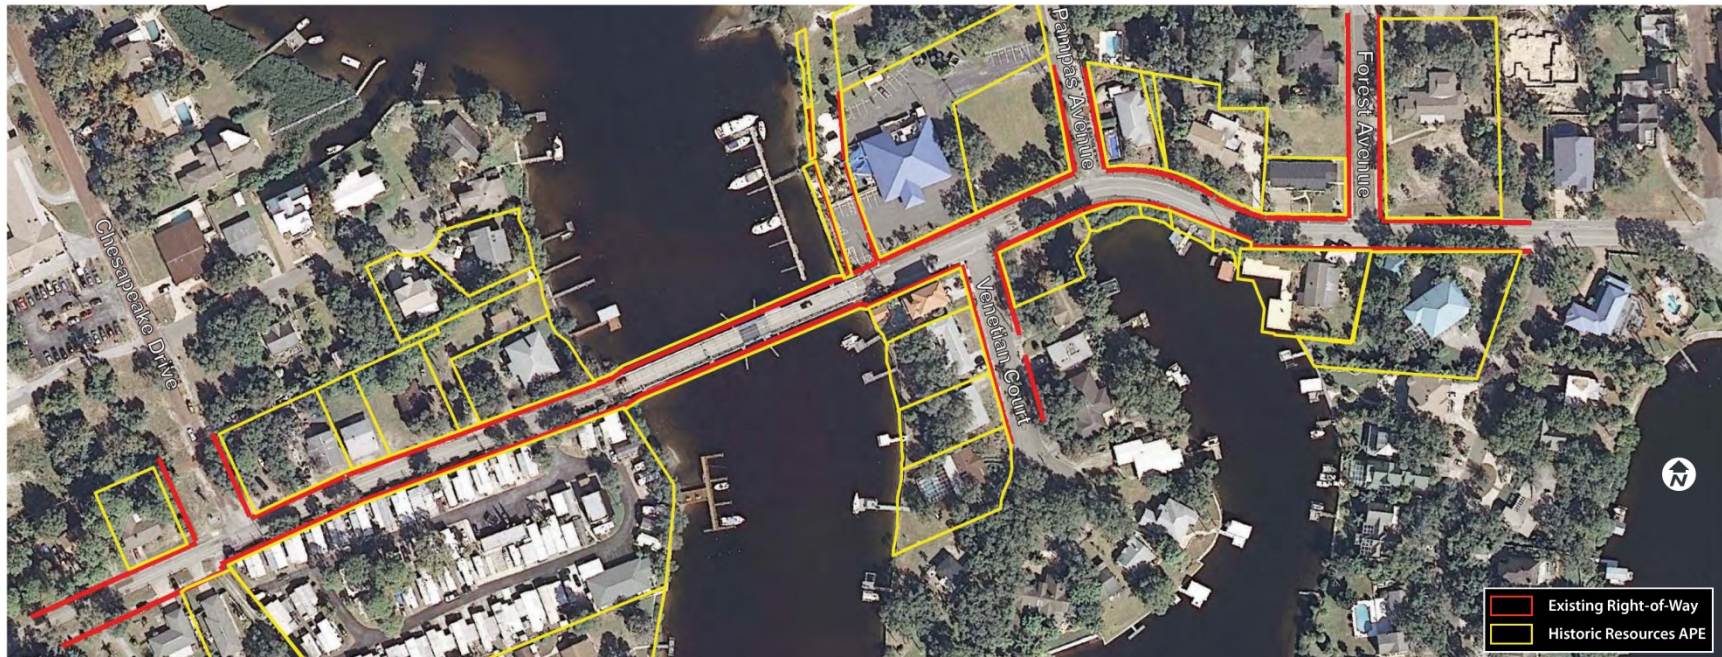
Figure 3-9 – Proposed Historic Resources Area of Potential Effect (APE)

The APE was determined by evaluating the improvements that may be implemented as part of the bridge construction. The improvements under consideration may range from rehabilitation of the existing bridge to the construction of a 28 foot high fixed bridge. The determination also considered the surrounding character of the area and the existing facilities found throughout the corridor. Additionally, a detour would be required for removal of the existing bridge, rehabilitation or replacement alternatives. The proposed detour plan was considered when determining the limits of the APE. The proposed APE for historic and archaeological resources is shown on **Figures 3-9 and 3-10**. The APE was reviewed and approved by FHWA and State Historic Preservation Officer (SHPO) by letter dated March 27, 2012, which is included in **Appendix F**.

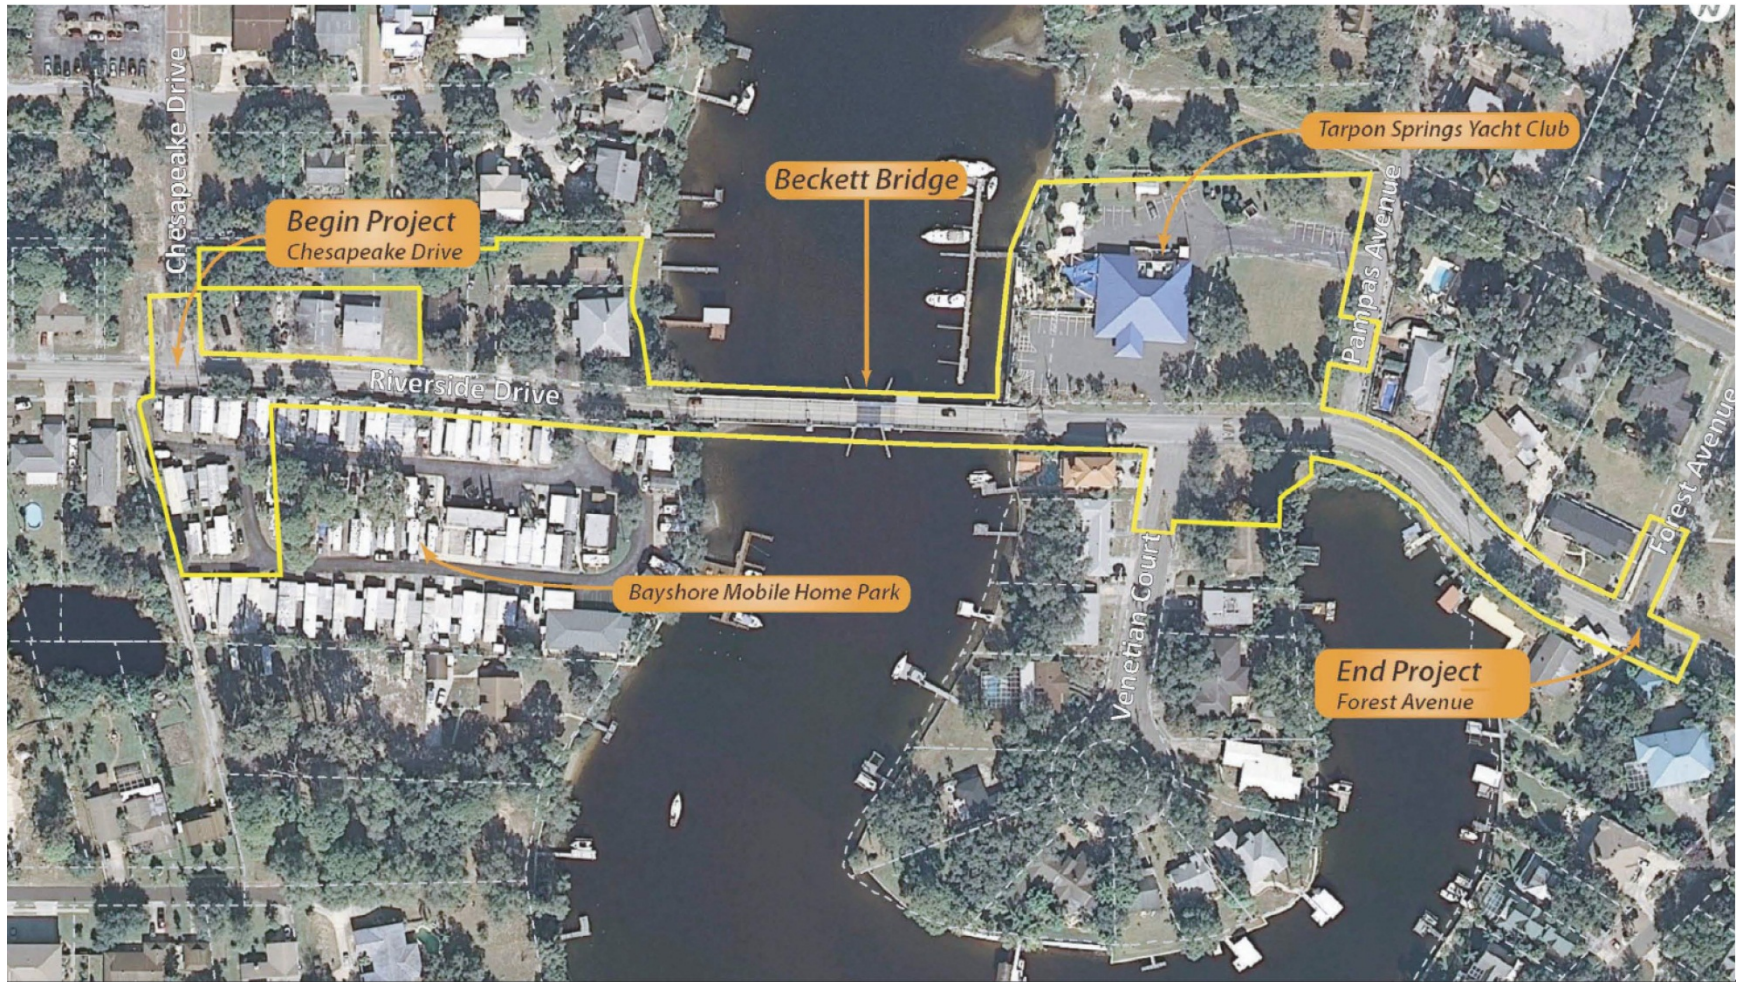
Figure 3-10 – Proposed Archaeological Resources Area of Potential Effect (APE)

The APE for historic resources includes any historic properties adjacent to the current roadway and any new proposed right of way acquisitions beginning at Chesapeake Drive and ending at Forest Avenue. This APE provides appropriate coverage for the alternatives related directly to Beckett Bridge PD&E project. In regard to the mid-level fixed bridge alternative that is being studied, the APE includes properties along the riverfront that can physically be seen from a reasonable distance in order to address any viewshed/visual effects. This APE extends two to four parcels on either side of the current bridge location on both sides of the bayou.

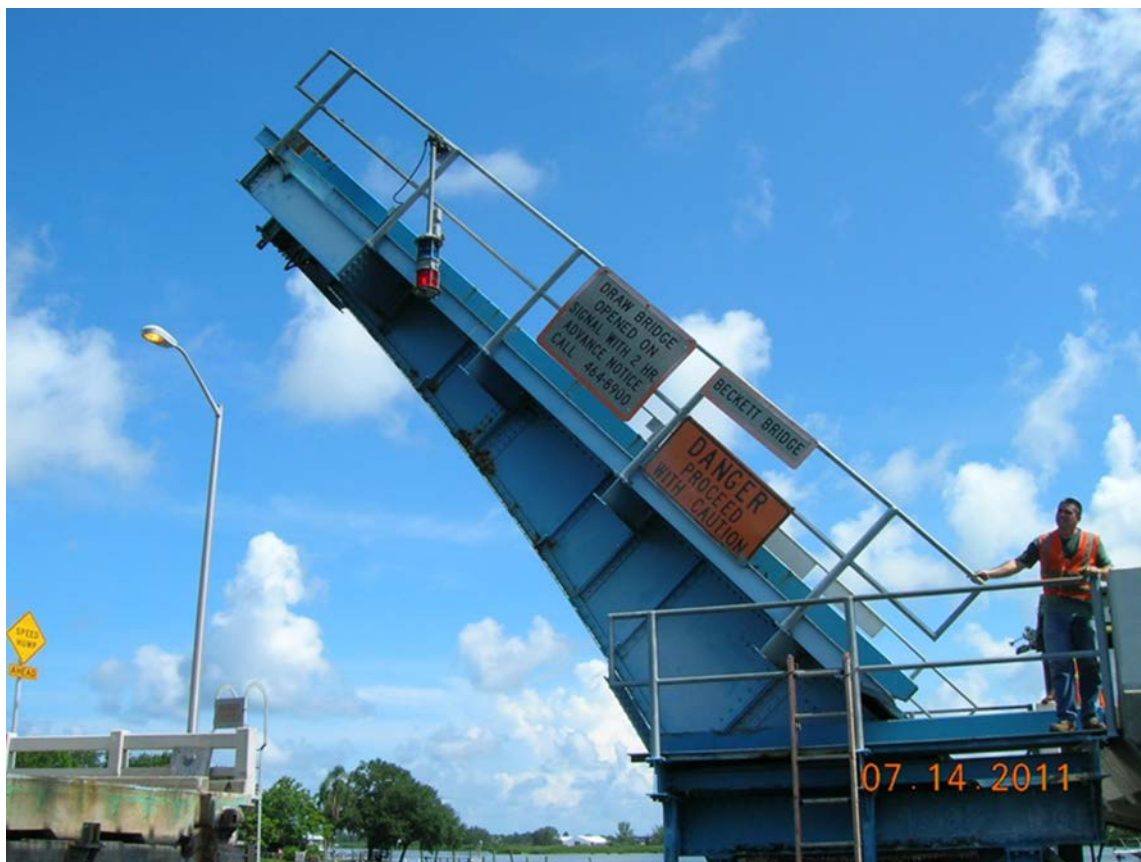
The existing bascule bridge crosses Whitcomb Bayou approximately perpendicular to the channel. Waterborne vessels are guided between the bascule piers by a fender system consisting of timber rub rails attached to driven timber piles. Navigation lights mounted to the fender system and the bascule leaf provides a warning indication. The channel has a minimum horizontal width of 25 feet between faces of fenders. When the bascule leaf is in the closed position there is approximately six feet of vertical clearance at the face of the east fender for the entire width of the channel. When the bridge opens, the leaf rolls away from the channel and rotates to a 49 degree angle. In this open position the bridge provides unlimited vertical only between the west fender and the tip of the span of approximately 14 feet. The remaining 11 feet of the channel is obstructed by the raised bascule span.

Bascule Leaf in Full Open Position – Unlimited Clearance Restricted

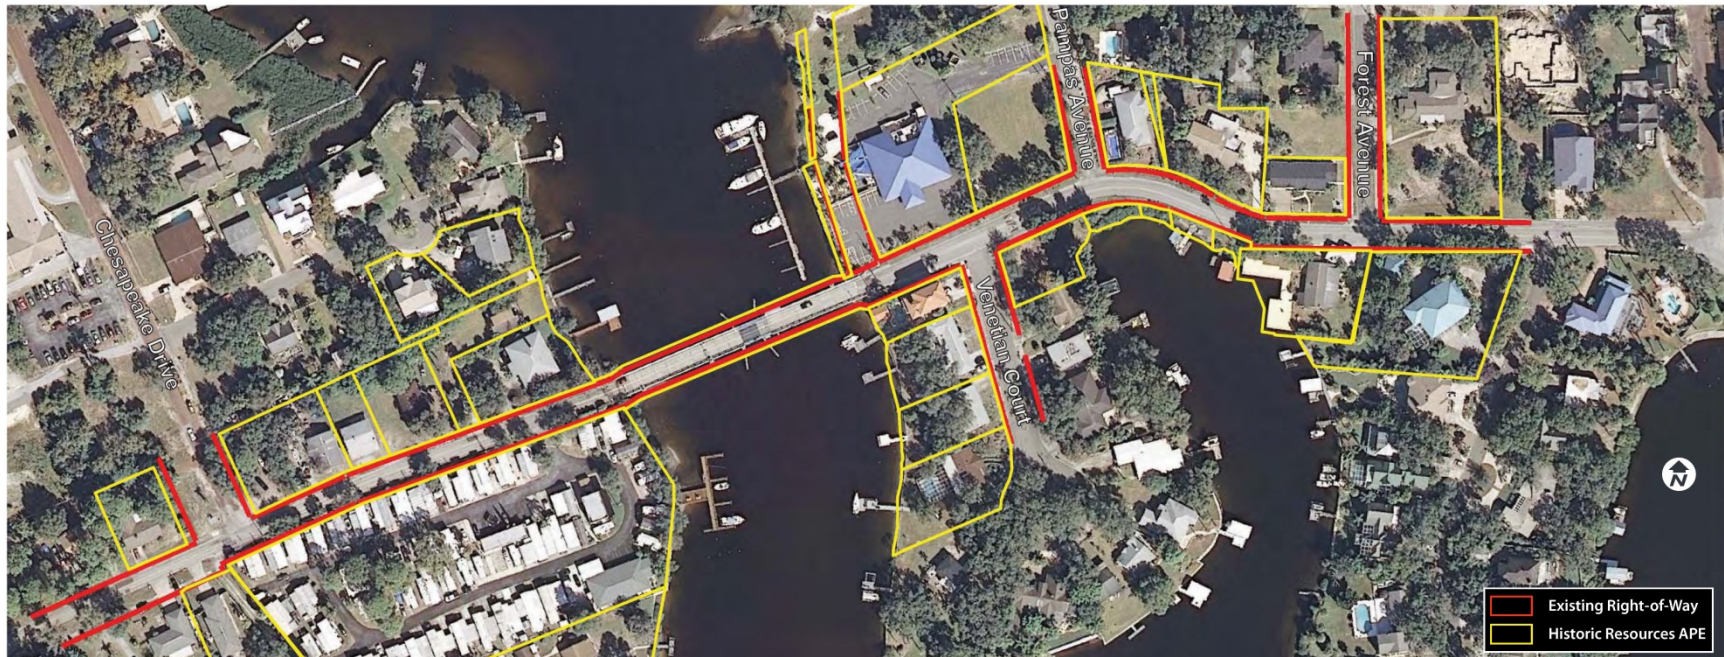
Figure 3-9 – Proposed Historic Resources Area of Potential Effect (APE)

The APE was determined by evaluating the improvements that may be implemented as part of the bridge construction. The improvements under consideration may range from rehabilitation of the existing bridge to the construction of a 28 foot high fixed bridge. The determination also considered the surrounding character of the area and the existing facilities found throughout the corridor. Additionally, a detour would be required for removal of the existing bridge, rehabilitation or replacement alternatives. The proposed detour plan was considered when determining the limits of the APE. The proposed APE for historic and archaeological resources is shown on **Figures 3-9 and 3-10**. The APE was reviewed and approved by FHWA and State Historic Preservation Officer (SHPO) by letter dated March 27, 2012, which is included in **Appendix F**.
