Beckett Bridge Replacement Tarpon Springs, FL

E. Technical Documents

Bridge Investment Program (BIP)
Grant Application

Technical Memorandum

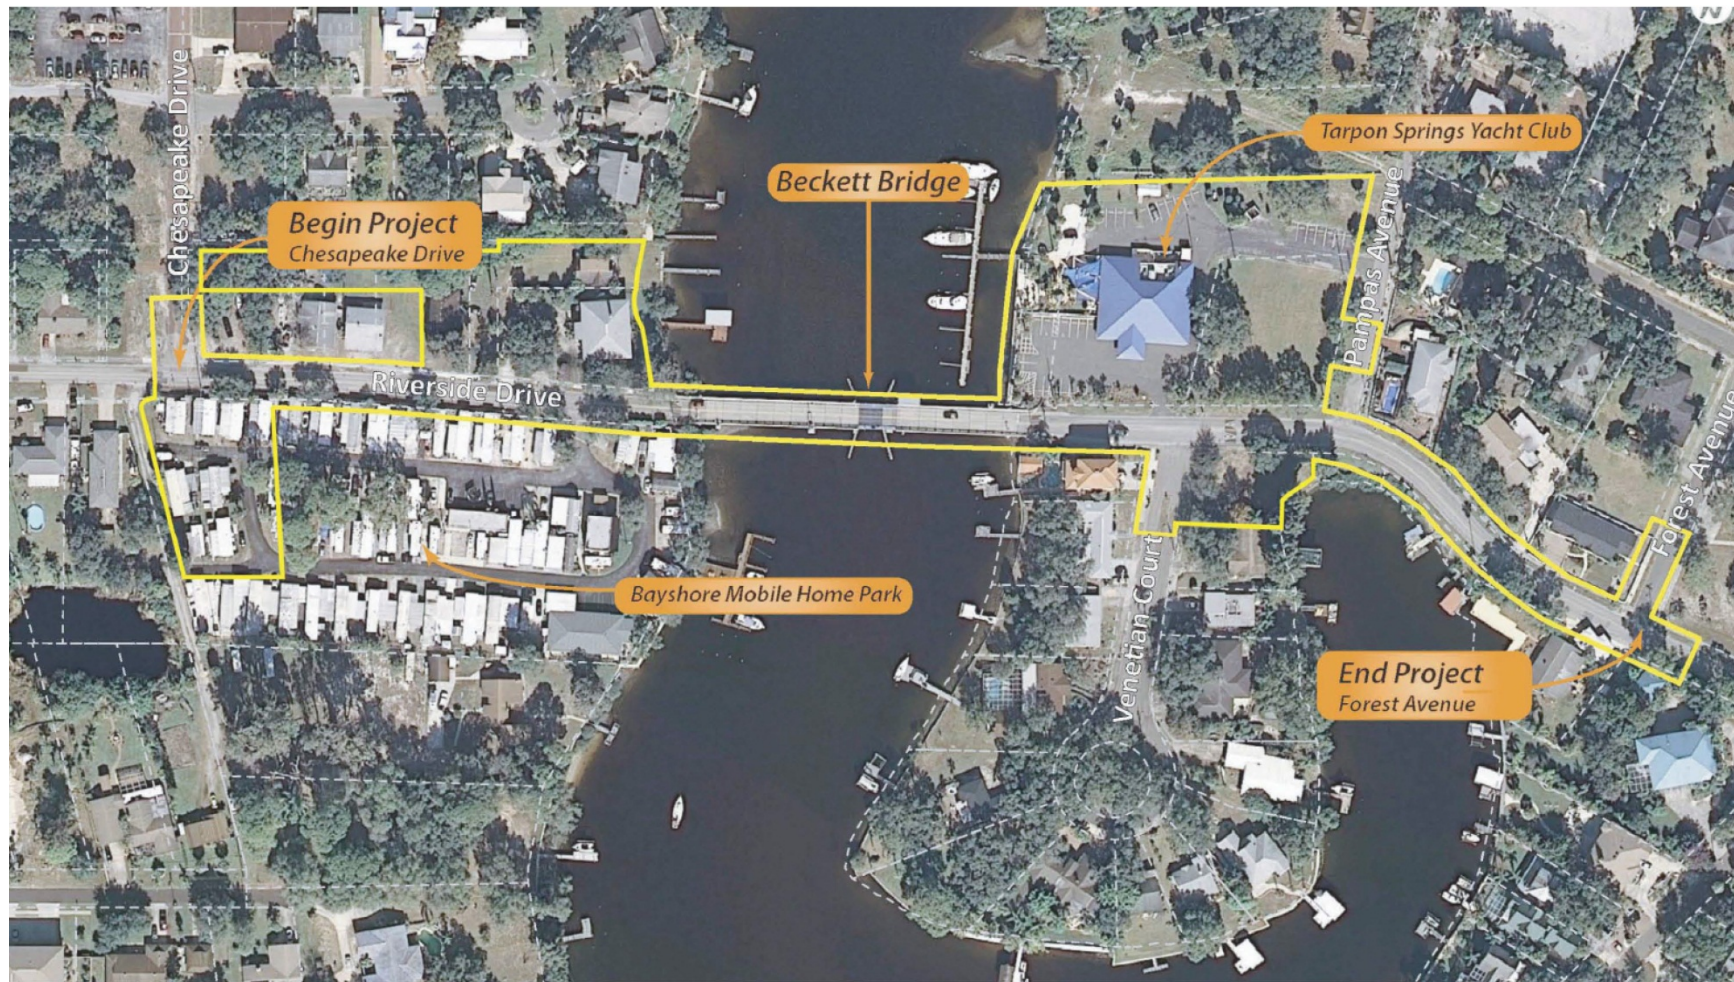
Figure 3-10 – Proposed Archaeological Resources Area of Potential Effect (APE)

The APE for historic resources includes any historic properties adjacent to the current roadway and any new proposed right of way acquisitions beginning at Chesapeake Drive and ending at Forest Avenue. This APE provides appropriate coverage for the alternatives related directly to Beckett Bridge PD&E project. In regard to the mid-level fixed bridge alternative that is being studied, the APE includes properties along the riverfront that can physically be seen from a reasonable distance in order to address any viewshed/visual effects. This APE extends two to four parcels on either side of the current bridge location on both sides of the bayou.
