# Limited Wind Hardening Study Lealman Gymnasium

**5175 45th St. N.  
St. Petersburg, FL 33714**

Project No. MBAAC23005

Issue Date: September 28, 2023

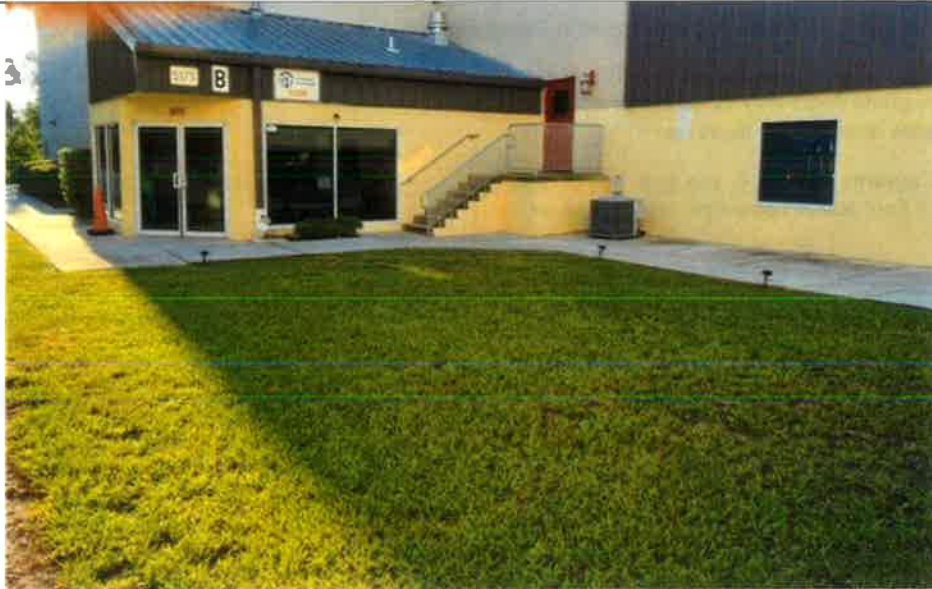
Photo One Caption: 09/21/2023 Front View Facing Southeast.

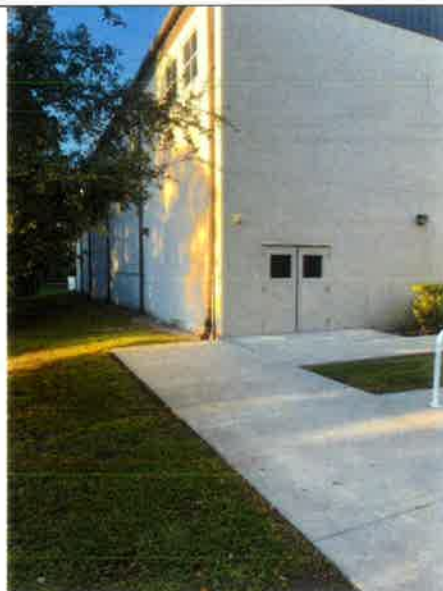
Photo Two Caption: 09/21/2023 Rear View Facing South.

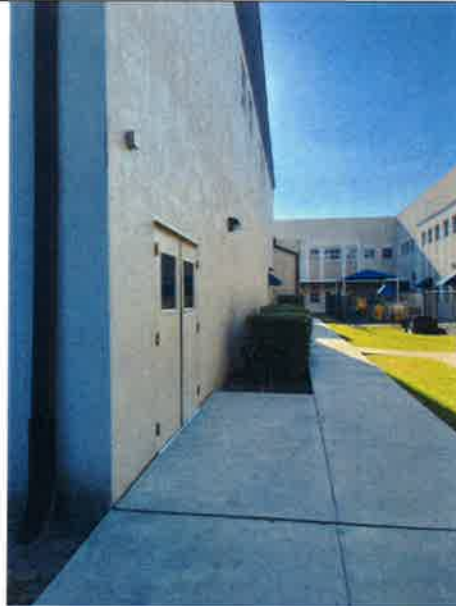
Photo Three Caption: 09/15/2023 Side View Facing West.

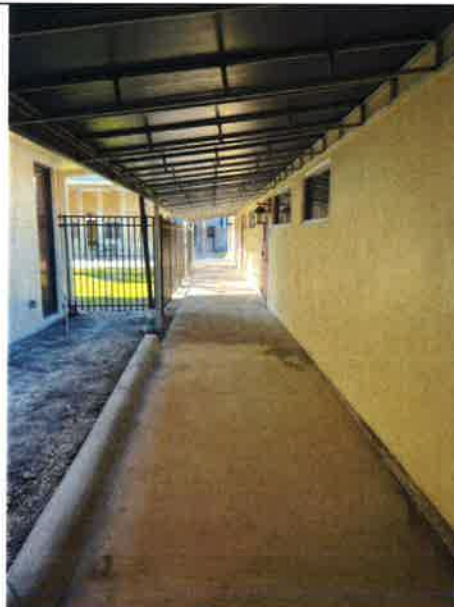
Photo Four Caption: 09/15/2023 Side View Facing North.

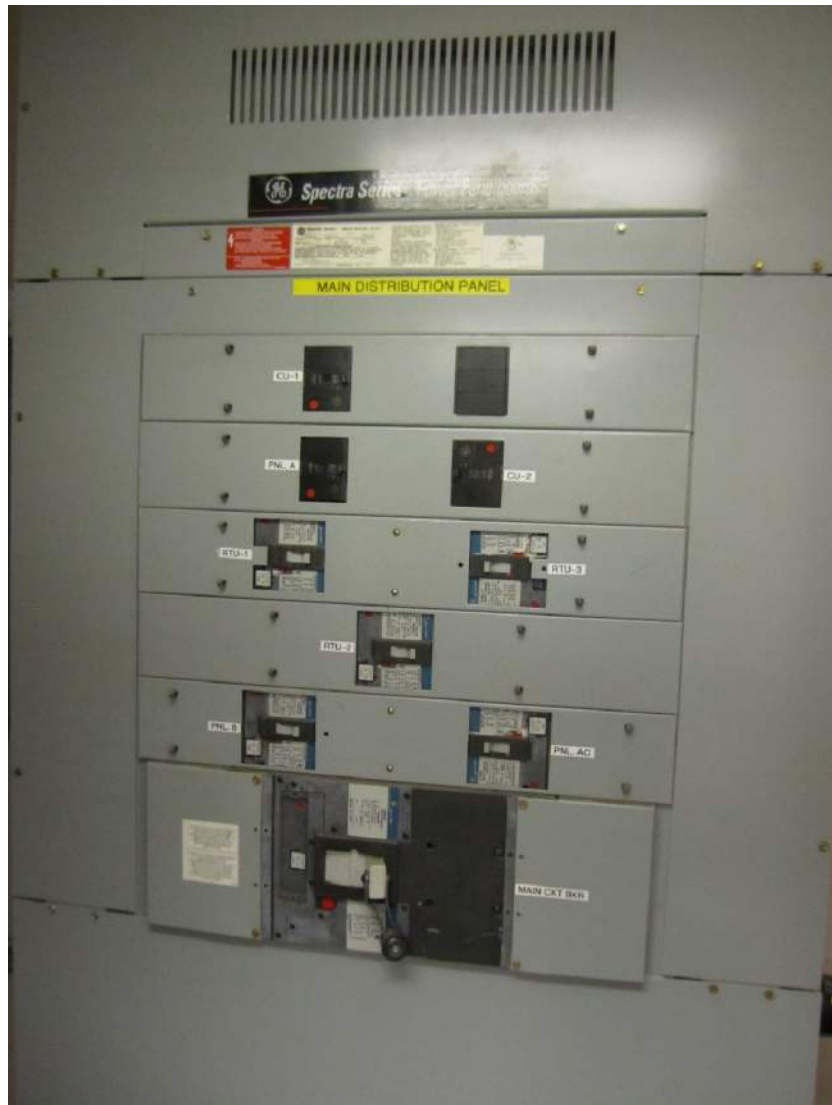
#### **GYM POWER**

Service entrance conductors and feeders were run in conduit both above grade and below grade. Above ground conduit appeared to be metallic type.

According to record drawings, it is presumed the power distribution system consists of all copper conductors.

Life safety devices are provided with battery back-up in the event normal utility power is lost.

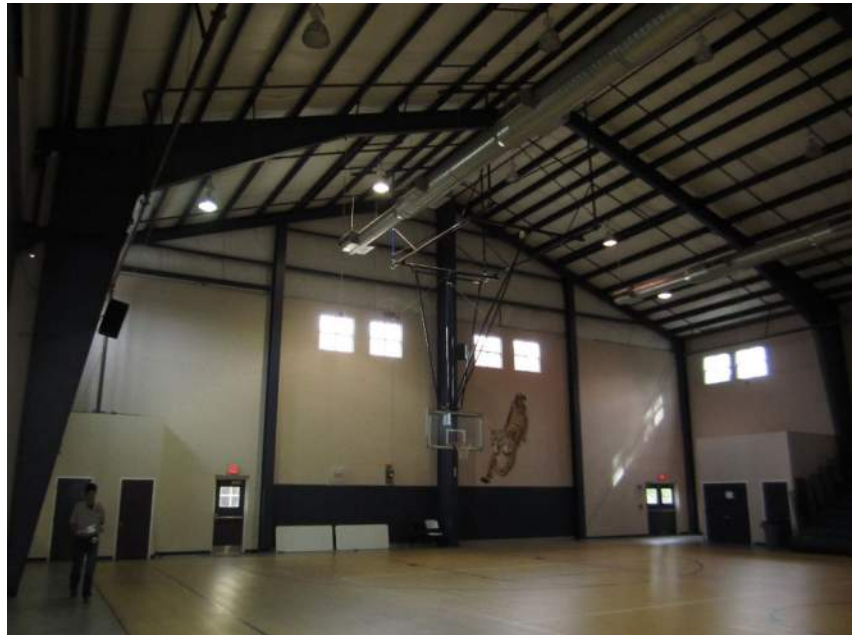
**GYM LIGHTS**

Lighting for the gym court consists of high bay, metal halide fixtures. Some of the fixtures are provided with quartz re-strike.

The building surrounds were illuminated by wall-mounted fixtures. These fixtures appeared to be fluorescent and/or incandescent type.

General interior lighting control, typically, consists of manual toggle switches within each enclosed space. There did not appear to be any automatic lighting control (i.e., occupancy sensors).

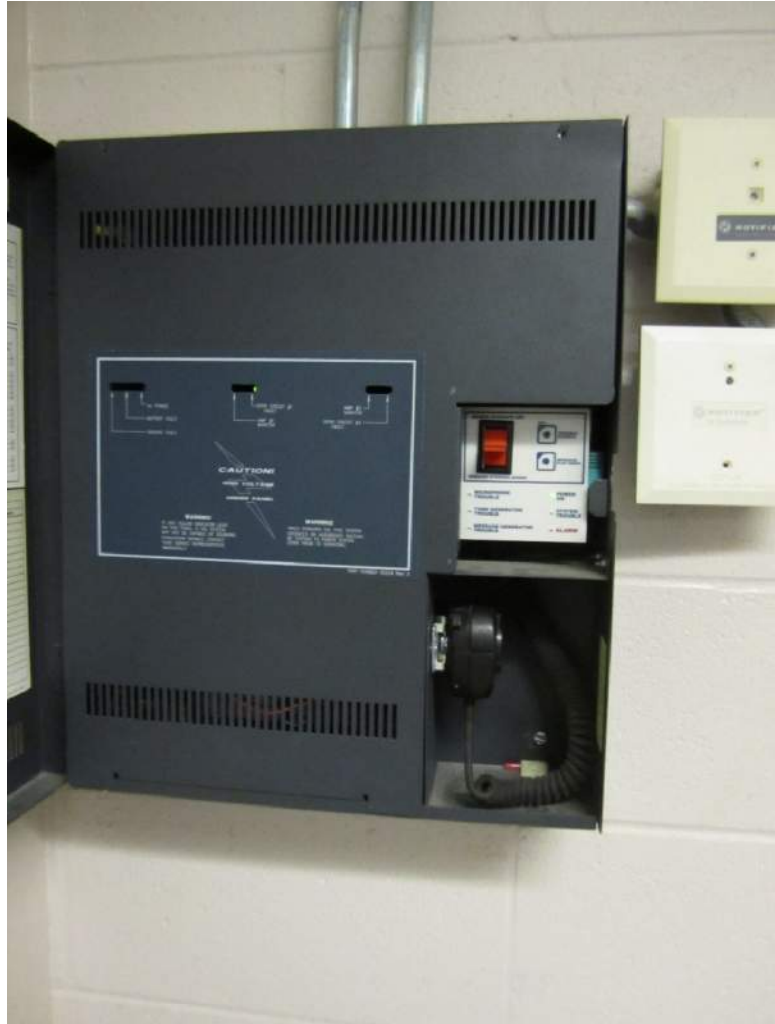
**GYM FIRE ALARM**

The existing fire alarm control panel (Notifier Model VEC-25/50) appears to be an addressable, voice evacuation system. The field devices consist of manual pull stations, speaker/strobes, spot-type smoke detectors, and heat detectors.

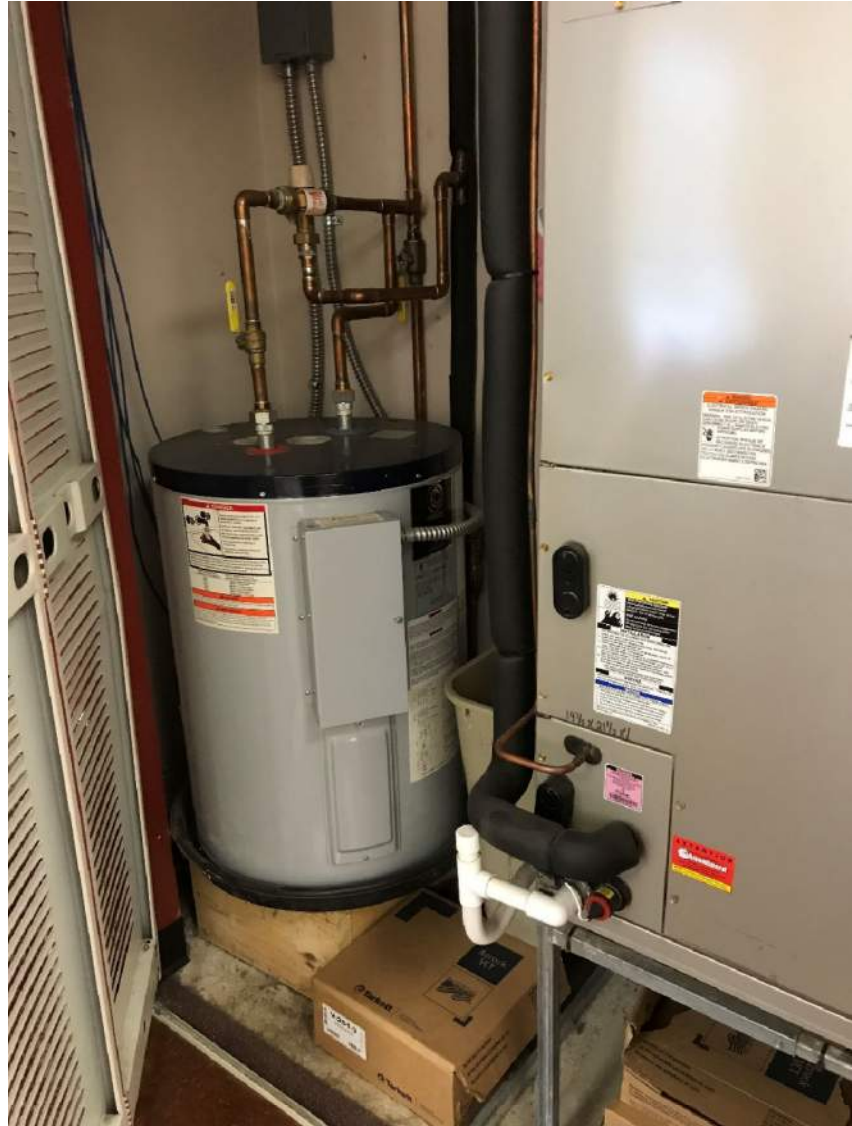
**GYM WATER HEATER**

The Gymnasium building has two 50-gallon, electric storage style water heaters that provide hot water to the entire building.

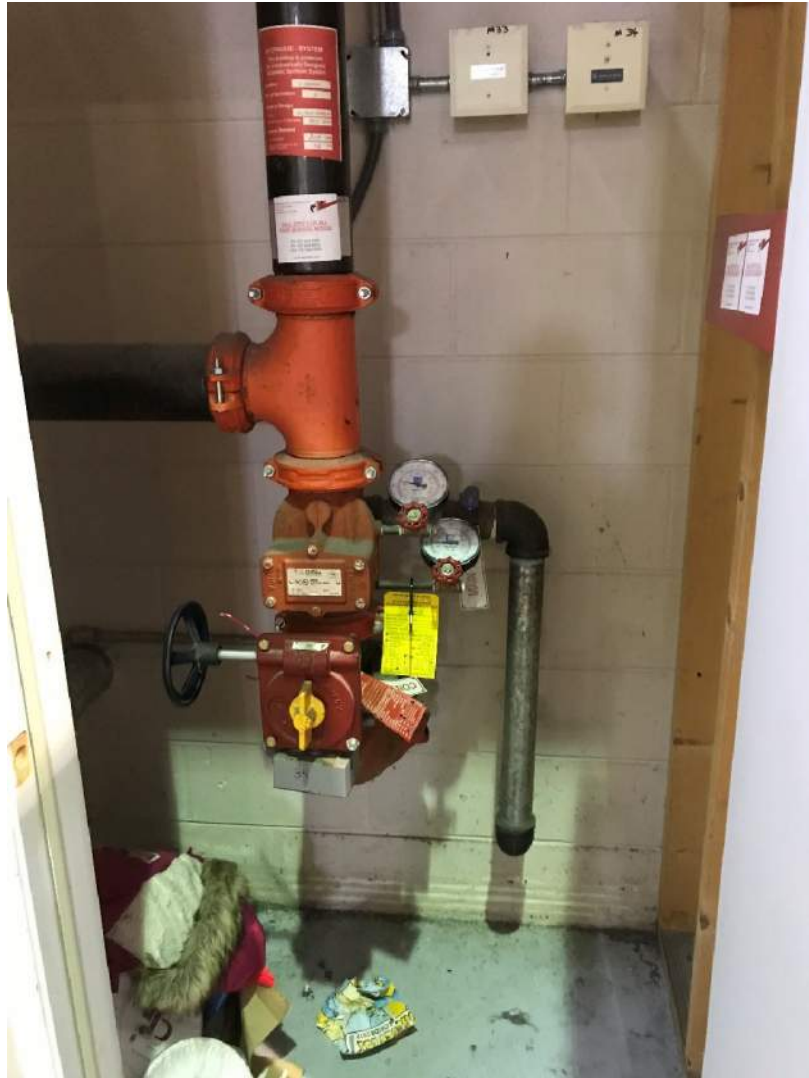
**GYM SPRINKLER RISER**

The Gymnasium is provided with a wet pipe sprinkler system riser that provides complete protection for the entire building. The single fire sprinkler riser is in a room on the north end of the building.
