# Limited Wind Hardening Study Lealman Gymnasium

**5175 45th St. N.  
St. Petersburg, FL 33714**

Project No. STHAX26009

Re- Issue Date: July 16, 2026

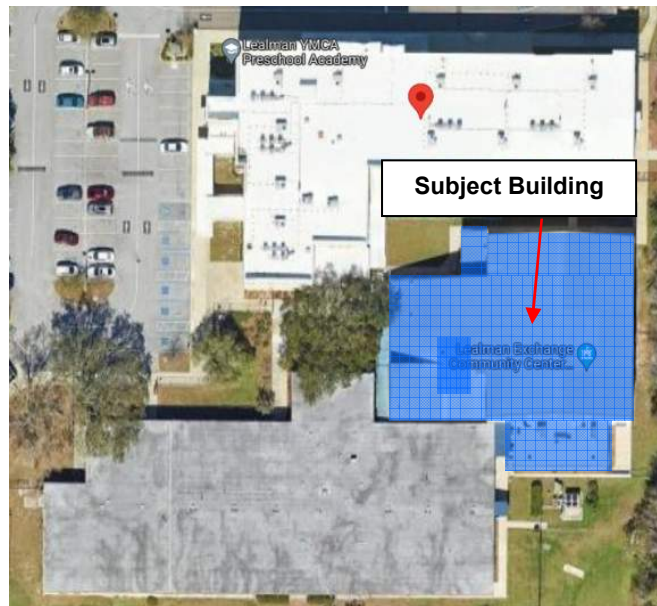
Figure 1-1 – Aerial Photograph Subject Building

Based on our review of the existing plans, the subject building is located in Pinellas County and operated as a gymnasium for Lealman Exchange School. The structure was constructed in approximately 2001 based on Pinellas County Property Appraiser records. The facility is a single-story pre-engineered metal building built on shallow concrete foundations, masonry exterior walls, pre-engineered tapered steel frames, steel roof purlins and metal roof deck. The high gable end walls of the gym are constructed of metal wall panels connected to the main building steel frames. The aerial of the building is shown in **Figure 1** below.

Field measurements were obtained of readily accessible areas of metal wall and roof panels. The panels have 4" shallow ribs with approximately ~ 1 ft spacing. The panels are estimated to be 28 gauge.

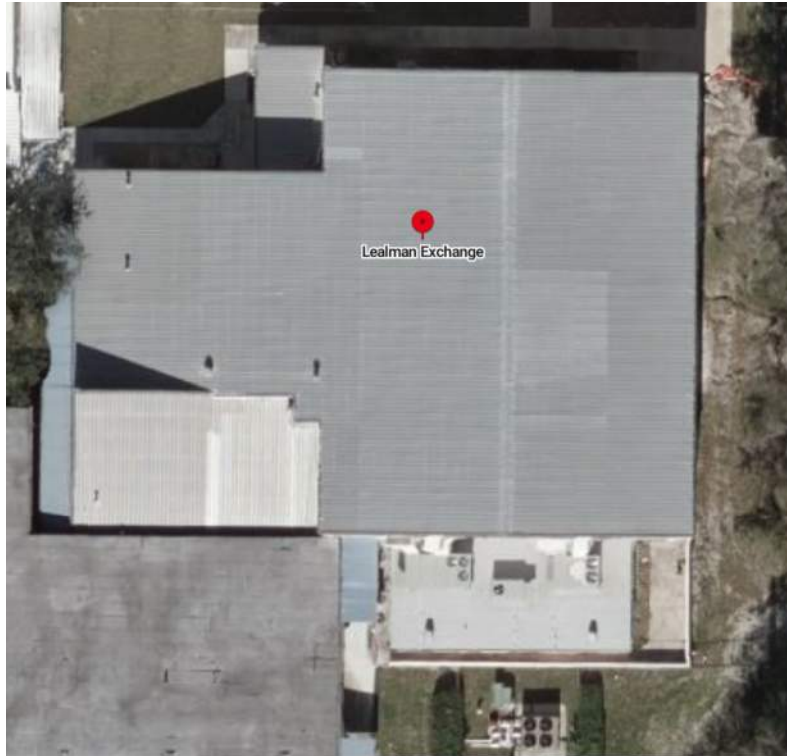
**Photograph 1 – Overall Aerial Photo (Google 2023)**

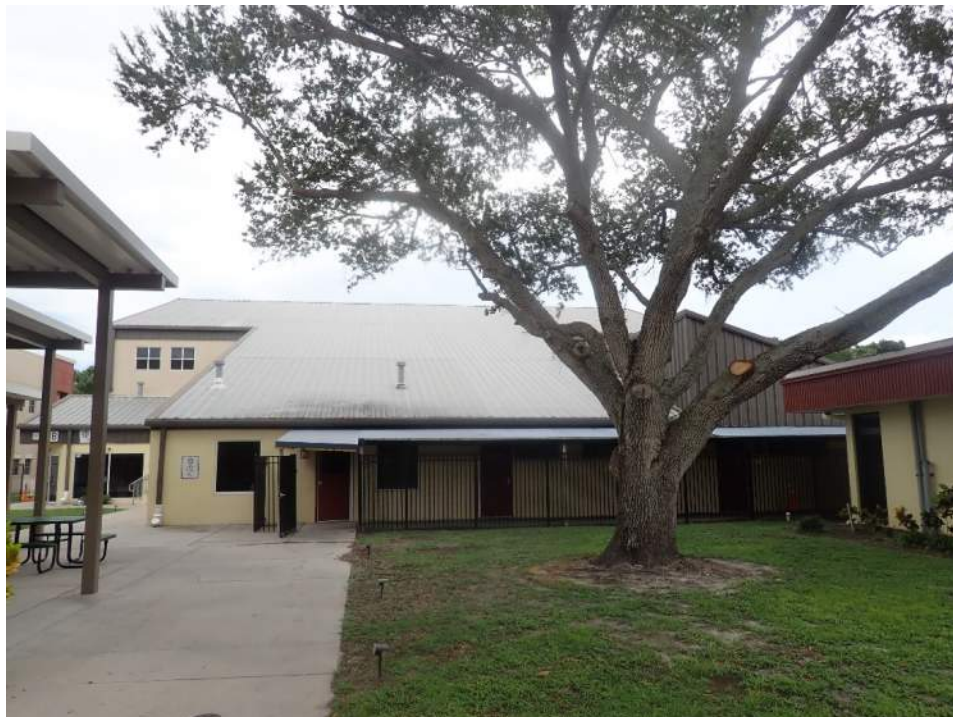
**Photograph 2 –West Elevation**

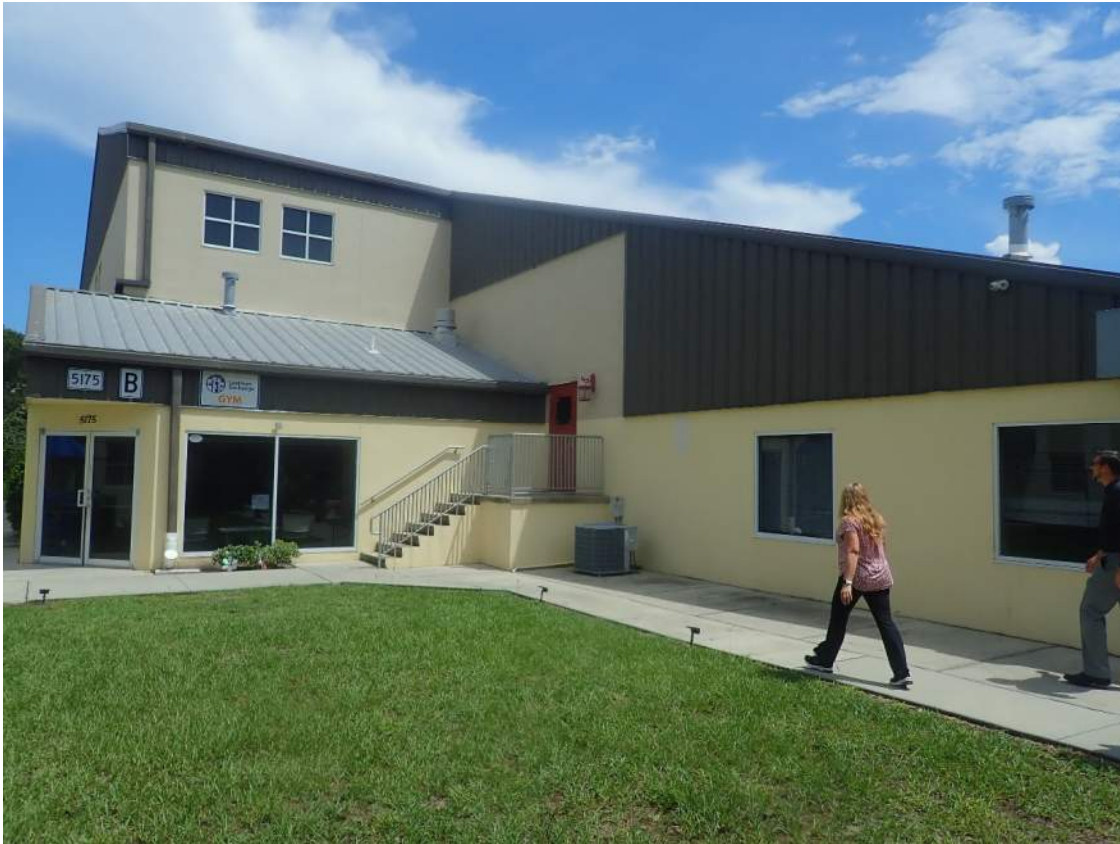
**Photograph 3 – North West Elevation**

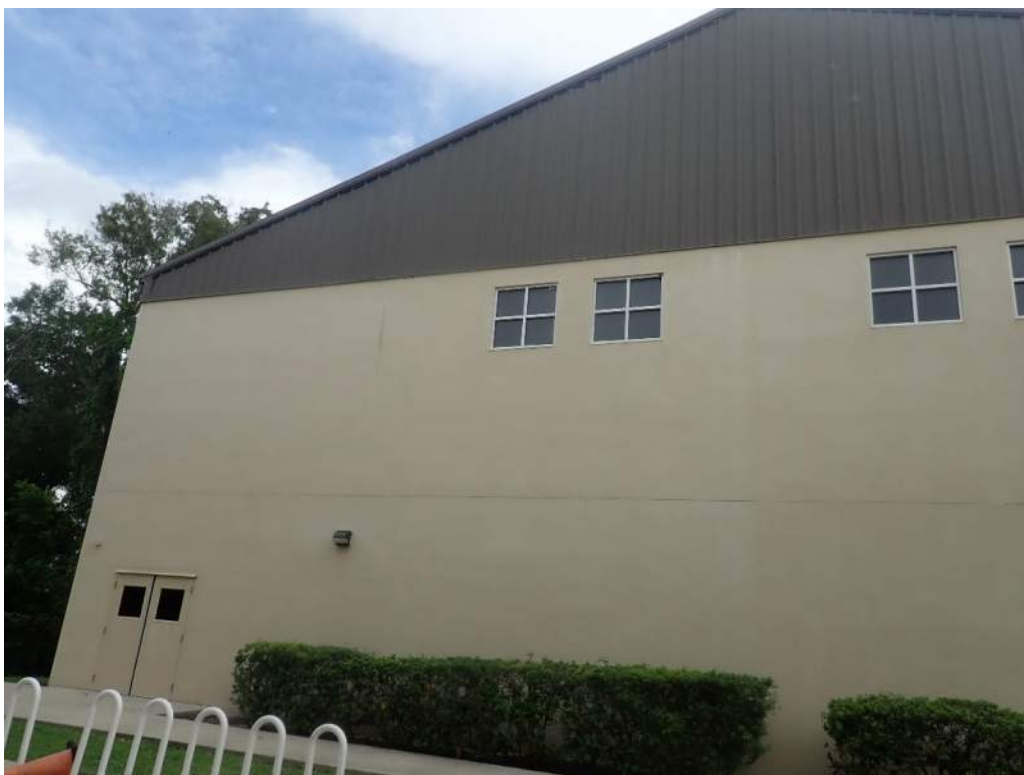
**Photograph 4 – Partial North Elevation (Left side)**

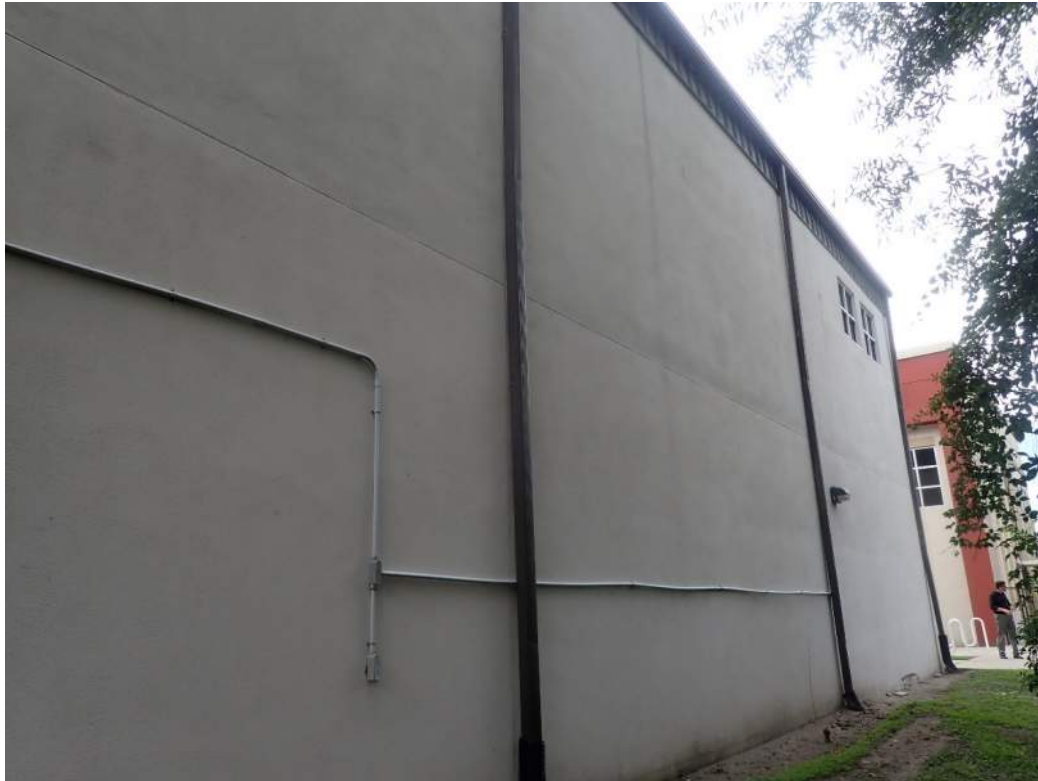
**Photograph 5 – Partial East Elevation (Right side)**

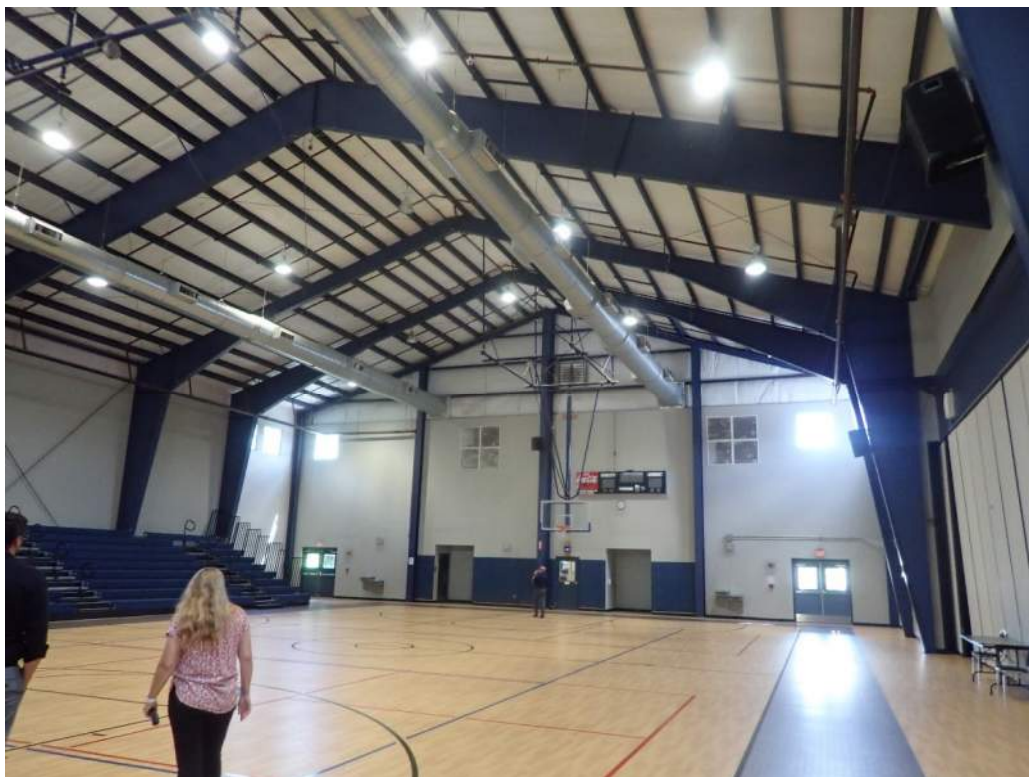
**Photograph 6 – Interior View of Gymnasium**

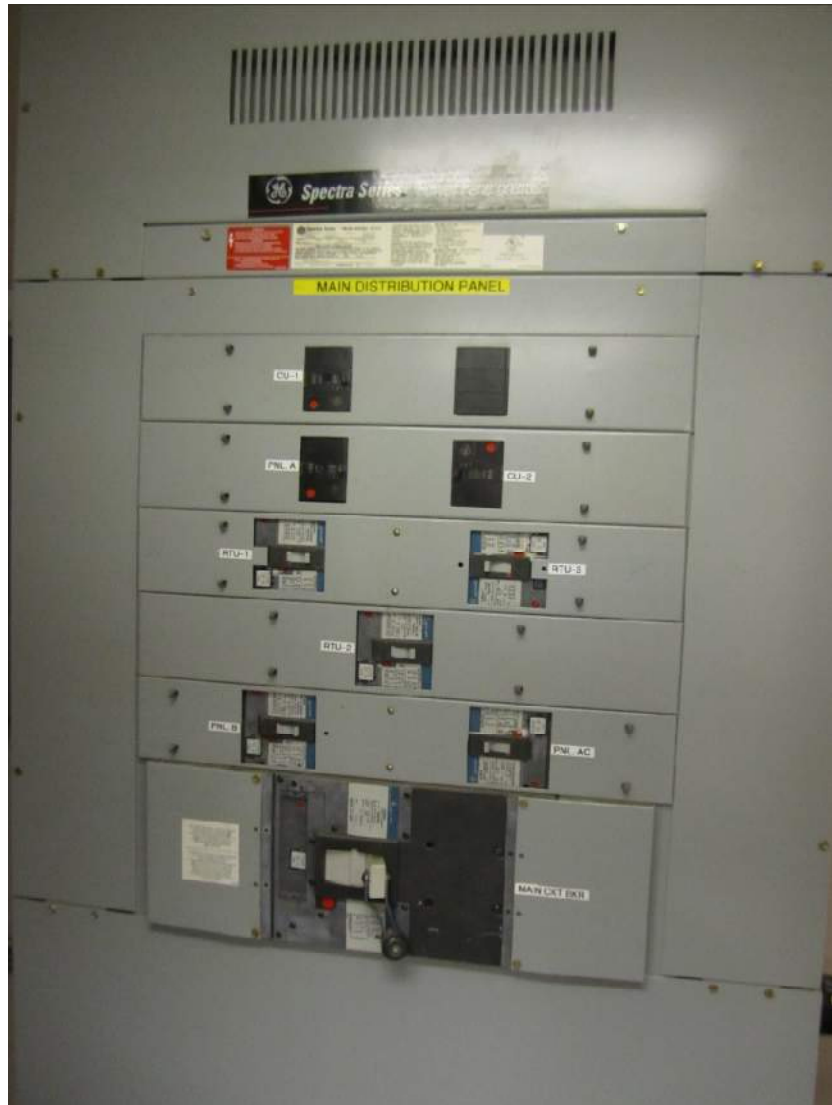
#### **GYM POWER**

Service entrance conductors and feeders were run in conduit both above grade and below grade. Above ground conduit appeared to be metallic type.

According to record drawings, it is presumed the power distribution system consists of all copper conductors.

Life safety devices are provided with battery back-up in the event normal utility power is lost.

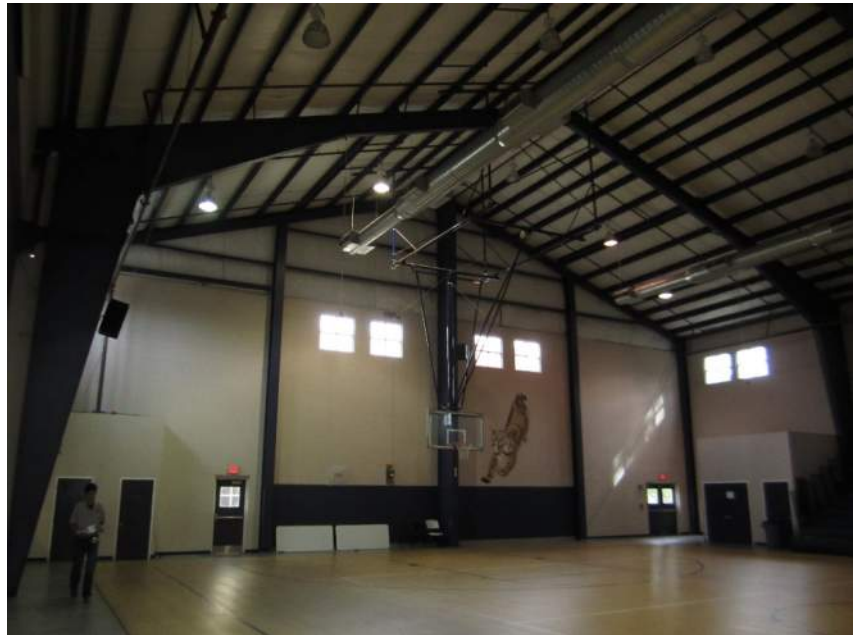
**GYM LIGHTS**

Lighting for the gym court consists of high bay, metal halide fixtures. Some of the fixtures are provided with quartz re-strike.

The building surrounds were illuminated by wall-mounted fixtures. These fixtures appeared to be fluorescent and/or incandescent type.

General interior lighting control, typically, consists of manual toggle switches within each enclosed space. There did not appear to be any automatic lighting control (i.e., occupancy sensors).

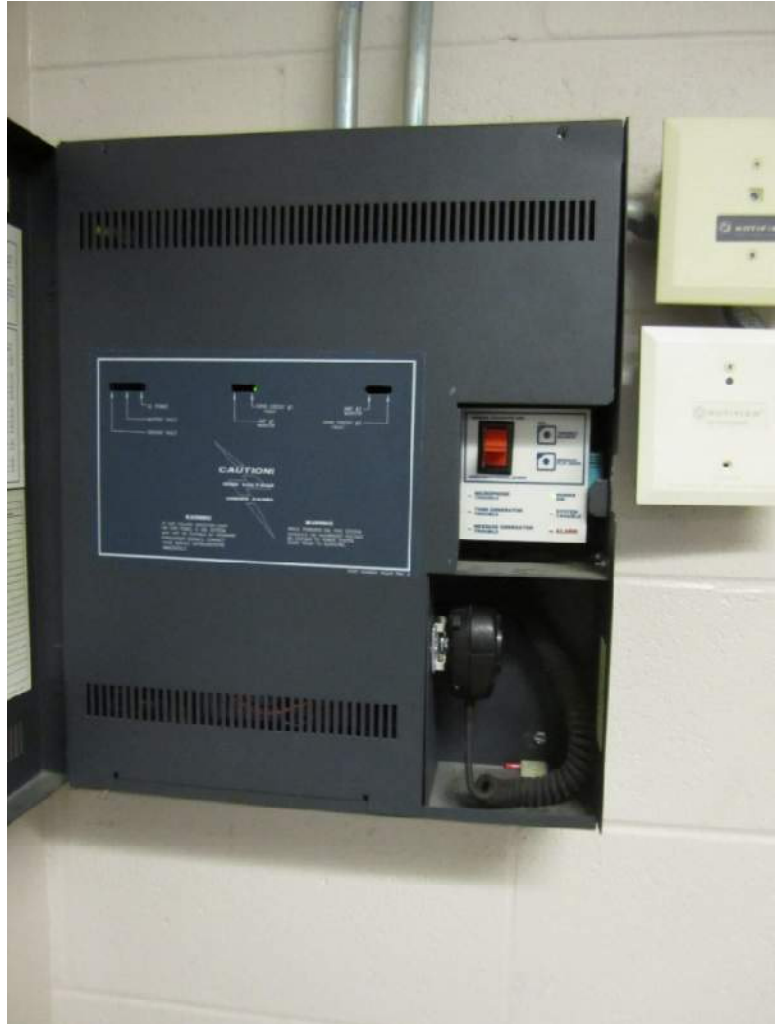
**GYM FIRE ALARM**

The existing fire alarm control panel (Notifier Model VEC-25/50) appears to be an addressable, voice evacuation system. The field devices consist of manual pull stations, speaker/strobes, spot-type smoke detectors, and heat detectors.

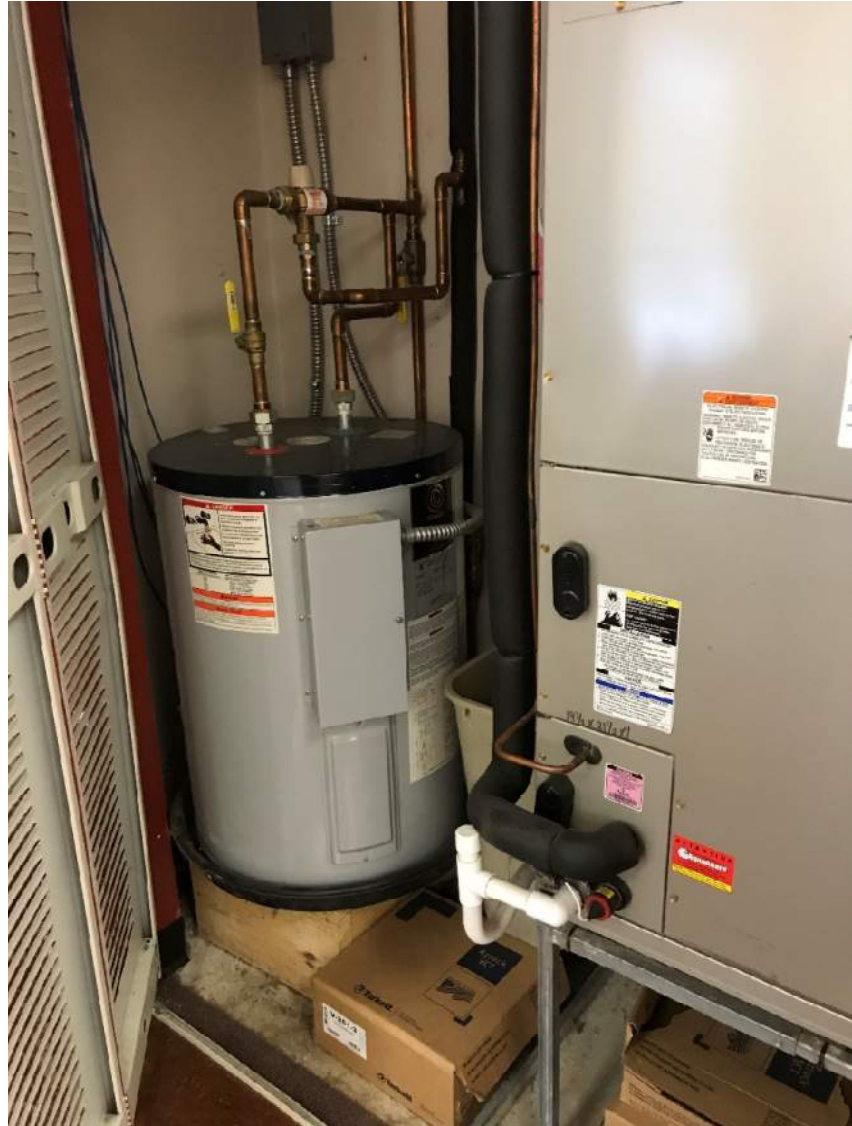
**GYM WATER HEATER**

The Gymnasium building has two 50-gallon, electric storage style water heaters that provide hot water to the entire building.

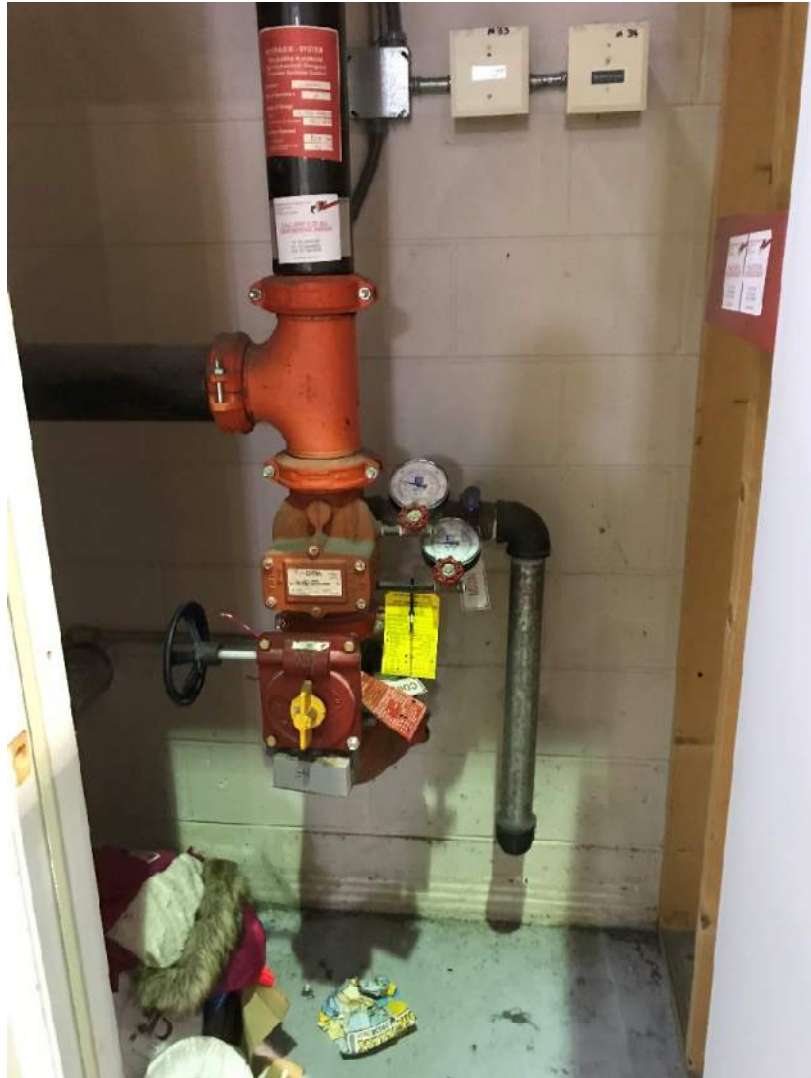
**GYM SPRINKLER RISER**

The Gymnasium is provided with a wet pipe sprinkler system riser that provides complete protection for the entire building. The single fire sprinkler riser is in a room on the north end of the building.
