Alvarez Residence Backus Road & West Lake Road, Palm Harbor Parcel: 07-28-16-00000-110-0700 Pinellas County, Florida Geotechnical Services July/August 2023

Report Number. 245375

Re: Geotechnical Investigation for Proposed New Alvarez Residence Backus Road & West Lake Road Property, Palm Harbor, Florida 34684 (Parcel: 07-28-16-00000-110-0700, Pinellas County, Florida) CFTL Report No. 245375

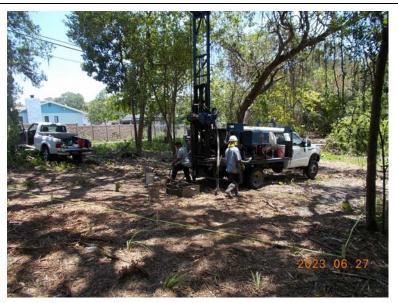
The borings were advanced using a truck mounted drill utilizing rig а recirculating bentonite drill fluid to maintain the borehole in noncohesive soils and to remove cuttings created by the drill bit. Upon completion the boreholes were sealed in accordance with **SWFWMD** regulations.
