## **FOLLOW-UP AUDIT OF PINELLAS COUNTY CAPITAL IMPROVEMENT PROGRAM AND INFRASTRUCTURE - UTILITIES**

**REPORT NO. 2019-24**  
**AUGUST 21, 2019**

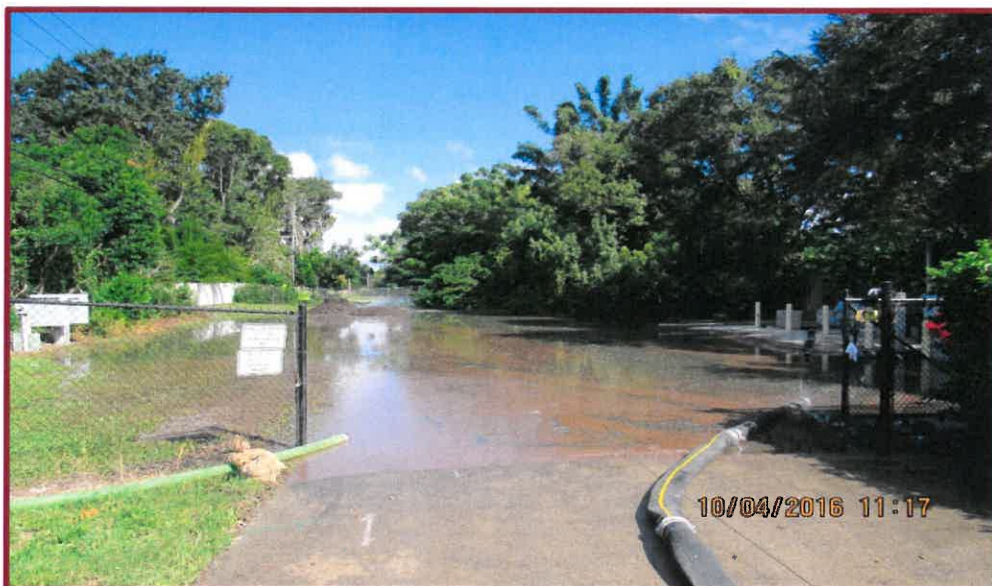
An example of a costly, unplanned failure occurred on October 4, 2016, when a 30-inch sewer line broke in the Palm Harbor area. We toured the area of the break, located on Alderman Road and Omaha Street, on October 4, 2016 at approximately 10:30 am. Utilities and contractor crews were already on-site responding to the issue. We observed that the sewer line break caused

sewage to spill out in the retention pond, almost to the sidewalk by the Utilities pumping station. The smell emerging from the break was very toxic; in addition, there was heavily soiled greenery by the street.

Management stated the break was a result of several factors, which included the age of the pipe, air release valves (ARVs) not opened due to odor issues from years past (it was an administrative decision at that time), as well as the set-up of the pipes that created unnecessary gasses to build up, which eroded the pipes faster than expected.

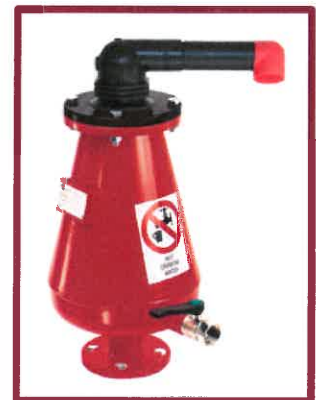
ARVs are hydromechanical devices designed to automatically release air and wastewater gases or admit air during the filling, draining, or operating of liquid piping systems for water and wastewater services. As air and gas pockets form in the sewer pipes, it is important to have functioning valves to release these gases to help prevent corrosion, burst pipes, as well as reduced sewer flow.

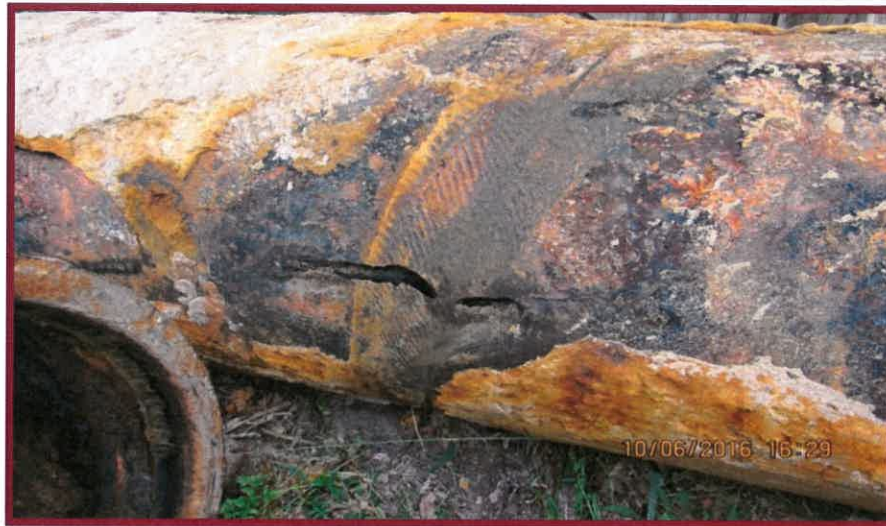
The picture below demonstrates the level of deterioration of the sewer force main, which caused the Palm Harbor sewage spill.

As a result of this spill, Management stated they will be changing their method of operations regarding ARVs, including not closing them despite the smell and complaints from citizens.

Starting in 2017, Utilities reviewed and reorganized their PM operations and now have a team solely dedicated for sewer ARV maintenance.
