Patel, Greene & Associates, PLLC

August 9, 2017

**Subject: Wetland Delineation for Parcel 03-29-16-00000-330-0700
910 South Bayshore Boulevard, Safety Harbor**

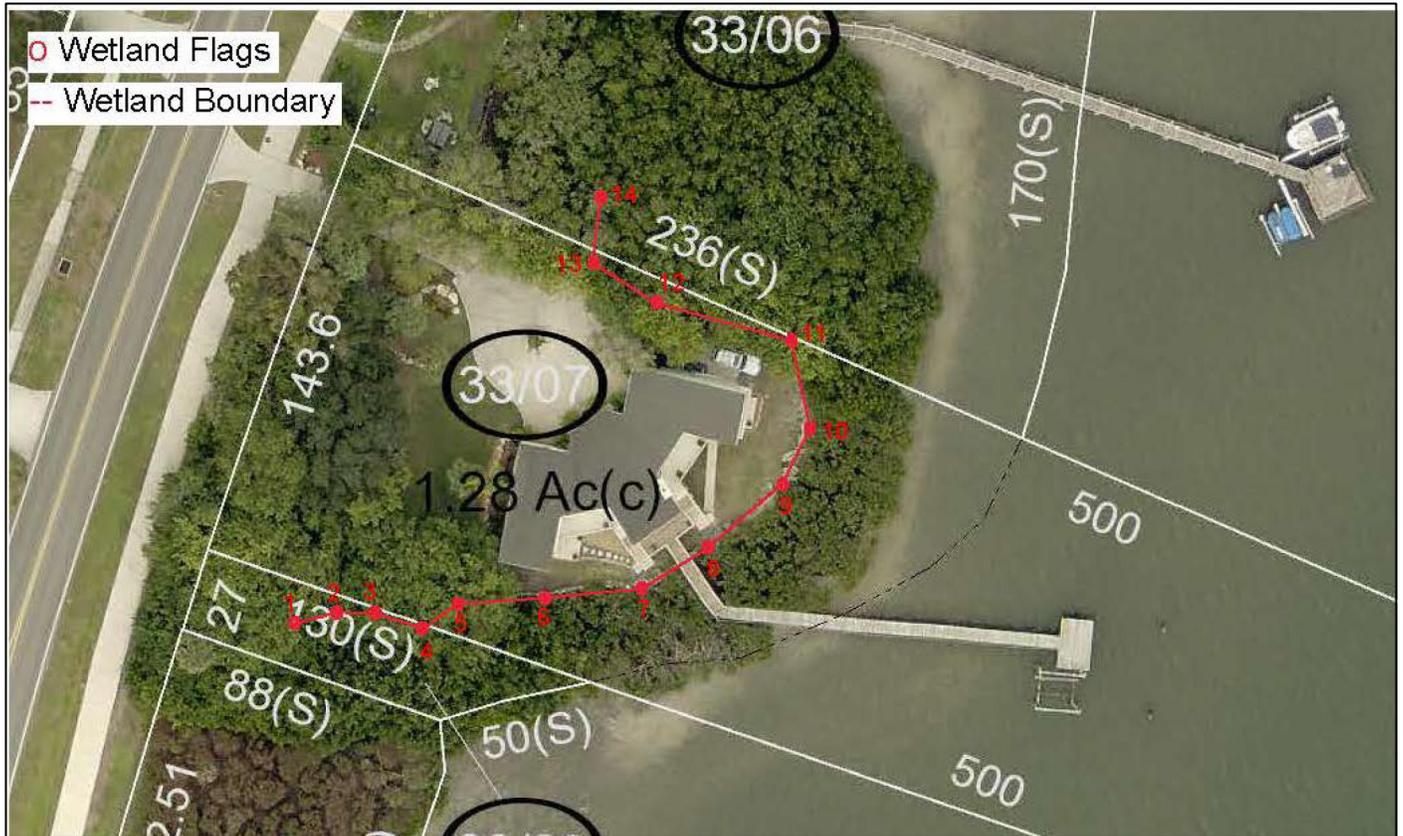
Figure 1: Aerial showing 910 S. Bayshore Boulevard with wetland boundary and flag locations that were delineated by Terry Cartwright, Lead Environmental Scientist with Patel, Green and Associates, PLLC on August 1, 2017.

As part of the field review, wetland boundaries at the project site were delineated using the procedures within Chapter 62-340 "Delineation of the Landward Extent of Wetlands and Surface Waters," Florida Administrative Code (FAC), and the criteria found within the U.S. Army Corps of Engineers (USACE) *Regional Supplement to the USACE Wetlands Delineation Manual: Atlantic and Gulf Coastal Plain Region* (Version 2.0). The wetland boundary at the project site was marked with 14 pink flags labeled as "Boss WL (1-14)" beginning on the southwest side of the property as shown on **Figure 1**. Most of the flags were set along the riprap top-of-bank except for Flags 1, 2, 12, 13, and 14, which show the wetland

boundary transitioning north and south of the project site. The flag locations were approximated on an aerial in the project file field notes. It is PGA's understanding that the wetland flags were surveyed, by others, on August 8, 2017 for inclusion on a site plan to be used for permitting through the City of Safety Harbor.
